## Case History: Bleacherman fixes others mistakes

**Situation:** Croton-Harmon High School in Croton, NY had 25-year-old Hussey Bleachers that showed signs of wear and tear. The school district contracted with a local company for bleacher refurbishment. Unfortunately, this refurbishment ended up costing a lot more than the owner had anticipated. The job was not completed to the owner's satisfaction and was not accepted upon completion. (This required additional expense for legal fees.) Ultimately, the Bleacherman was called in, to finish the job correctly.

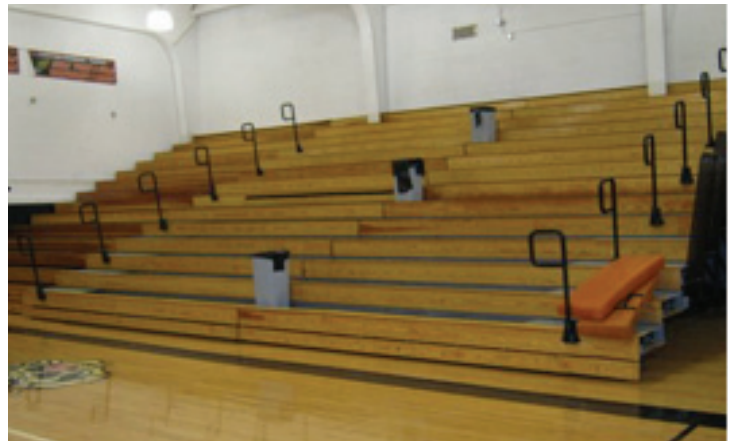
This photo shows the bleachers before the Bleacherman went to work. Note the aisles (with P-rails) are in the wrong location, and broken/damaged boards can be seen.

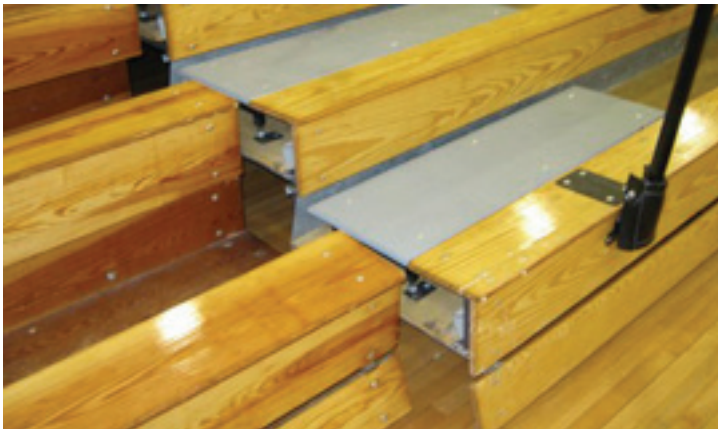
All the aisles with P-rails were incorrectly installed. P-rail should not be mounted in the first row -- in this position, it protrudes into the gym floor, presenting a safety hazard.

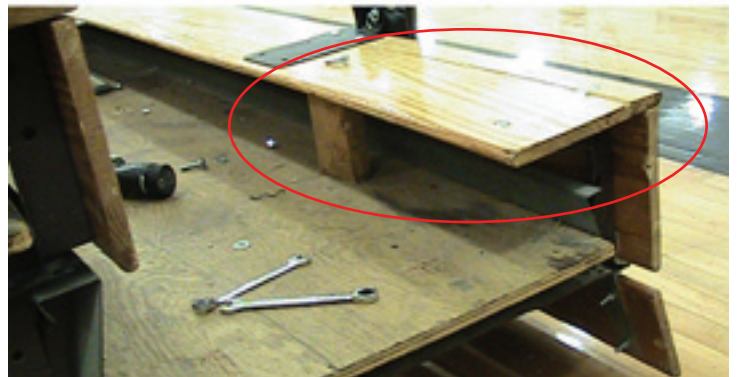
After removing aisle board, the unsafe workmanship that was previously hidden from view, was now evident and confirmed the owner's concerns for safety. Note broken seat-board at the aisle! (See pictures below).

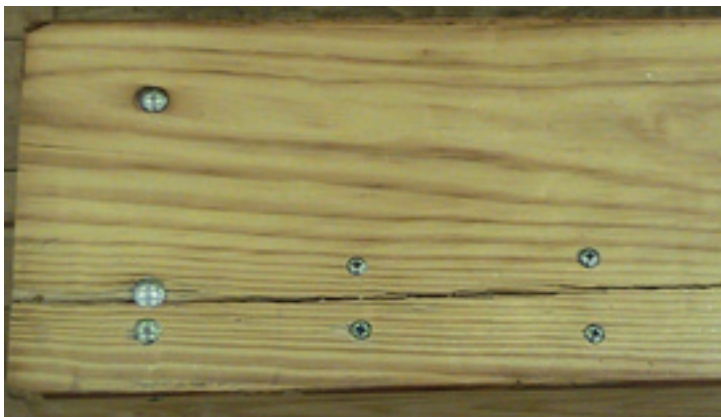
Top view of seatboard seen in photo above. See split running through where bolt is, with 5 additional screws trying to hold it together. This board is unsafe and must be replaced. It should never have been installed, much less at an aisle.

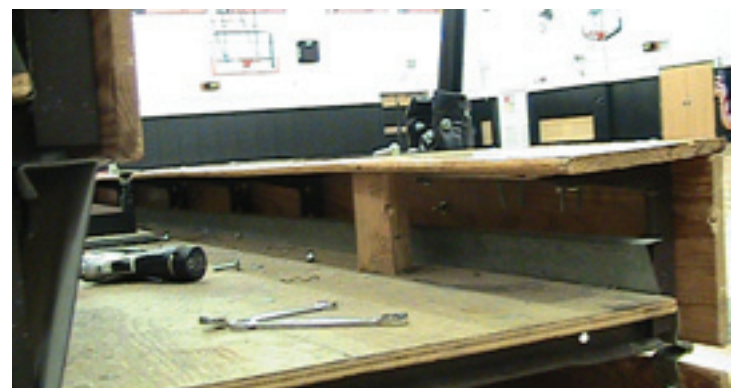
A chunk of wood was used to prop up the broken seatboard. There is no reinforcement for the P-rail attachment to the seat and riser. Potential safety hazards such as this (the first of many), point out the risk of using unqualified contractors to work on your bleachers.

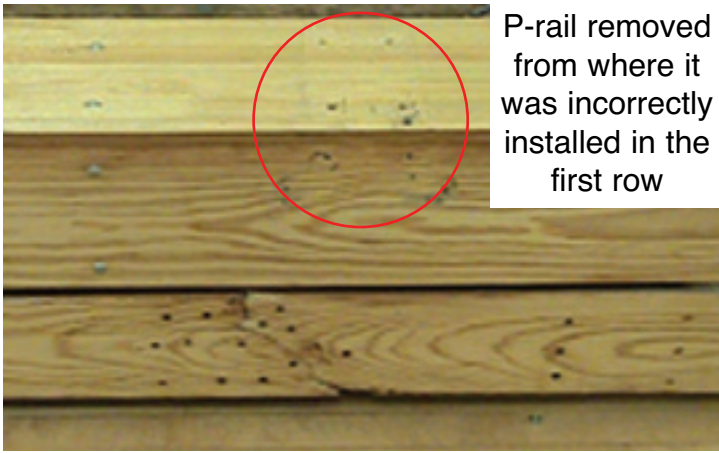
P-rail removed from where it was incorrectly installed in the first row

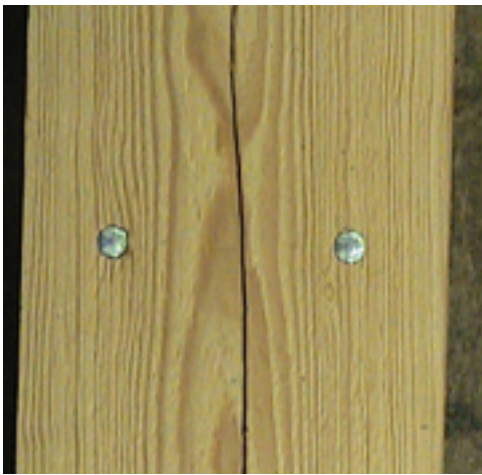
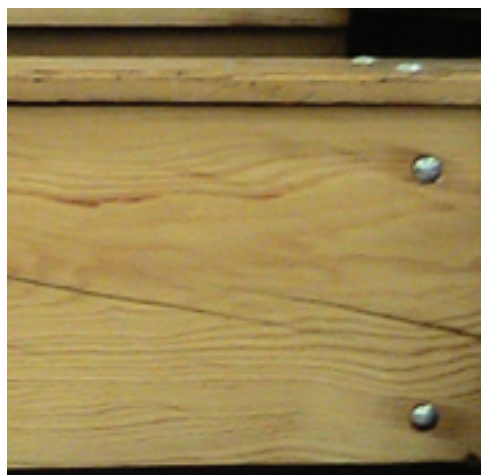
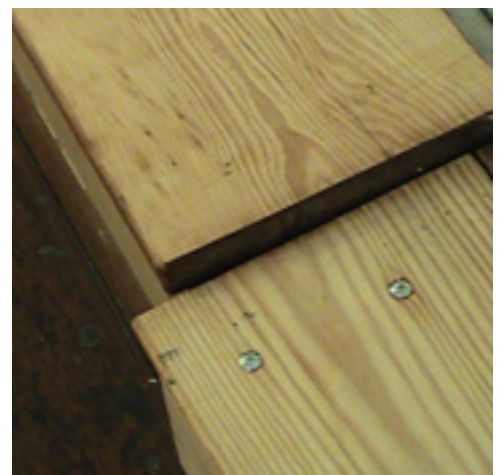
The contractor who originally worked on the bleacher refurbishment had refinished and reinstalled cracked and broken boards -- which should have been replaced.

These boards should have been reinstalled evenly. As seen above presents a trip hazard.

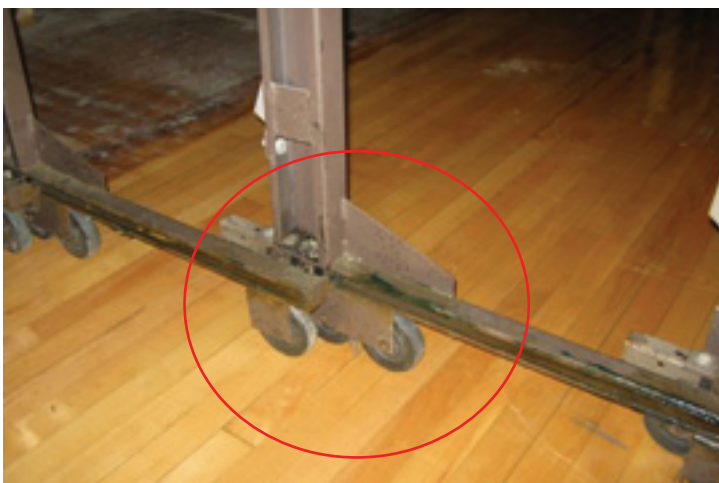
Circle shows where the row lock for this vertical support column used to be. It appears the contractor removed all of the row locks from the bleachers. This device actually locks the row in place in the open position, for added stability. These are a necessary and required part of the bleacher understructure. The Bleacherman replaced all the missing row locks from our extensive parts inventory.

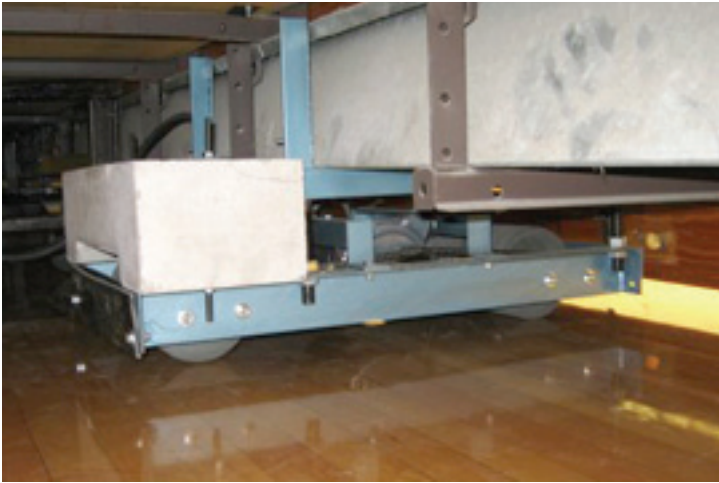
New motor drives were installed by the previous contractor. Even though these are brand-new, the motor drives were not working properly. Note white concrete weight mounted on the back of motor drive.

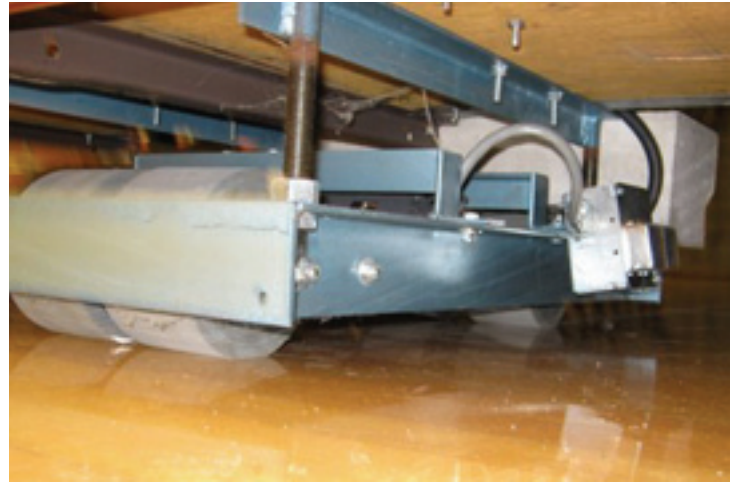
Motor drive seen from front, has no counter weight to offset the 90-lb weight on the back.

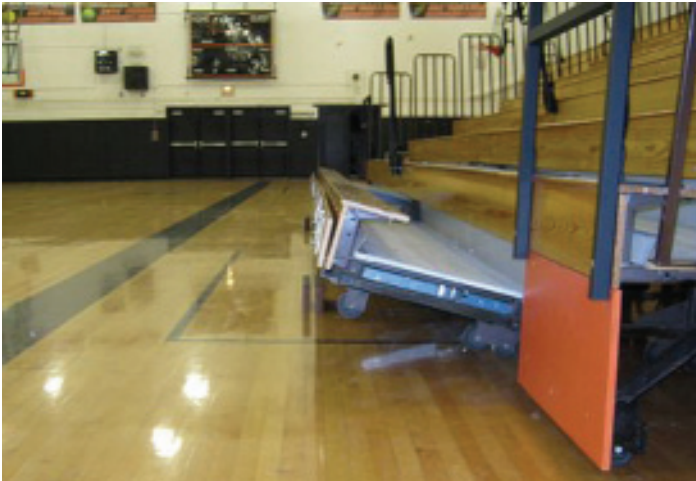
During operation to full open position, the first row would tilt up -- the front wheels of the motor drive and the bleachers would lift up, damaging the first row.

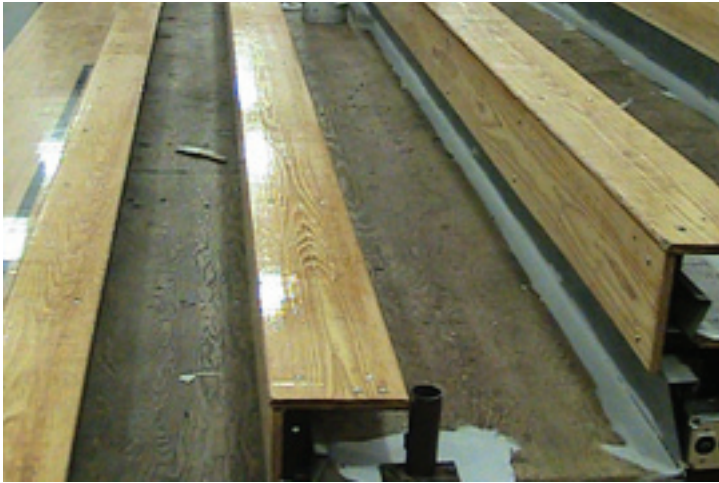
Plywood deck system was unsightly and needed to be finished for an as-new look. Photo above shows the footboards prepared for painting -- workers have started edging the heelboards prior to painting the deck.
