On-line “Quick Quote” starts the process, saves thousands

Situation: Biola University is a private Christian university located in La Miranda, California (near Los Angeles). The telescopic bleachers in the University’s Chase Gymnasium and Fitness Center had seen better days since they were installed over 30 years ago. Originally manufactured by Hussey® Seating Co., the wood seating was worn, scratched and shabby-looking. What’s worse, the understructure was showing

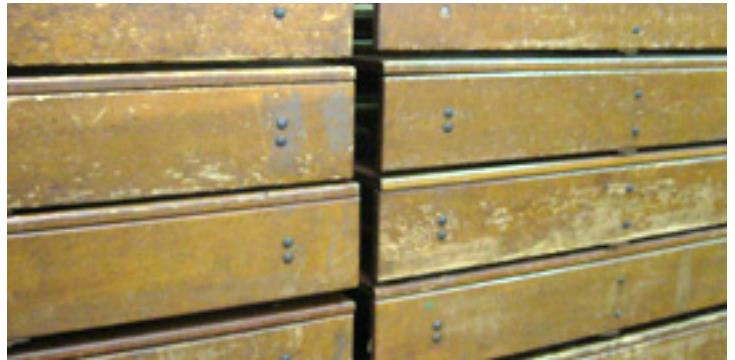
The wood bleachers in the Chase Gymnasium showed their age. Note the gap between sections.

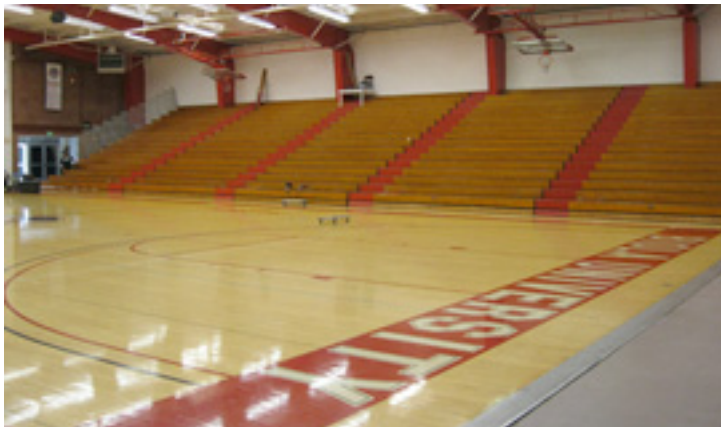
Outdated bleachers lacked proper safety equipment required to be code-compliant. Other serious problems are hidden from view, underneath the bleachers.

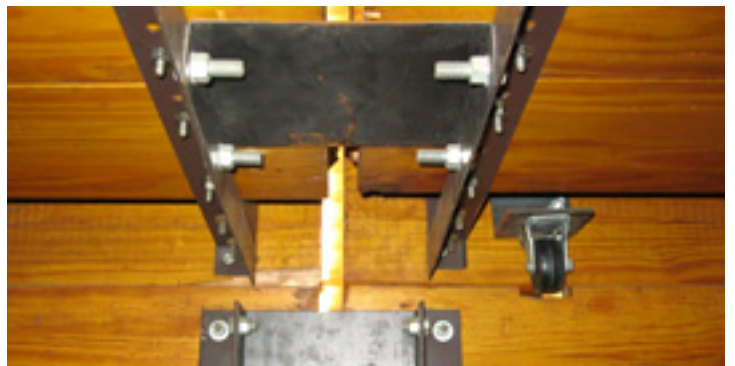
Original row ties shown here do NOT close the gap between sections, which requires that the bleachers be unbolted from the wall and pushed together to fit flush. Note wheel on footboard does NOT provide continuous support like the Century Design® system does.

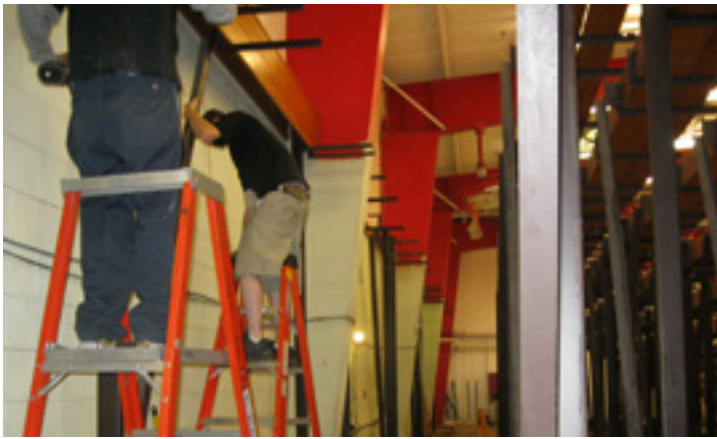
First, the Bleacherman crew unbolted the old bleachers from the wall, in order to join the sections together flush and remove the top row.

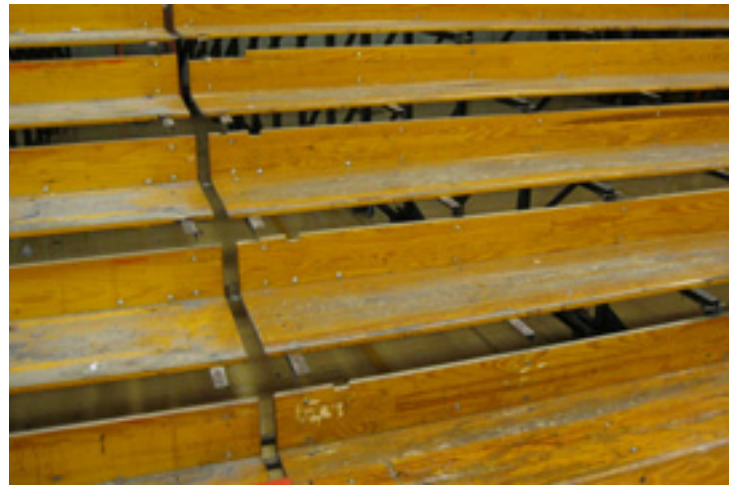
Seat boards and risers are removed for planing and edging. Heelboards and footboard remain in place for refinishing.

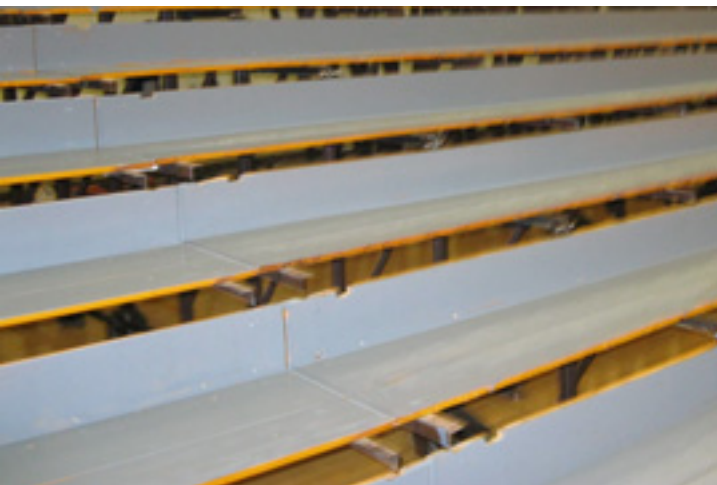
Heelboards and footboards are painted a contrasting color of wear-resistant enamel. Note flush fit (no gaps) between sections.

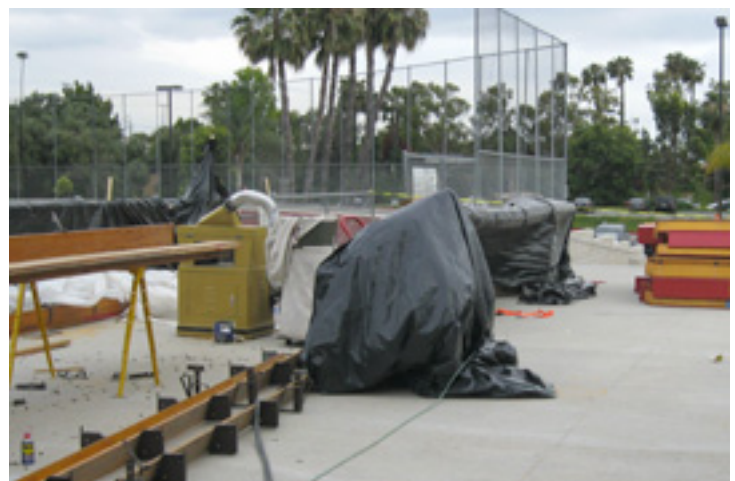
Bleacherman's sanding/edging/refinishing equipment set up outside at Biola University. Seatboards and risers were recycled and refinished on-site.

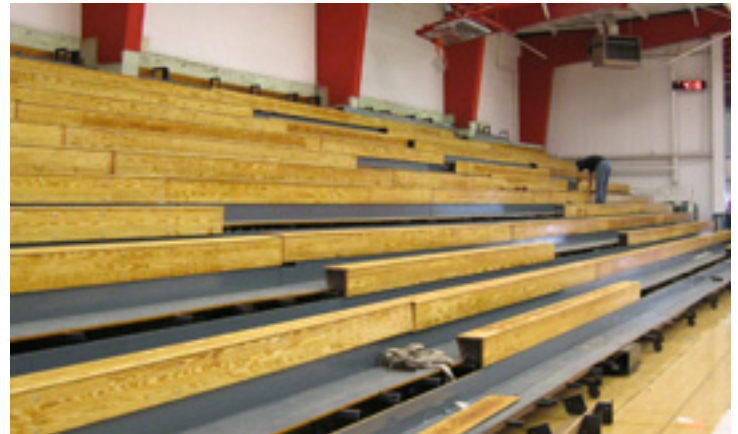
What a difference. after the original wood is planed, edged, sanded and sealed. It's hard to believe it's the same wood!

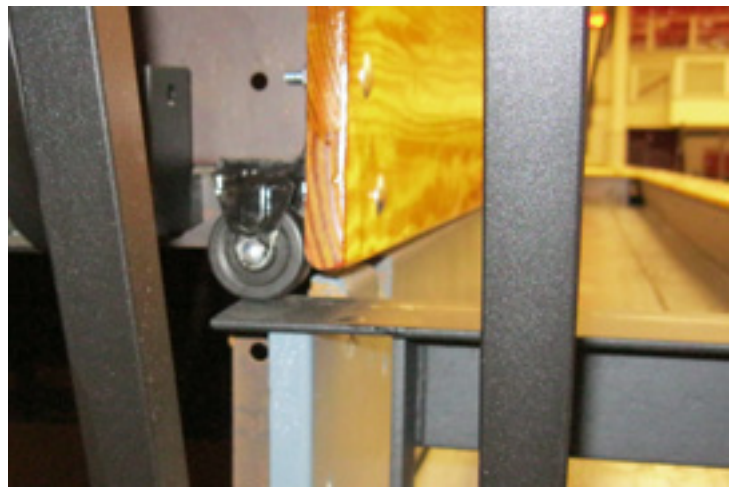
Close-up showing Century Design® system wheel on runner. This patented system prevents sagging because it supports the bleacher structure in any position.

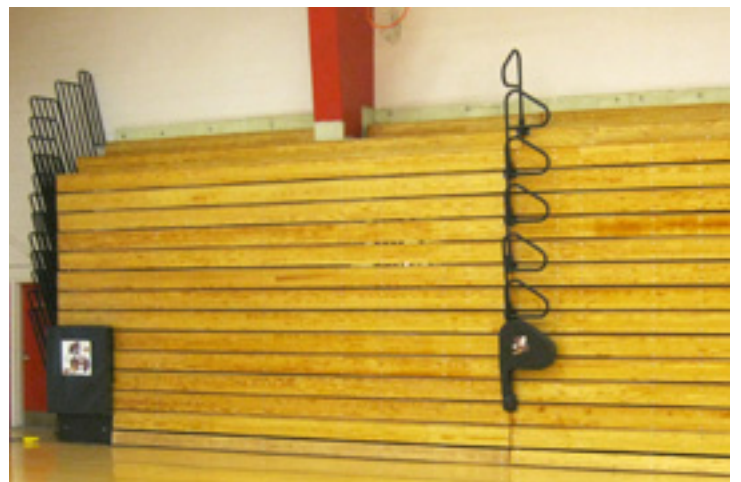
Refurbished Bleachers in closed position. Note padding on ADA rail at end, also customized with the school mascot.
