Case History: Camp Edwards, MA

Rusted bleachers repaired and refinished -- transformed into Evergreen Bleachers™

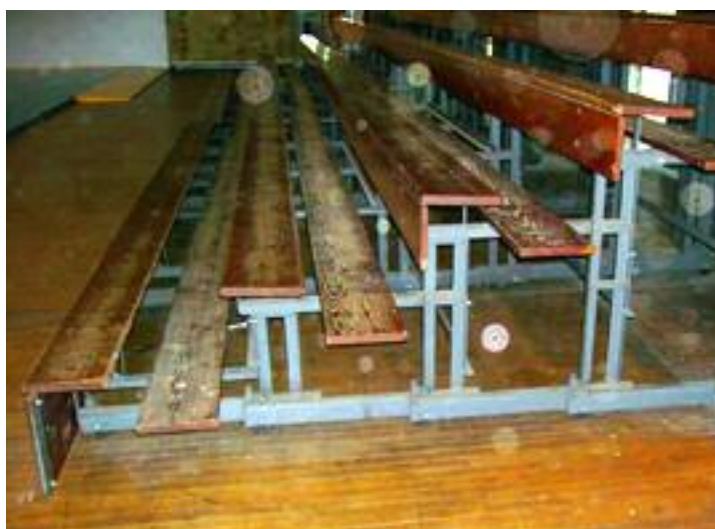
The finish on the original Safway bleachers was completely worn away in spots. These bleachers have an open deck system, with large gaps on each side of floorboards.

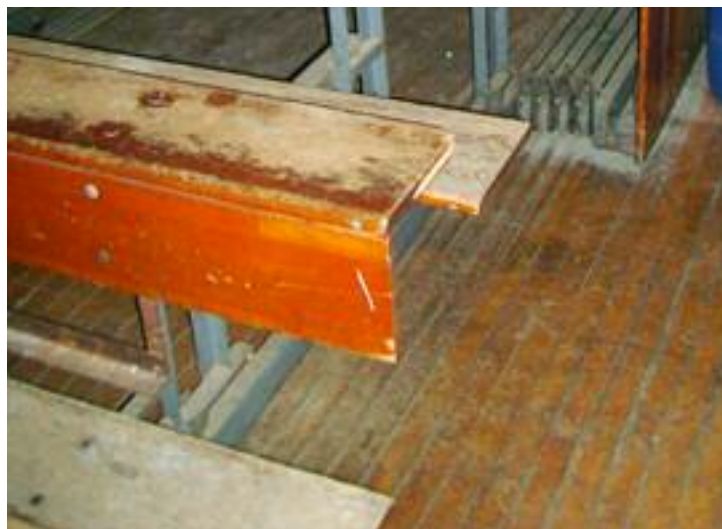
Even though the cosmetic appearance was bad, these bleachers had some good points: one-inch solid Fir wood and a four horse understructure. Note condition of original floor.

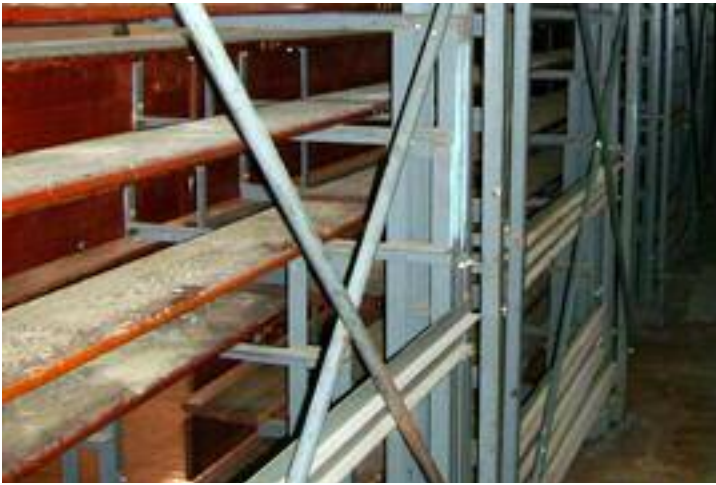
View from the back. Floorboards are extensively worn. Most of the understructure was sound, with minor rust, mainly on the lower portions.

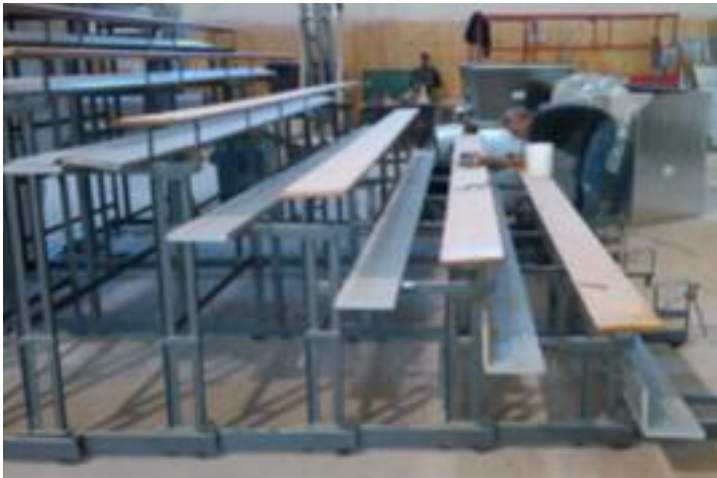
In this picture, the understructure has been reconditioned and painted.

remove rust, then treated with a phosphate solution to prevent future rust. Finally it was primed and coated with a protective rust-resistant finish. The wood was refinished to “as new” condition and re-installed on the reconditioned understructure.

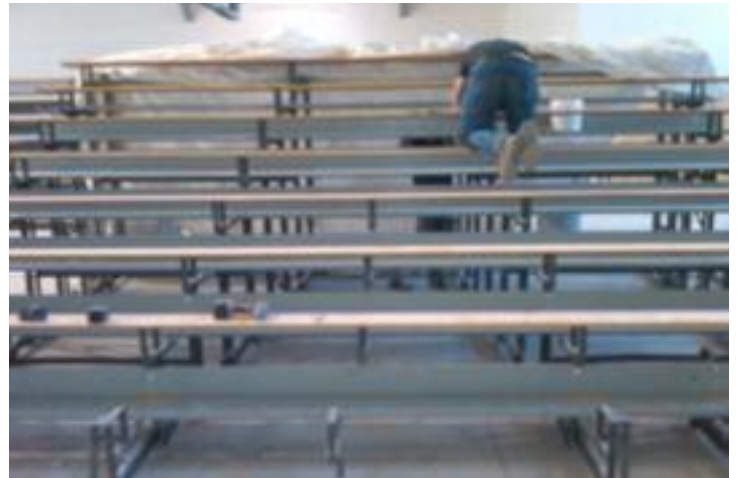
Bleacherman crew members are beginning to re-attach refined lumber. Floorboards and heelboards have been primed.

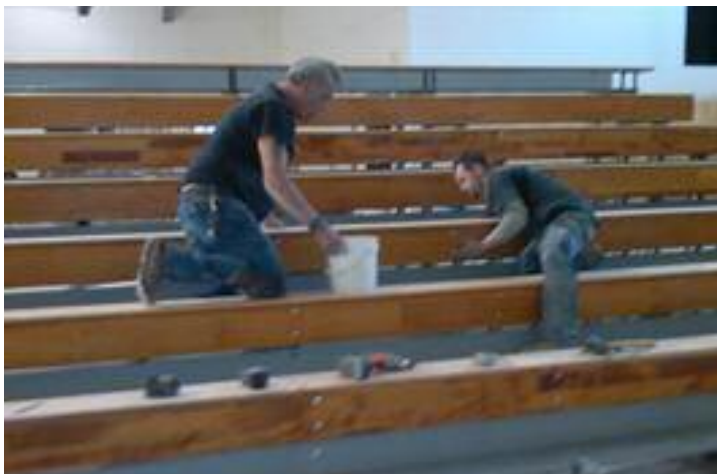
Crew members installing risers.

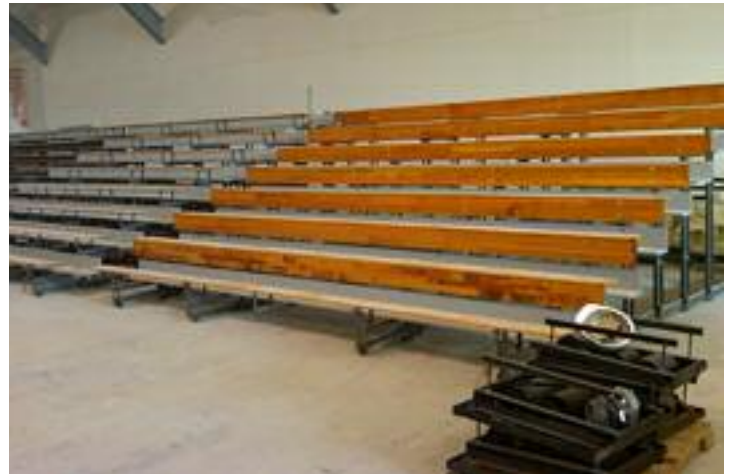
Work in progress: the bleacher section in front has new seats and risers installed.

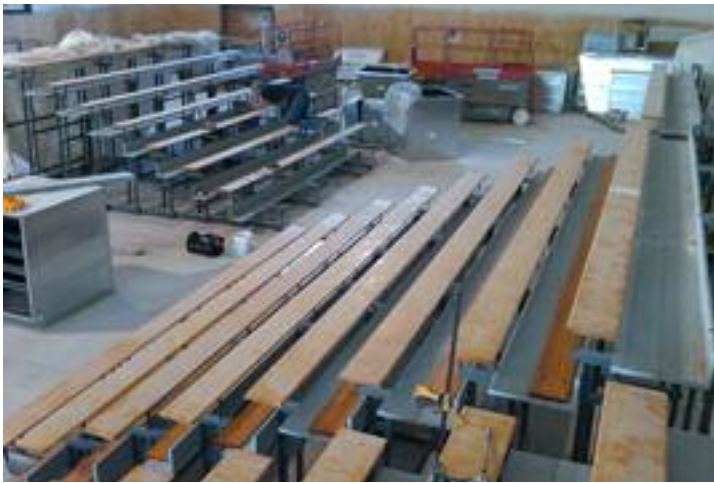
All of the bleachers were unanchored from the wall and moved, so that floor renovations could proceed. Note new riser boards on floorboards, “staged” for installation.

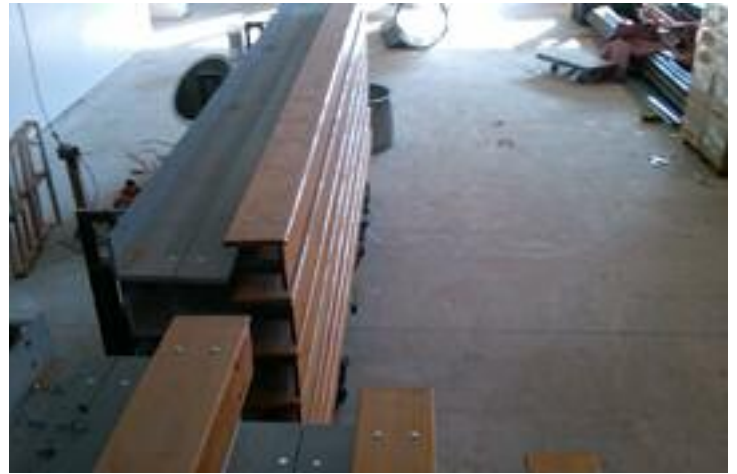
Reconditioned bleachers are ready to be re-anchored in the next step of renovation.

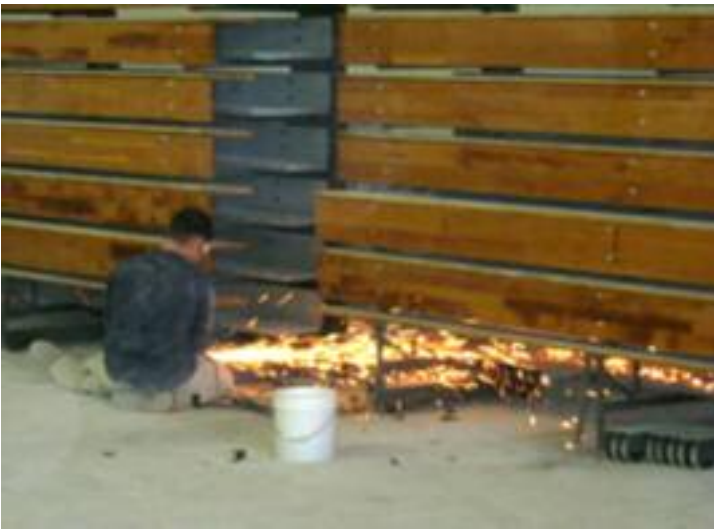
Bleacherman crew member prepping understructure for new nosebeam assembly.

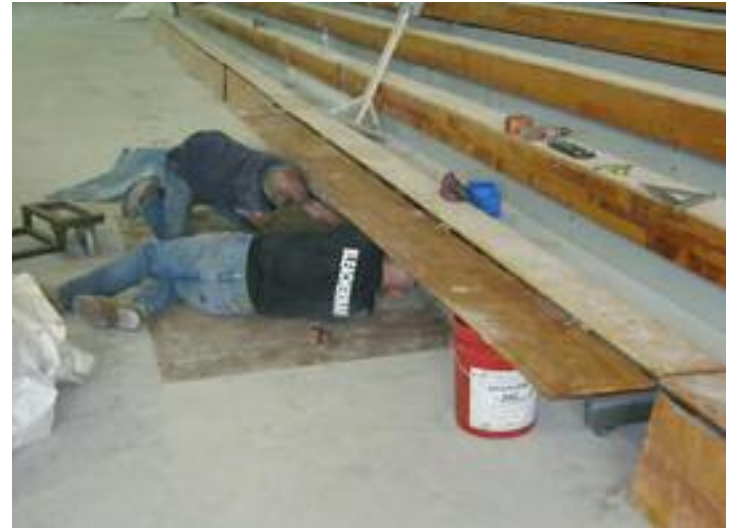
Preparing mount for new motorized drives to be installed.

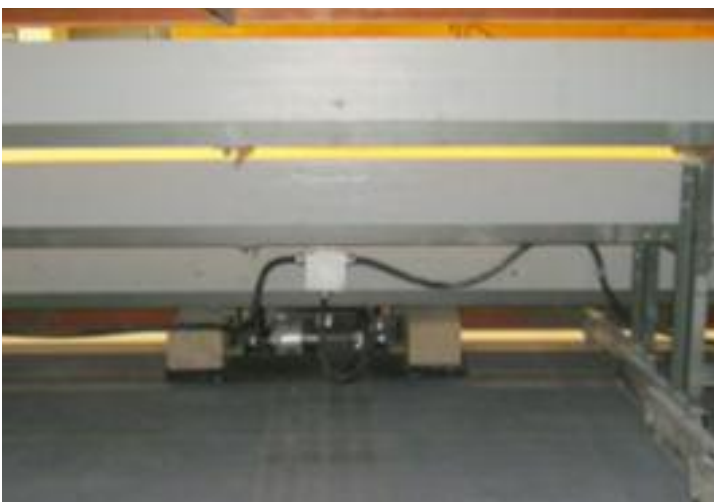
Bleacherman’s heavy duty motorized drive, as seen from the back. Note ballast blocks on either side to add weight and increase traction.

Also, motorized drives were installed on these previously manually operated (!) bleachers, along with the patented Century Design® “no-sag” system.

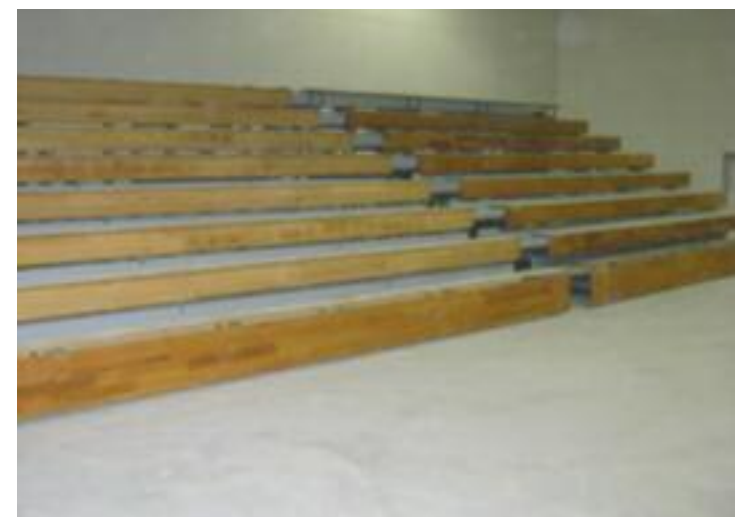
Bleacher section in the foreground is ready for stain application, to match bleachers in background.

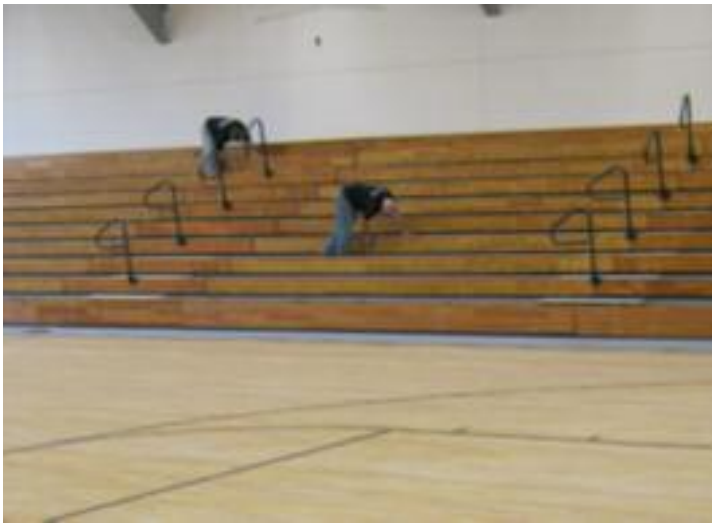
Applying the final seal coat. Owner was very particular about appearance of the refinished bleachers.

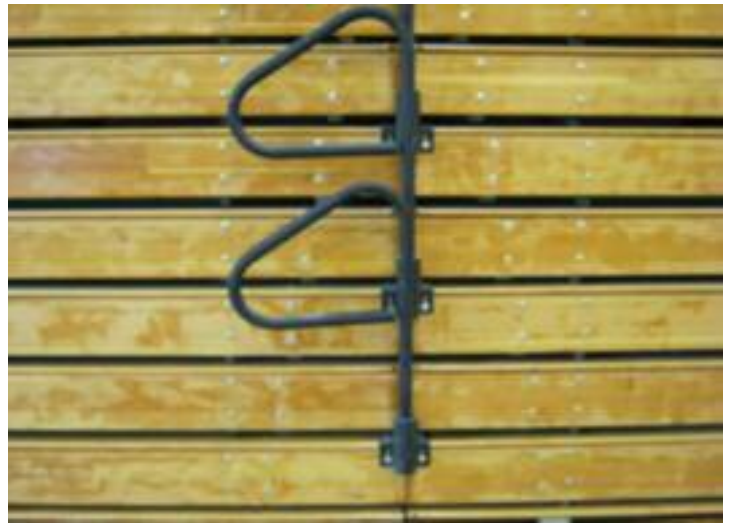
Refinished Fir lumber shows the natural color variations that are typical for this material.

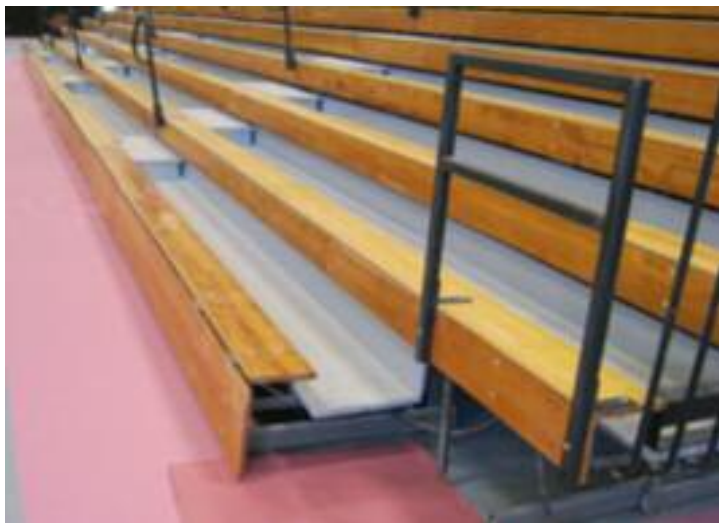
Bleachers are nearing completion, with P-rails, intermediate steps and ADA cutouts installed.

Refurbishing the understructure and refinishing the wood transformed the bleachers into new Evergreen Bleachers™, with all the features required to make the bleachers code-compliant, such as self-storing end safety rails, aisles with P-rails, intermediate steps with non-skid surfaces, ADA cut-outs with safety rails.

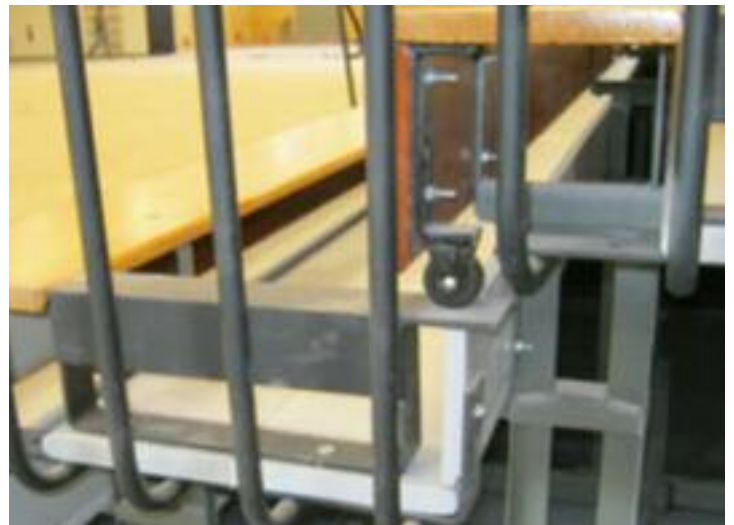
Patented Century Design® "no-sag" system installed. Wheel rests on seat level runner for continuous support.
