Case History: Lejeune High School, Camp Lejeune, North Carolina

Recycling saves money, helps qualify construction for LEED credits

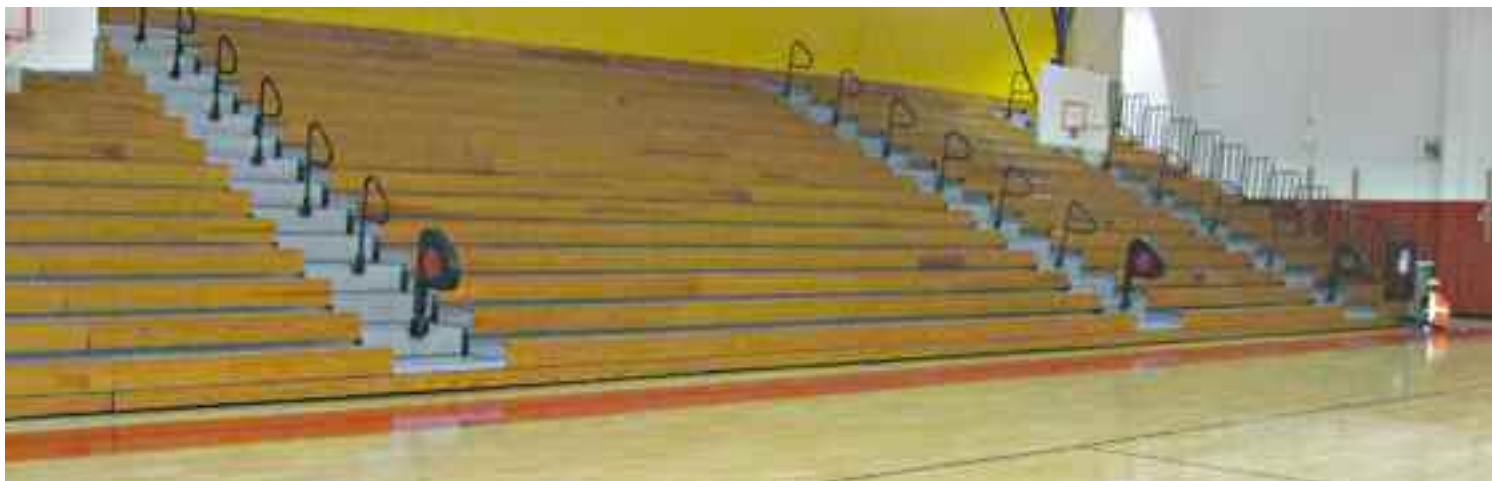
Unfortunately, no "before" pictures are available for the Lejeune High School project. The photo above shows the bleachers after they were repaired and relocated onto the new floor. (The wood risers and seating were in good condition and did not require refinishing.)

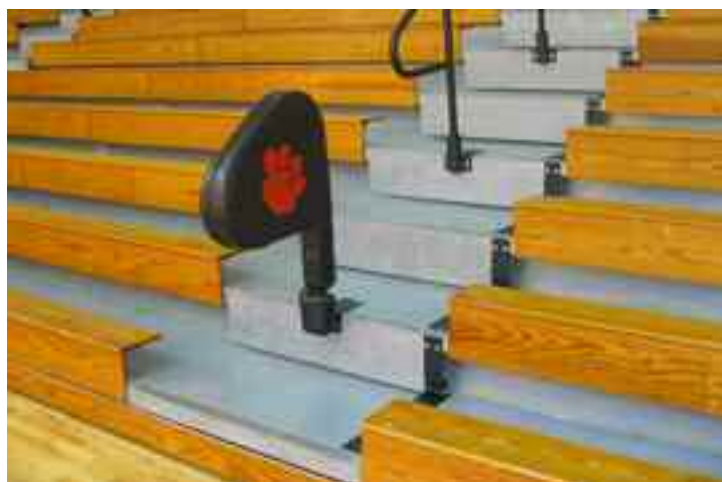
These bleachers were originally manufactured with aisle closure panels with no intermediate steps.

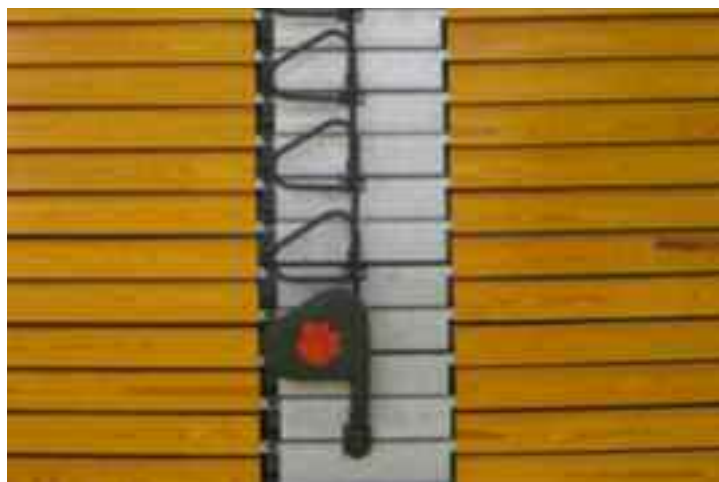
Aisle closure panels deter climbing on the bleachers in the closed position. The owner chose not to discard this feature.

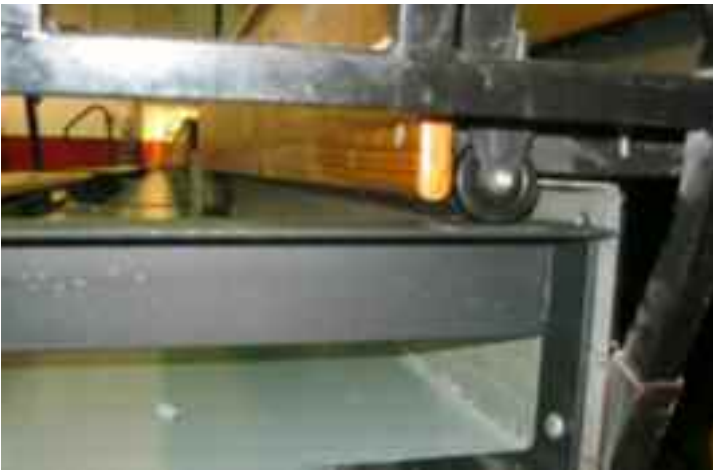
Further inspection revealed the real problems: the bleachers were sagging, the old motors were underpowered, plus the drive rollers were decomposing and delaminating.

Sagging of bleachers (which makes them hard to open and close) is prevented with the addition of the patented Century Design® “no-sag” system, after the understructure was repaired. This photo shows a Century Design® wheel on a seat-level runner at the end of the bleachers.

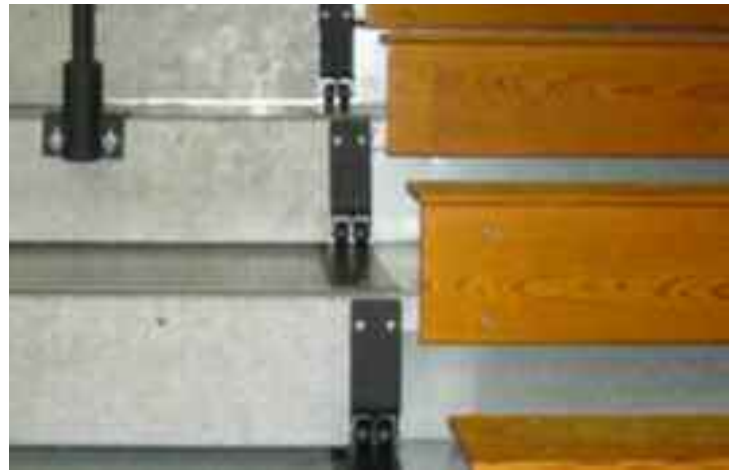
Century Design® was also installed at the aisles. A two-wheel design on one side of the aisle is used here due to the sagging issues, instead of the more common one-wheel system, to assure long-term trouble-free use.

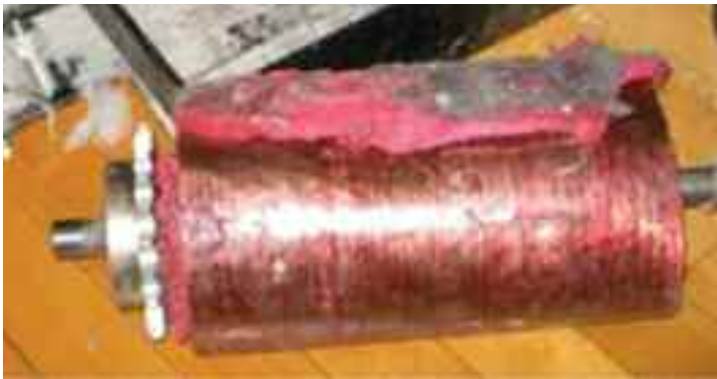
Typical drive roller showing deterioration and delamination of the outer covering from the metal roller. We replaced five existing motors with our heavy duty motors equipped with 50-durometer drive rollers that won't delaminate, guaranteed.

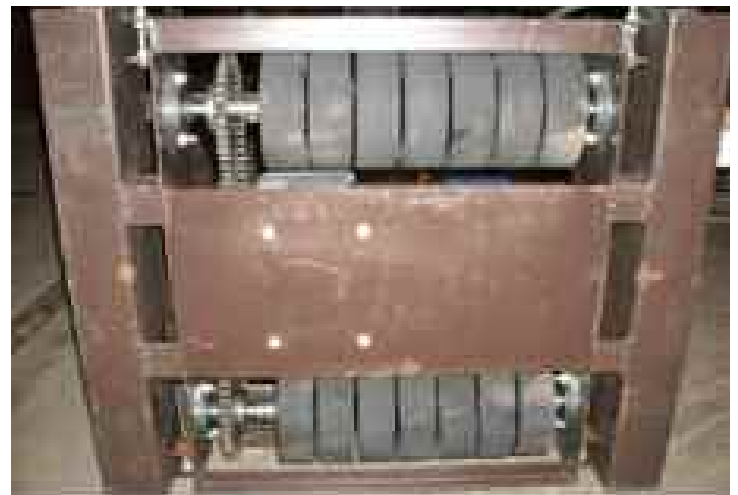
Bottom view of Bleacherman's heavy duty motor drive replacement shows two rows of 14-inch wide drive wheels for maximum traction.

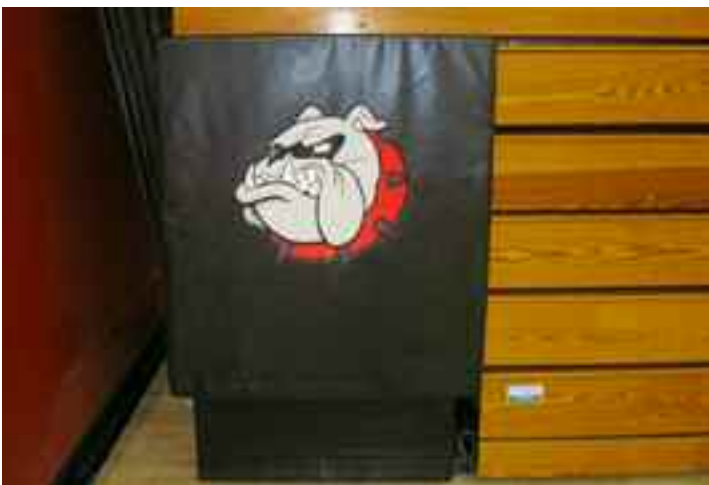
School mascot “Devil Pups” appears on ADA safety rail pads. A popular nickname, Marines were called “devil dogs” by the Germans in WWI, which is where the mascot comes from.

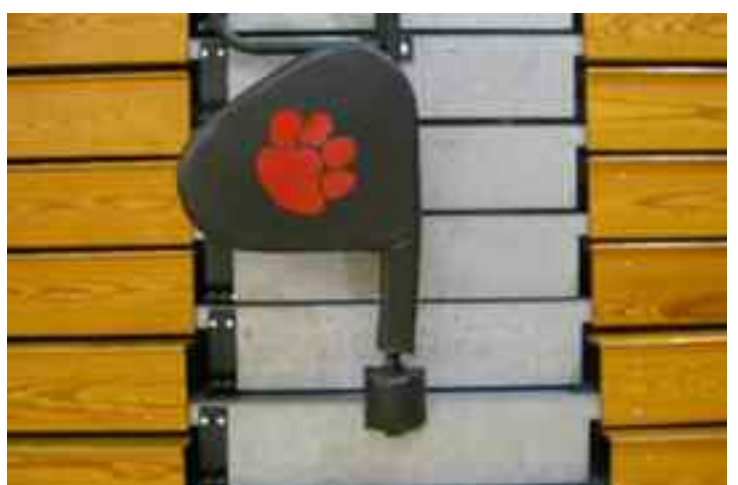
P-rail pads continue the “devil pups” motif, with a paw print screen-printed on both sides. Logo artwork for Lejeune High School's padding was donated by Sgt. Mark Schumaker and Lcpl. Robert McArthur (both retired Marines).

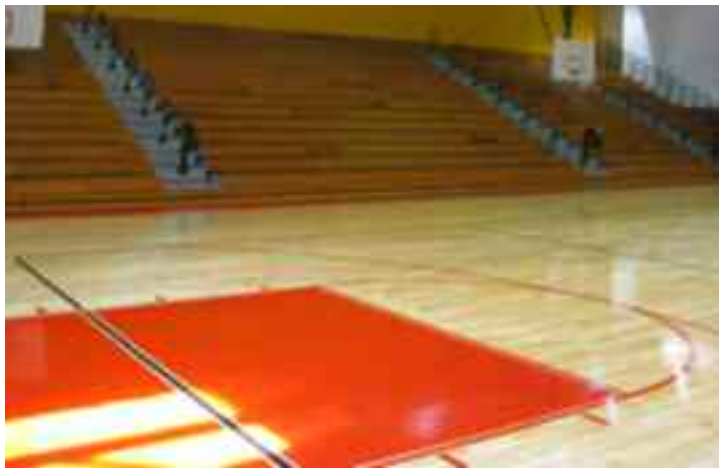
Brand new gym floor gleams in the photo above. If you are considering a new floor in your gym (or sanding/refinishing the existing floor), please note you do NOT have to discard your old bleachers! However, you may want to hire a specialist who knows how to move them.

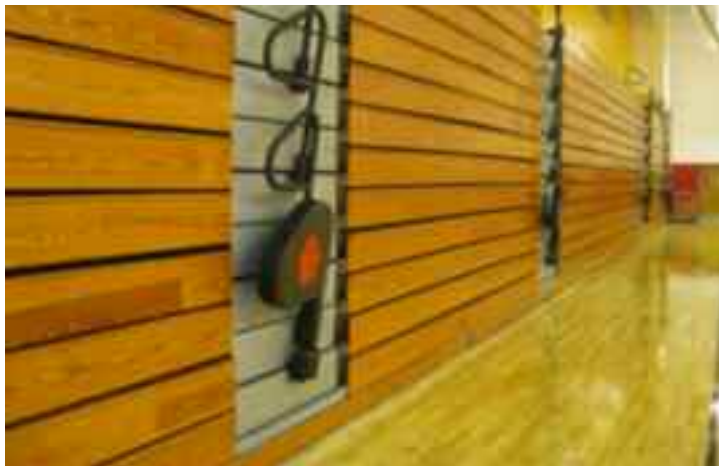
Refurbished bleachers in closed position. Note the lack of wheel marks on the floor in front of the bleachers. To keep your gym floor looking new, always clean the floor prior to opening the bleachers. This will remove any dirt or dust which can adhere to the understructure wheels and permanently mark the gym floor.

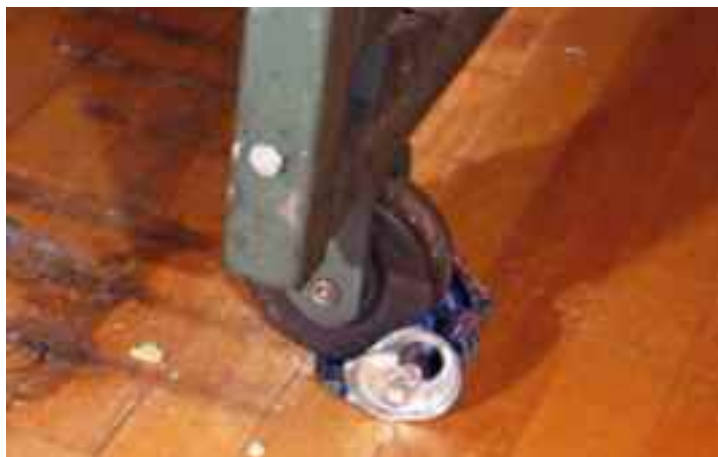
Above is an example of what NOT to do. Garbage, dirt and debris underneath the bleachers can also cause problems. Even though the understructure wheels are non-marking, over time they can pick up dirt and mark the gym floor with black lines.
