Case History: Old bleachers become new again

Situation: Chatham High School in Chatham, NJ had Hussey Bleachers. The wood seatboards, risers and other lumber showed the wear-and-tear of 25+ years of service -- they were discolored, dingy, and overall not attractive. Understructure was sagging and also required repair and service. Even though their appearance was delapidated, and safety updates were required, the basics were sound and could be brought to a "like new" condition at a substantial savings, compared to installing new bleachers. Installing a Century Design® "no-sag" system means these bleachers will continue to operate properly, without the problems associated with sagging.

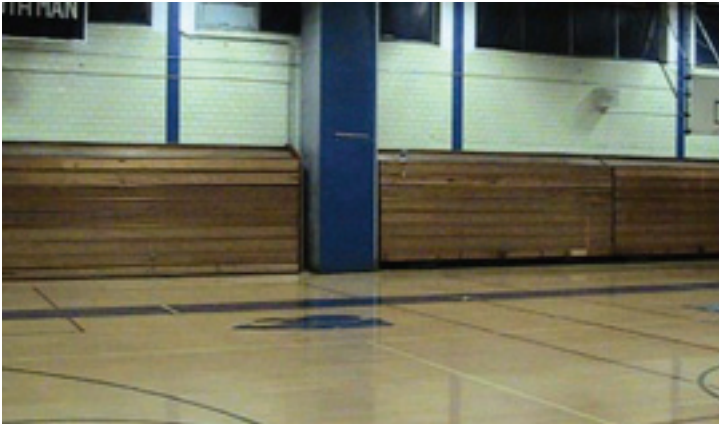
Original bleachers in closed position – No end safety rails, no aisles or ADA wheelchair spaces.

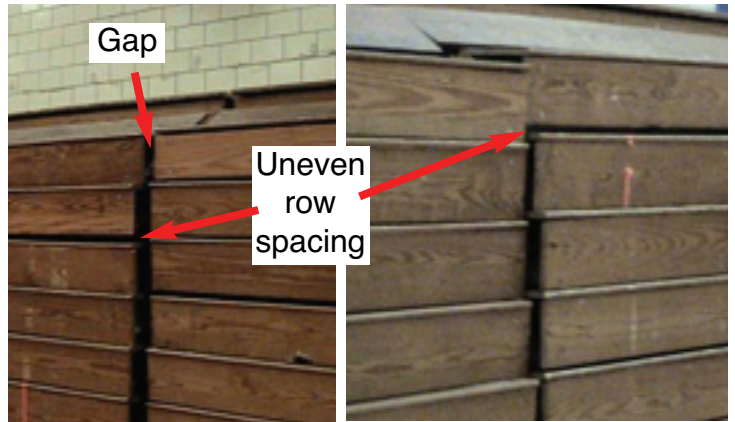
Manually-operated bleachers have gaps between sections, presenting a safety hazard. Also note uneven spacing between rows, a sign that these bleachers are sagging, thus hard to operate.

P-rails and seat level aisles with non-skid tape were installed. Note: bleachers were unanchored, realigned (to eliminate gaps) and motor drives added. Compare this to the gaps between sections shown on page 1.

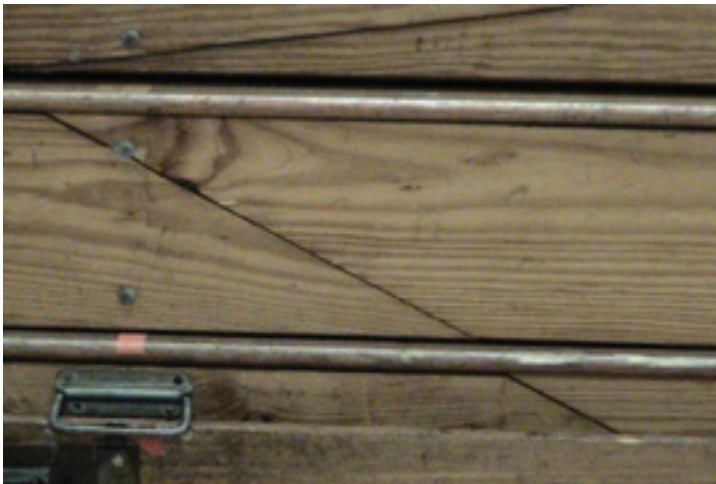
Broken boards have been crudely spliced together, but are not structurally as strong as a whole board,

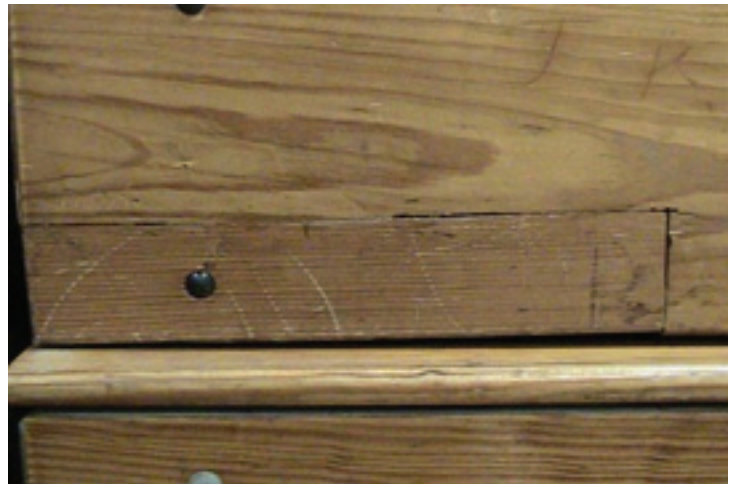
Here's another attempted repair, where a chunk of wood was bolted in, to replace a broken piece.

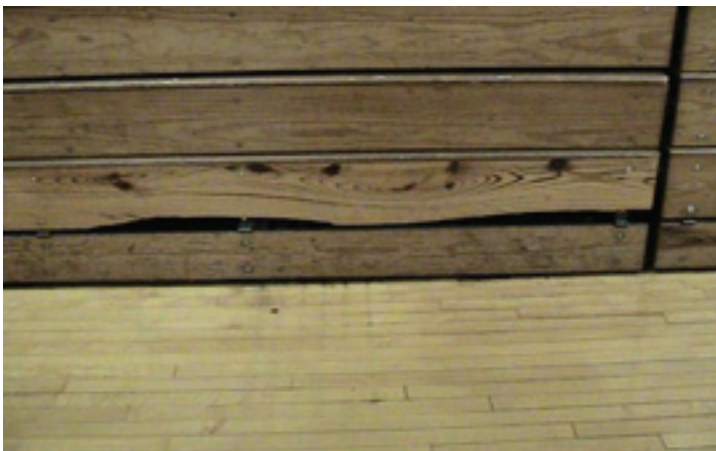
An original Southern Yellow Pine board was replaced with a locally-sourced Pine board with lots of knots. It has broken at the bottom and should be replaced.

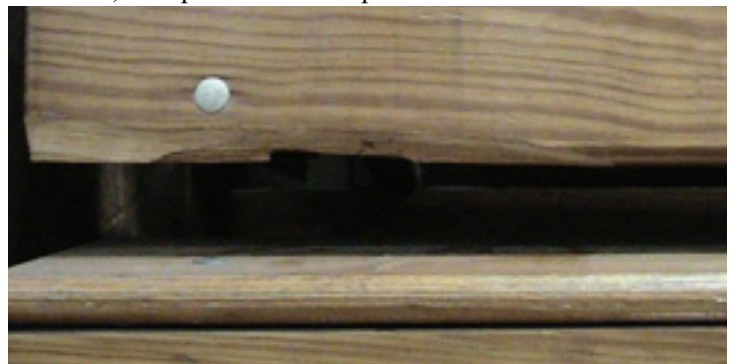
Another broken board. It will be replaced by a new board from the Bleacherman's inventory of wood, using the same species (Southern Yellow Pine) and stained to match. Our wood shop can manufacture any type or size of board needed for your bleachers: Pine, Fir, Mahogany, solid, finger-jointed, or laminated. [Click here for more info.](#)

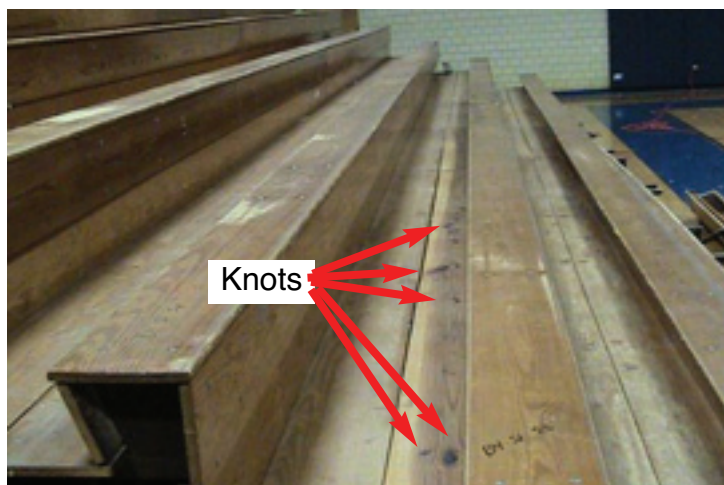
One of the footboards has been replaced with a locally-sourced Pine board. Note all the knots in the board. A knot is a “break” in the board, a weak spot where it is likely to break. All non-compliant boards were removed and replaced before deck was refinished.

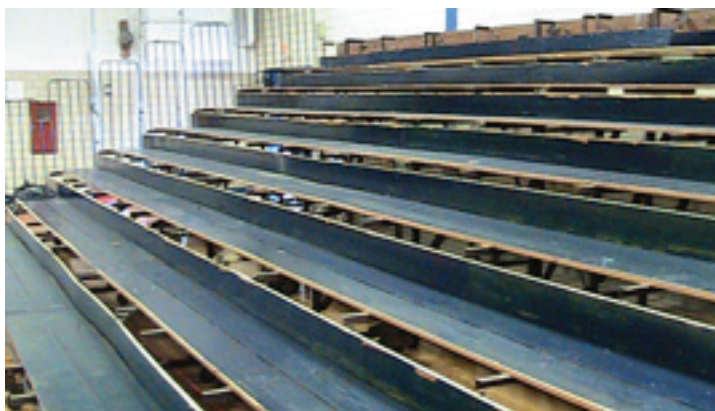
Seats, risers and toeboards were removed as one unit and sent to our shop for refinishing. Decks were cleaned and sanded. Here they are being painted with the first of two coats of approved floor and deck enamel. Owner chose the school colors for the contrasting deck color

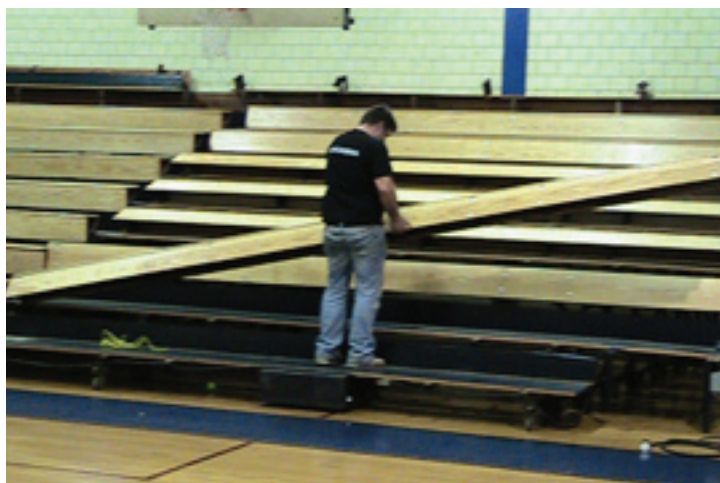
Bleacherman employee is re-installing refinished seat/riser/toeboard units. Each one is re-assembled with all-new hardware for an “as-new” look.

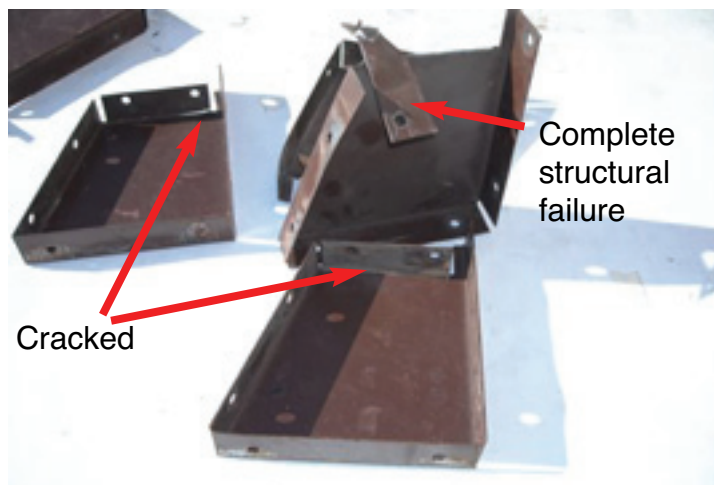
“Seat cans” shown here hold the seat, riser and toeboard together and attach to a footboard support bracket on the understructure. These ones show metal fatigue, cracking and structural failure. Fortunately, Hussey Bleachers are one of the easiest brands of bleachers to convert to Evergreen Bleachers™. We work on and manufacture parts and motor systems for all brands of bleachers – even those manufacturers no longer in business.

The understructure was repaired, motors and safety rails were installed, before the refinished wood was put back into place. Thirty-one of the “seat cans” (shown in the top photo) were replaced, prior to the re-installation.

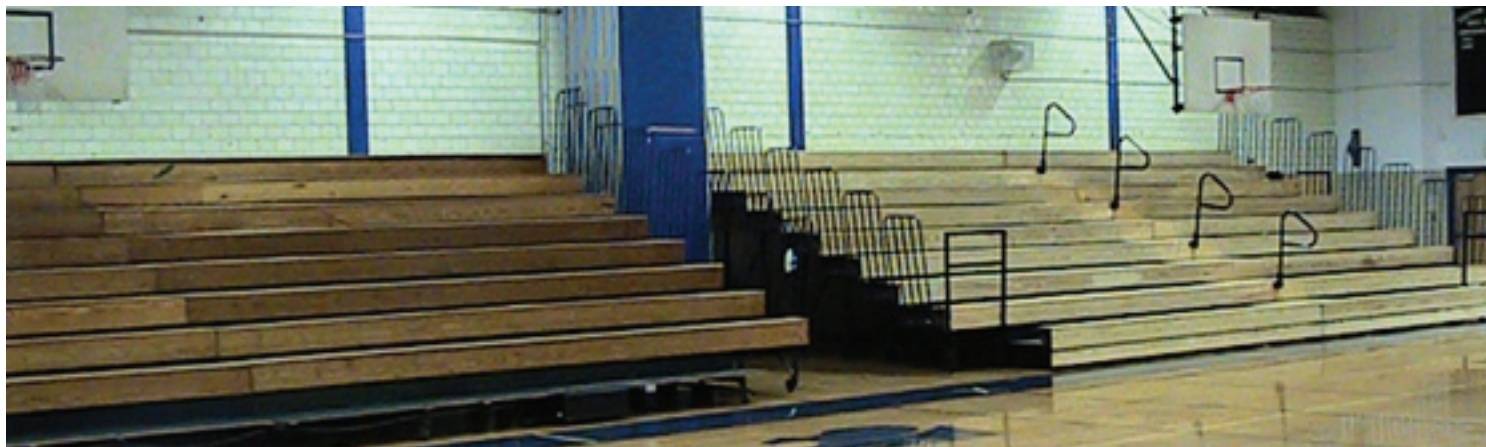
This photo shows the difference between the original condition of the wood -- and what they look like after being planed (removing only 1/16" of wood), edged, sanded and refinished with three coats of approved sealer. It's the same wood! This project was done during the school year, with one half of the gym being refurbished at a time. Classes continued in the other half of the gym, while the Bleacherman rebuilt the bleachers in the closed-off half. We work around your school's schedule. Before beginning work, the school's athletic director and principal provide a list of dates and events when bleachers must be completed by -- and we meet those dates.

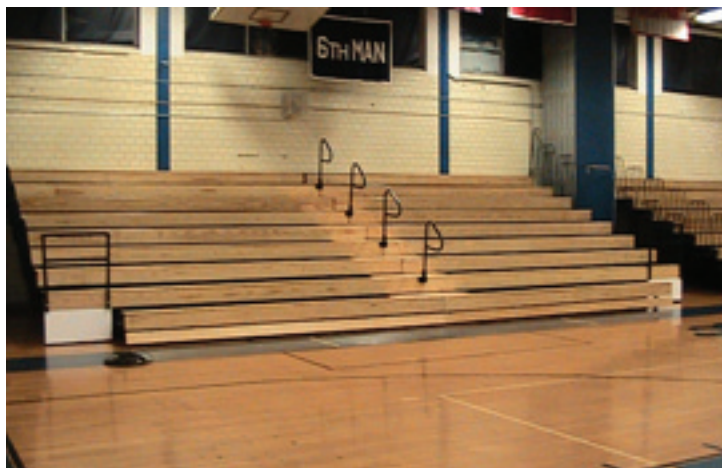
These bleachers look new and work like new. The 20-year Bleacherman warranty promises that they will continue to operate properly for many, many years to come.

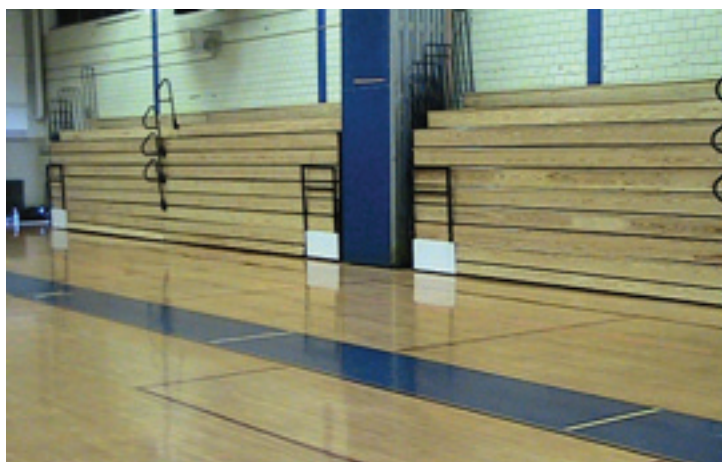
Long view shows the closed bleachers with new safety equipment (in school colors) in place, and refinished "like-new" wood. Not visible: new motor drives and Century Design® "no-sag" system.

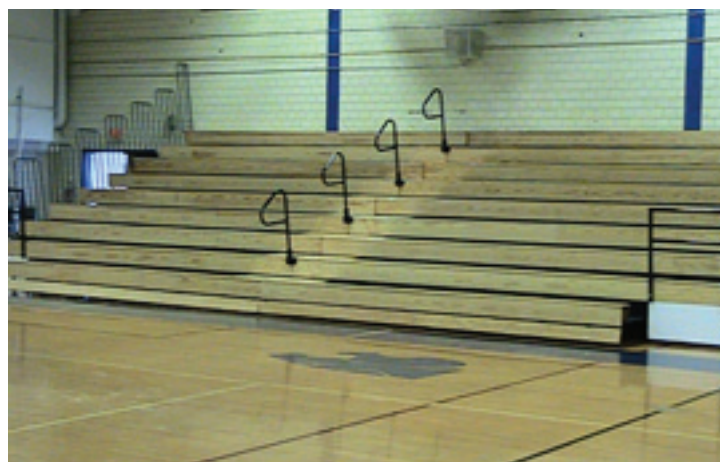
Motorized drives now will open the refurbished bleachers to the full open position at the push of a button. What a difference, compared to the previous, manually-operated bleachers.
