Case History: Delaminating Drive Rollers Retrofitting A Drive Unit with Bleacherman Drive Wheels

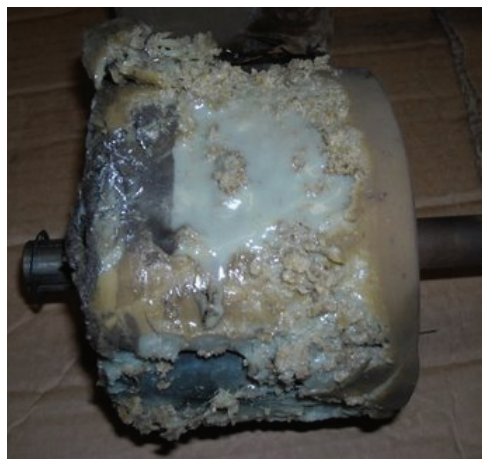
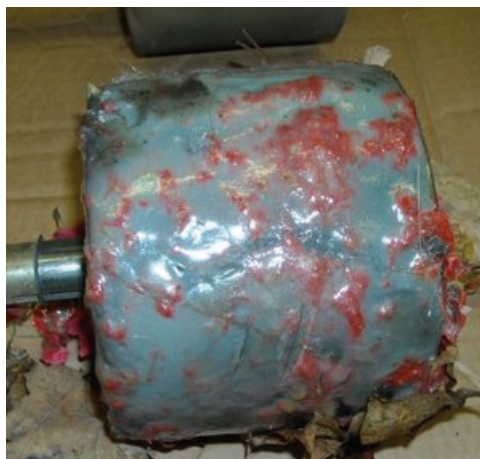
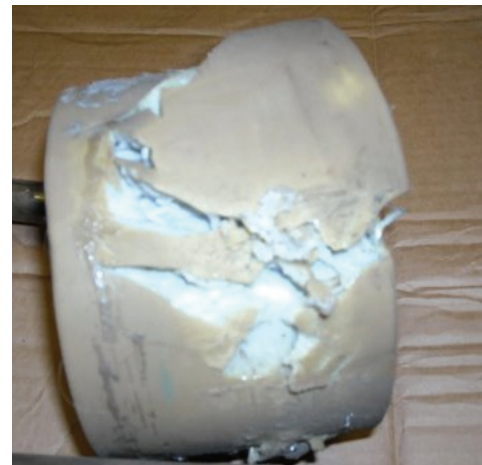
Synthetic material on drive rollers breaks down, decomposes and delaminates from steel core. The poor condition of wheels affects traction -- bleachers will not open or close properly and may cause damage to the floor.

Solution: Replace delaminating drive rollers, with new Bleacherman solid rubber wheels. These one-piece wheels will not delaminate and will maintain the required 50 durometer “softness” to “grip” the floor and provide the traction needed to operate bleachers. Replacing only the defective rollers - and re-using the serviceable components - saves 70-80% of the cost of total replacement.

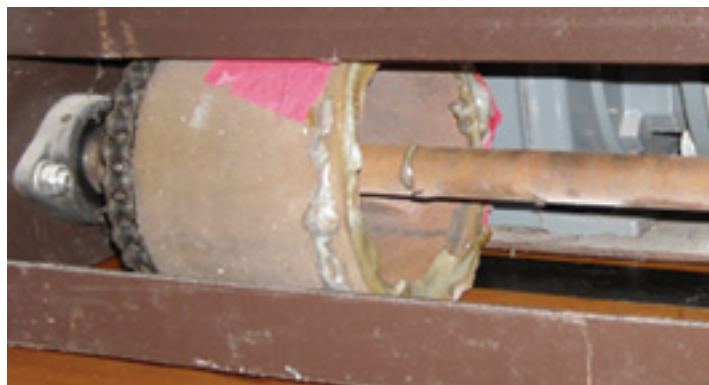
Delaminating drive roller in a drive unit.

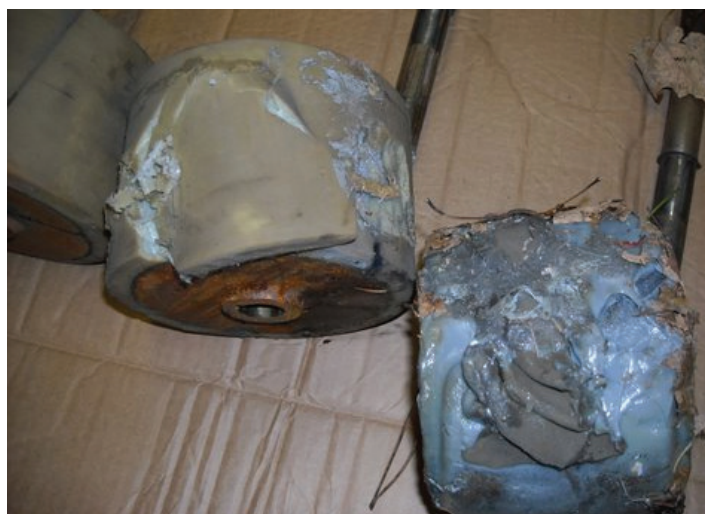
The synthetic covering on these drive rollers are breaking down, and peeling away from the steel drive roller core.

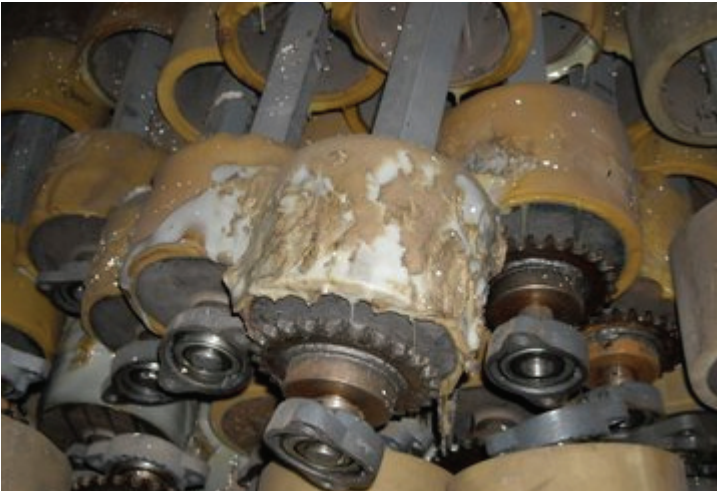
Delaminated drive rollers removed from bleacher drive units. Synthetic covers on steel rollers are decomposing and delaminating.

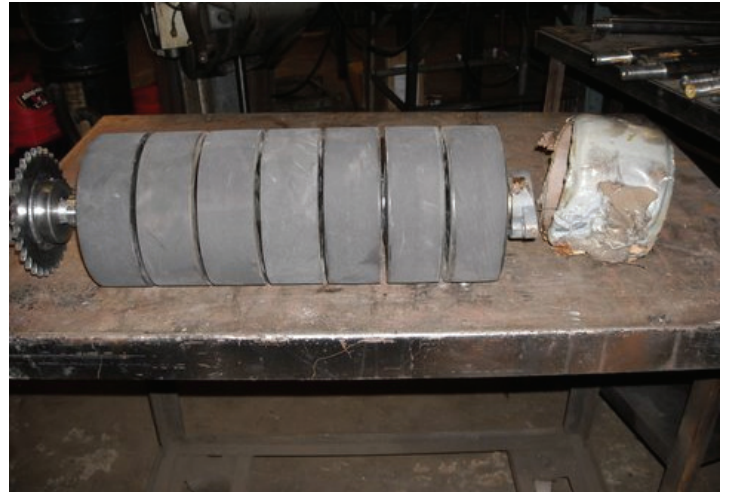
Bleacherman drive wheels (seen here mounted on shaft) will replace the old, delaminating drive rollers. Components such as drive sprockets, pillow blocks are reused.

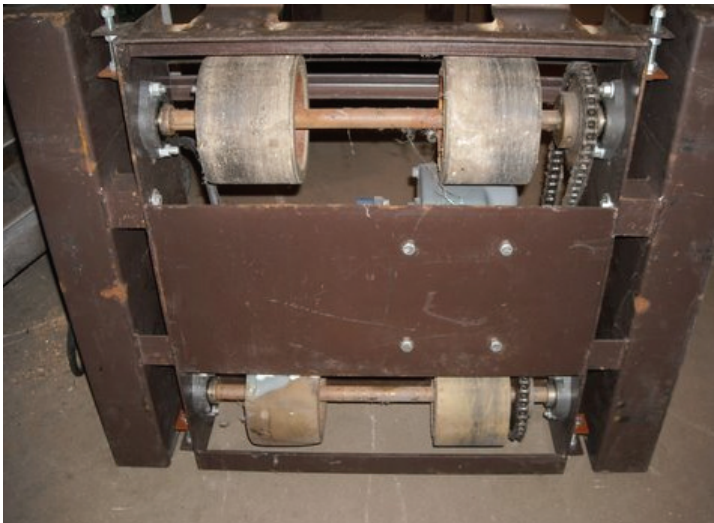
Bottom view of drive unit with original 4-inch wide drive rollers.

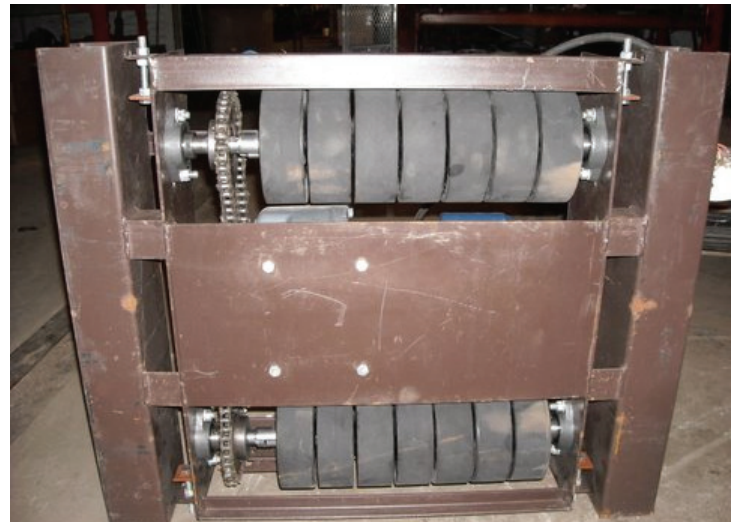
Same drive unit, now retrofitted with two 14-inch wide Bleacherman drive rollers. Note the additional surface that contacts the floor, for enhanced traction.

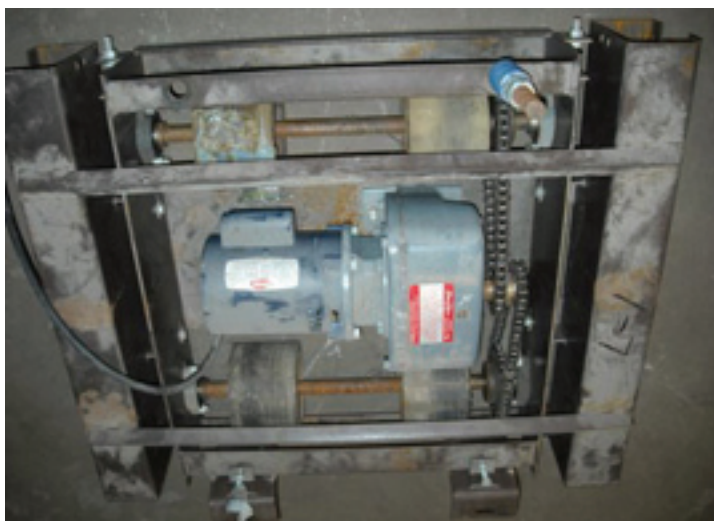
Top view of drive unit with original 4-inch drive rollers.

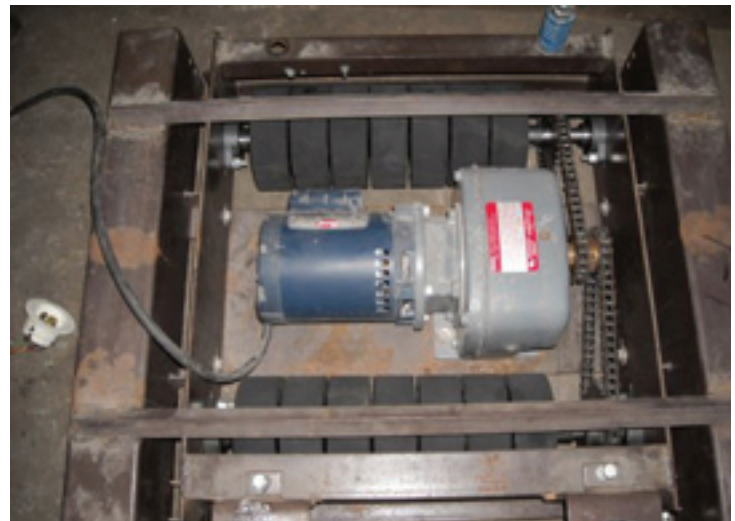
Top view of drive system with Bleacherman drive rollers. All useable components such as frame, motor, gear drive, are reused.
