## Case History: Delaminating Drive Rollers

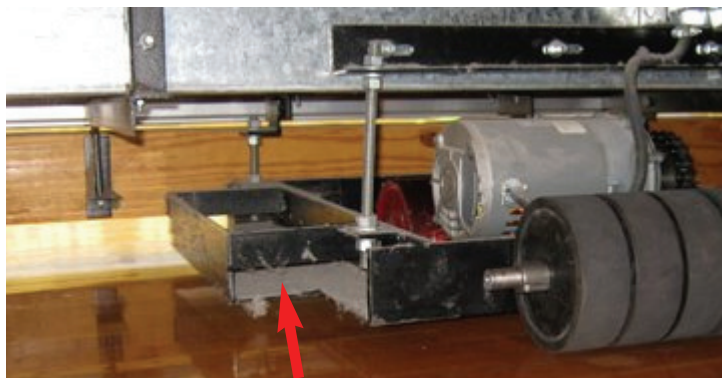
Drive motor unit before being detached from bleacher understructure. Note empty space to left of motor. This should have weights.

Also, these motor systems were missing the counter weights that provide the downward force for traction. It appears the installer has put the attaching/adjusting screws to the extreme utmost position, thus using the weight of the first row of bleachers for downward load. Problem is, this deformed the first row of the bleachers causing them to arch or bend.

The solution: replace the drive wheels, add the proper weights, and adjust the attaching screws to level the first row. This would allow the bleachers to at least open and close, without burning out motors or damaging the floor.

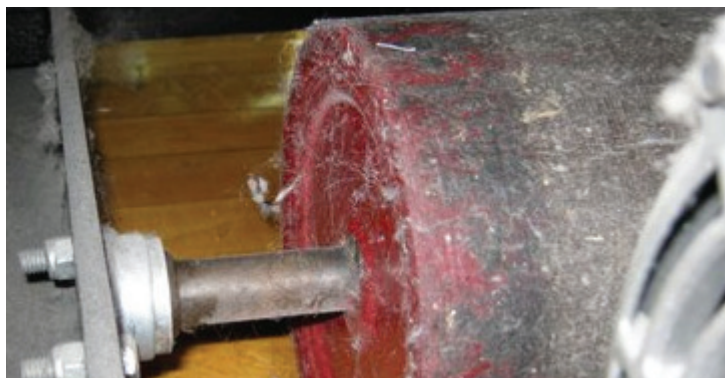
Electric motors, metal frames and gear drives were functional and serviceable. Problem was the drive rollers had decomposed and were delaminating. (The synthetic urethane covering is separating from the steel rollers, resulting in a loss of traction and damaging the floor.)

Delaminated drive roller. The urethane covering has peeled off, leaving a bare steel cylinder. This will damage the floor, whether wood or synthetic. (\$\$\$\$)

***Solution:*** Replace delaminating drive rollers, with new Bleacherman solid drive wheels. These one-piece wheels will not delaminate and will maintain the required 50 durometer “softness” to “grip” the floor and provide the proper traction. “Drop-in” installation allows re-use of existing components for a low cost solution. Rollers are warranted against delamination for 20 years.

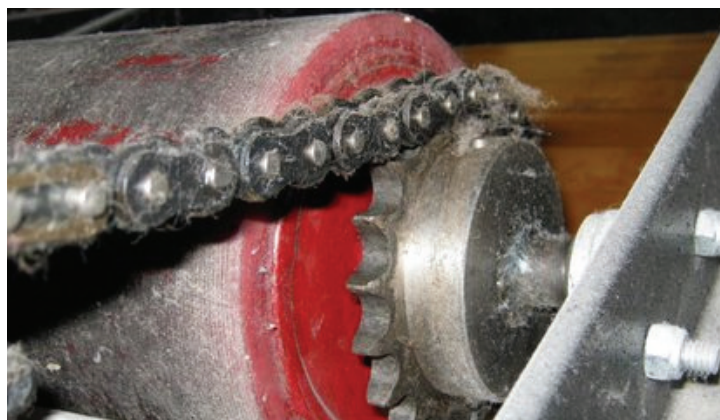
Another view of a completely delaminated drive roller. .

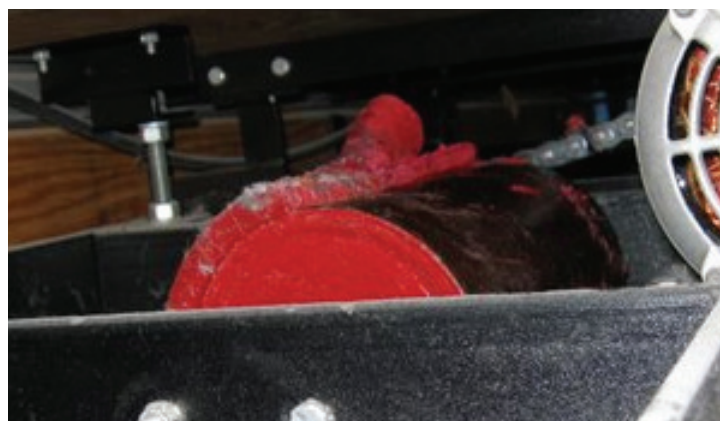
This drive roller shows how the urethane covering is peeling away from the drive roller.

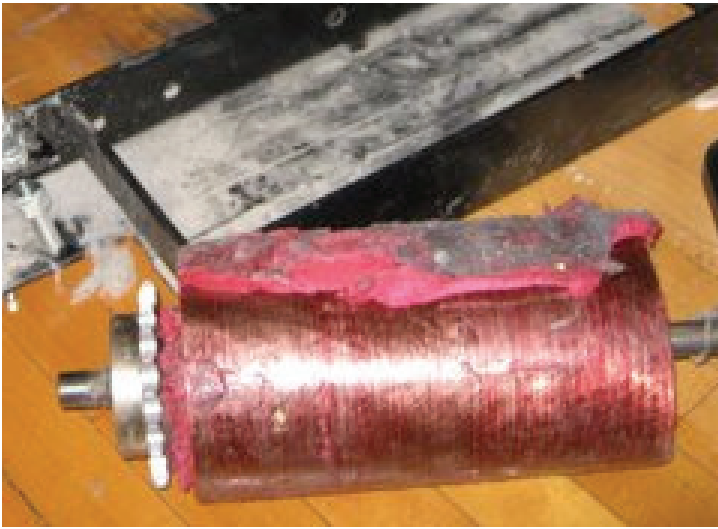
Here the delaminated drive roller has been removed from the motor drive frame

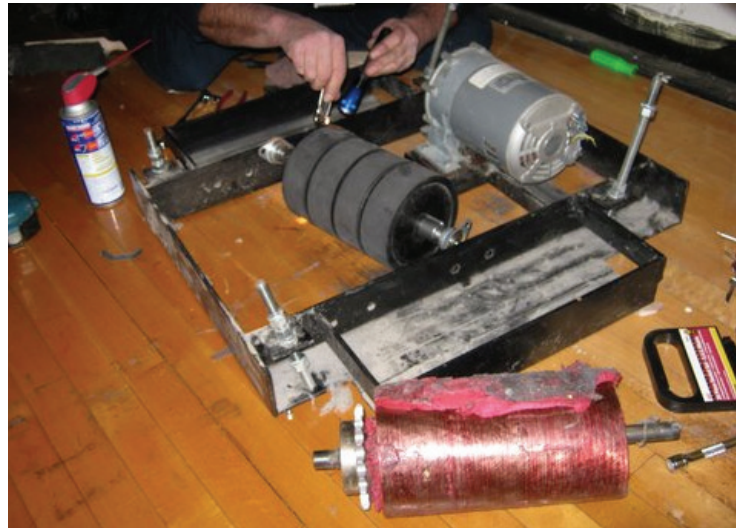
Bleacherman drive wheels being installed by owner's personnel. We provide instructions - special expertise is not required.

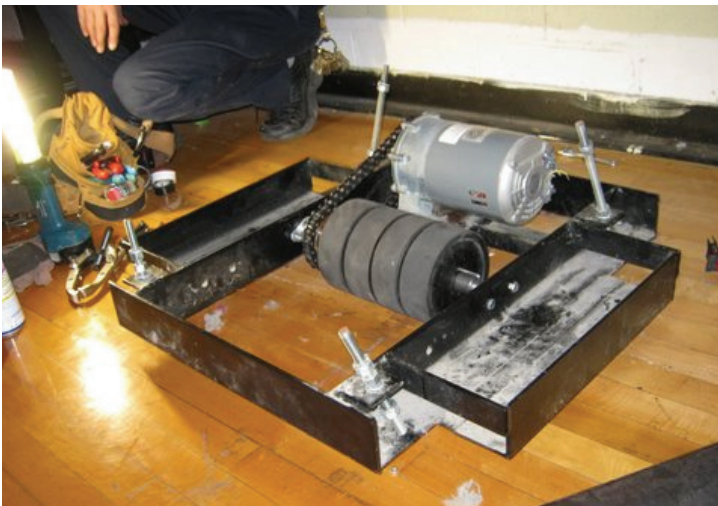
Bleacherman solid drive wheels installed in place of metal drive roller. Shafts are machined for "drop-in" installation, reusing the original frame, motor and gear drive.

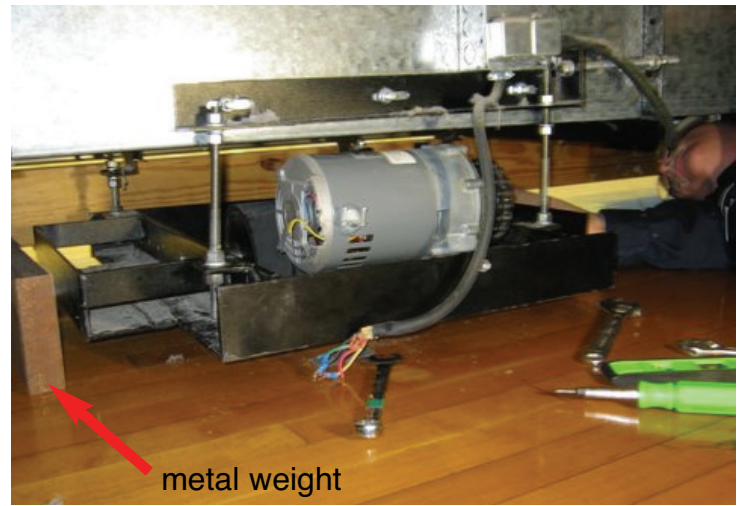
Motor drive being re-installed in position. After attaching and adjusting, electric power will be connected and new metal weights added.

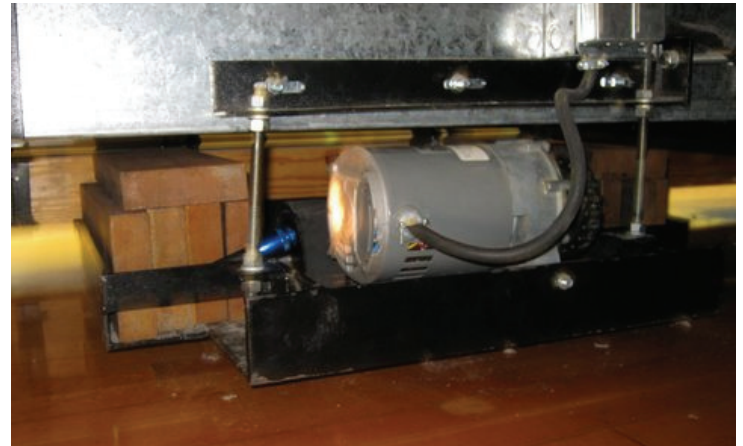
Installation is complete.
