# Case History: Hamilton High School West, Hamilton Township, NJ New Interkal® Bleachers (less than three years old) -- and they're sagging

**Problem:** *Almost-new, three-year-old telescopic bleachers are hard to open, very difficult to close. Why? Because that's what was specified, when the "minimum" specifications for these bleachers was OK'd. The design criteria met all the legal requirements -- the absolute minimum required by law -- but it didn't meet what the bleacher owner REALLY needed, which was bleachers that would not sag, no matter what.*

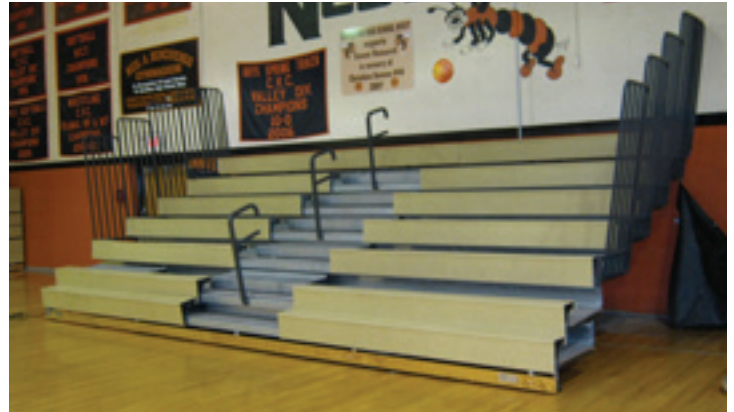
A section of the new bleachers is seen here. It is 24 ft in length, with vinyl on steel seating and all required safety equipment (aisles with P-rails, end safety rails).

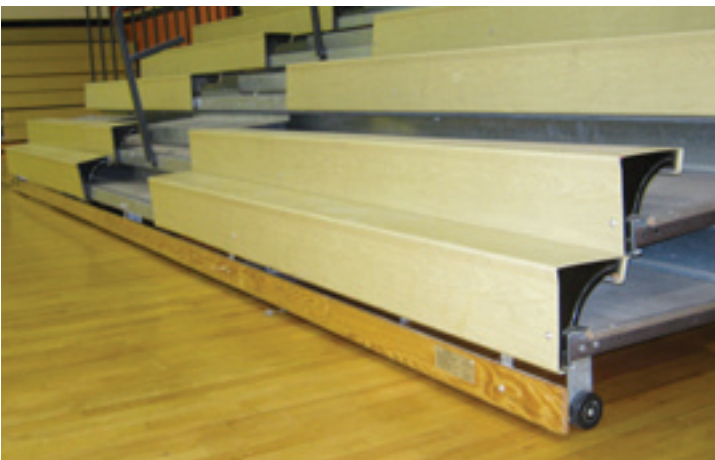
Sagging problems with new bleachers occurred almost immediately. In the photo above, Row 2 is bent down and forward. Row 1 is supported by wheels that roll on the floor.

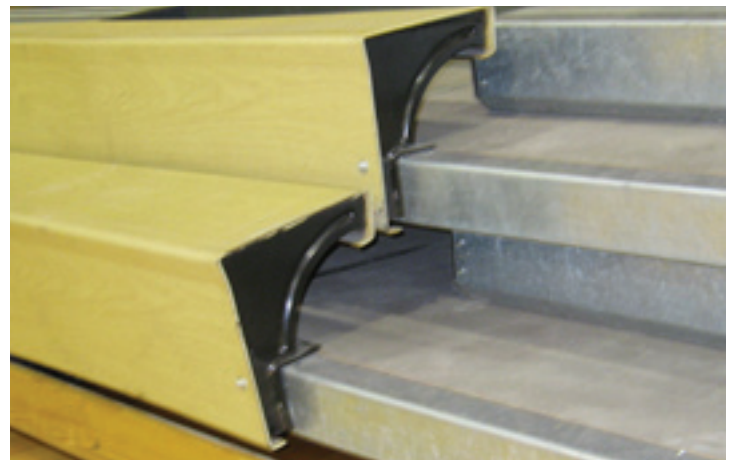
Row 1 should be able to slide underneath Row 2 without contacting it. However, Row 2 has sagged so much that the bleachers cannot be closed.

Bleacher operator seen here has pendant controls in one hand, a steel pipe in the other in order to lift the second row enough for the bleachers to close.

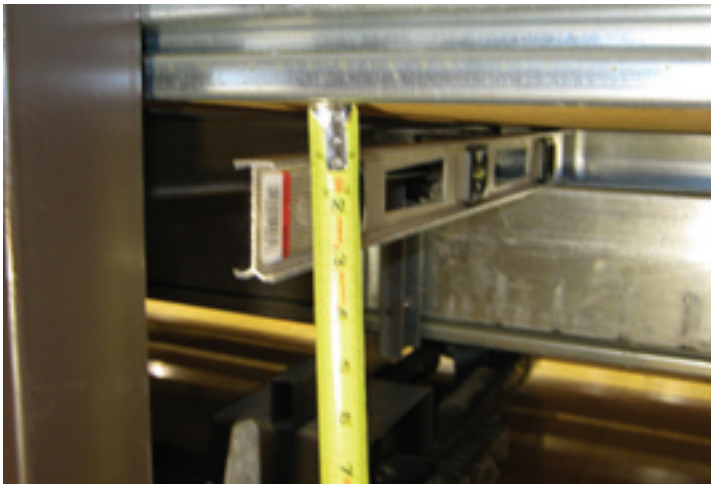
Carpenter's level shows that the footboard is sagging (even in the partial open position) approximately 1 inch toward the front of the bleachers. In the closed position, this row sagged approximately 3 inches.

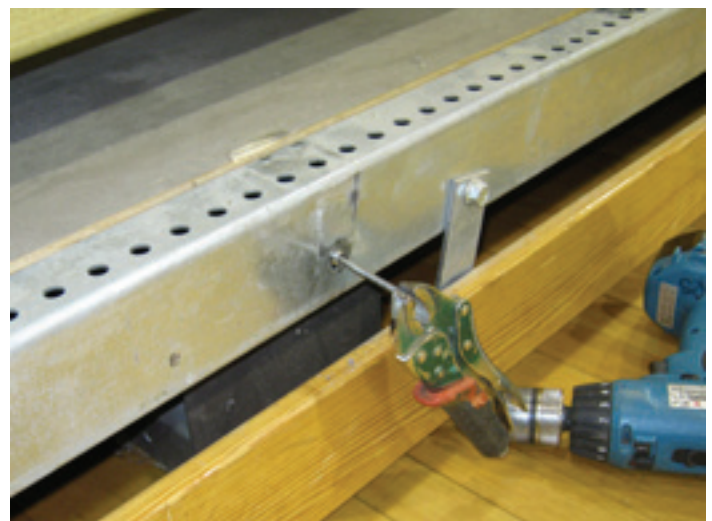
The bolt that held the seat bracket to the nosebeam was sheared off by the sagging row above. Here, the broken bolt is being removed (with an Easy-Out) for replacement.
