Case History: Hamilton Township School District, Hamilton, NJ

Corroded swimming pool bleachers rescued by the Bleacherman

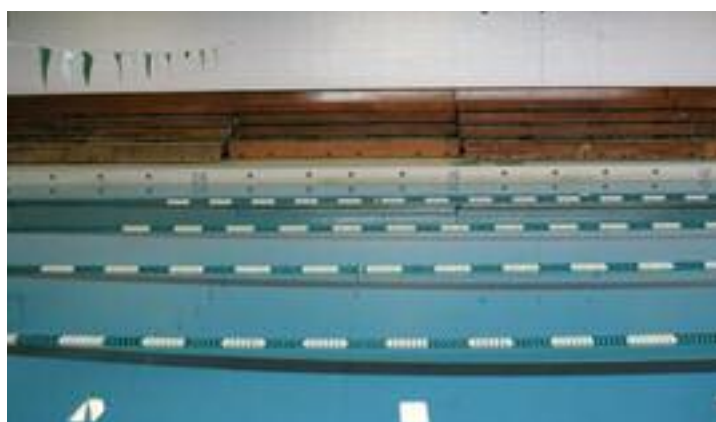
Three sections of bleachers were on either side of the indoor swimming pool. (Same configuration at each high school.)

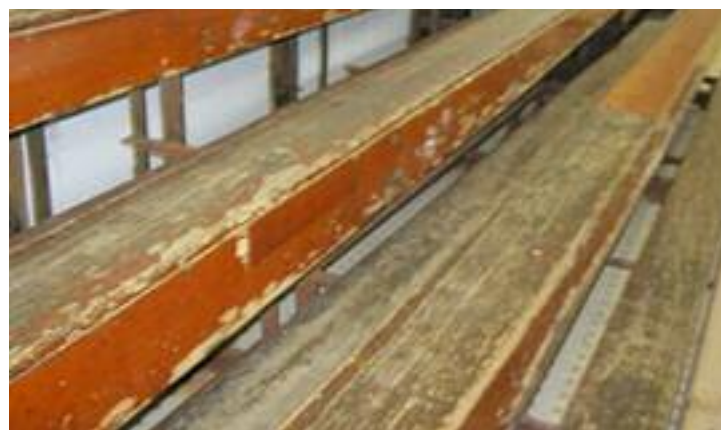
Original five row high telescopic bleachers show the effects of a high-humidity environment and years of heavy use.

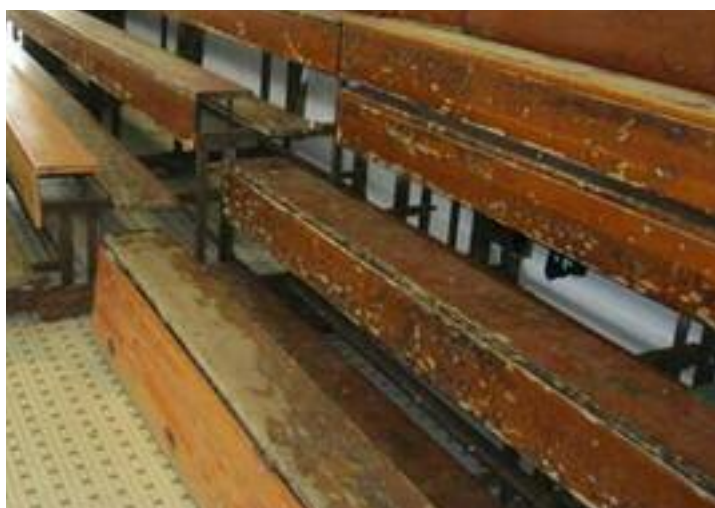
Bleachers on both sides of the natatorium were affected. The finish on the wood is completely discolored and worn away in some areas.

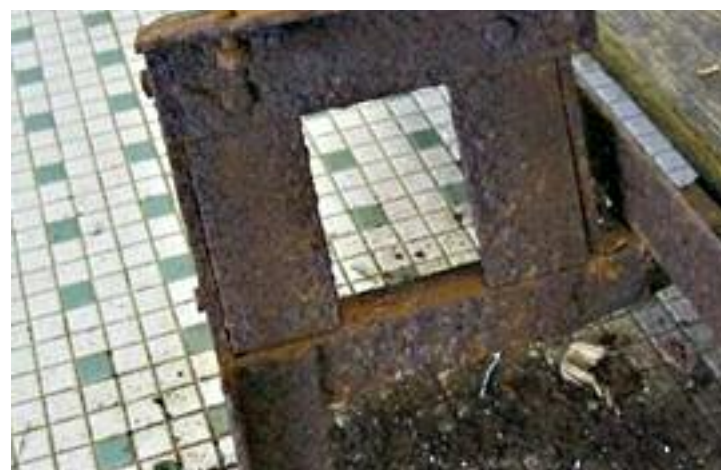
When the Bleacherman started to remove the wood, what we found was even worse - a badly corroded understructure on the first row only. The first row understructure was remanufactured - fabricated by the Bleacherman.

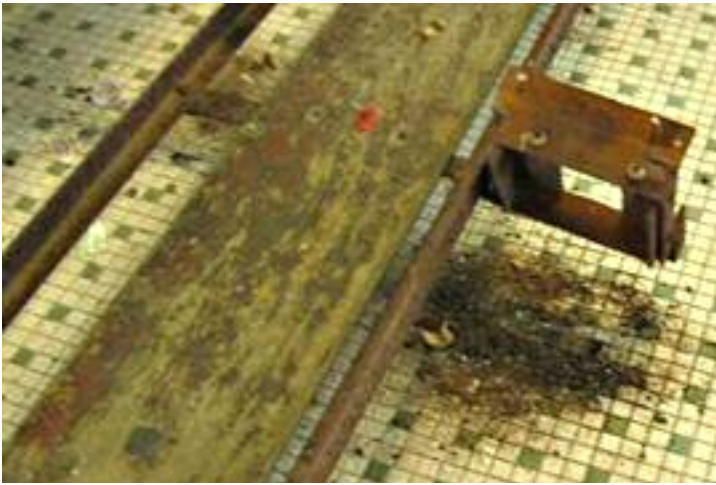
Lumber is removed for refinishing, as the first step in dismantling the original bleachers.

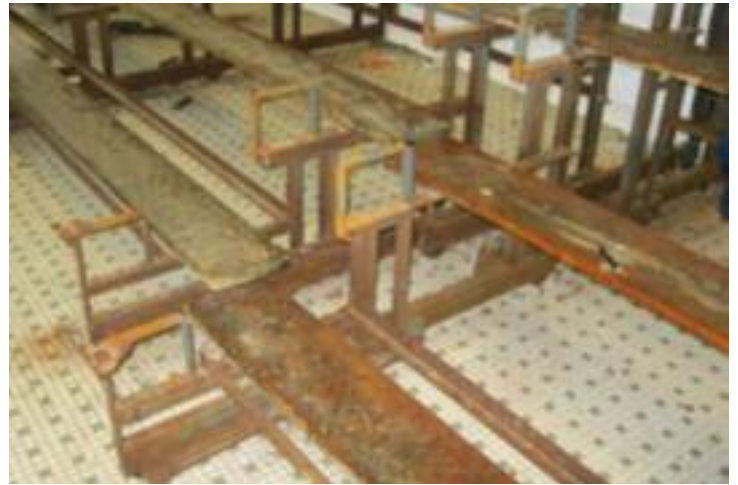
Some of the bolts were so rusted, they had to be cut off in order to remove the wood.

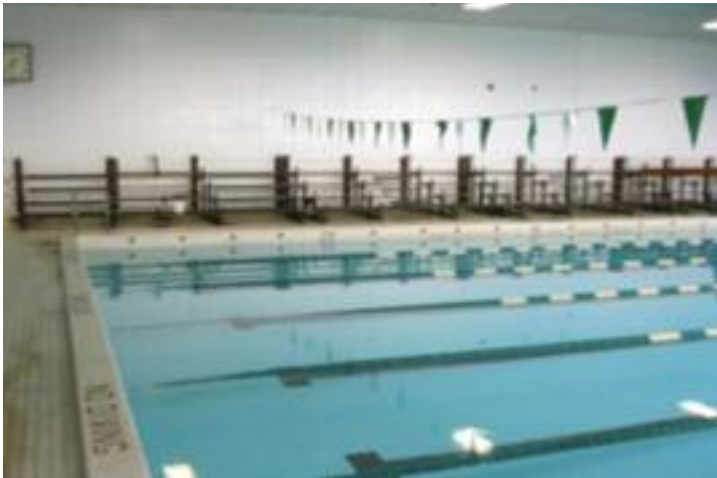
Most of the boards have been removed in this picture. Lumber was recycled for use in the new “closed deck” bleachers. The original understructure was salvaged and rebuilt at the Evergreen manufacturing facility.

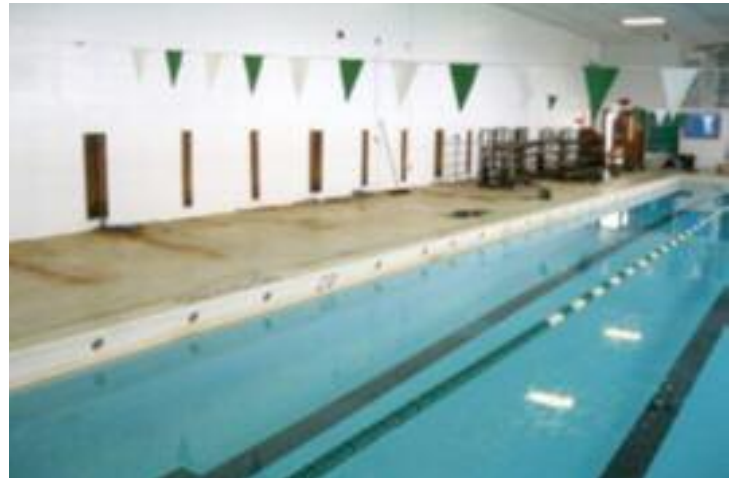
The Bleacherman crew has one more section of bleachers left to remove in this photo. Note staining of floor below where the bleachers used to be located.

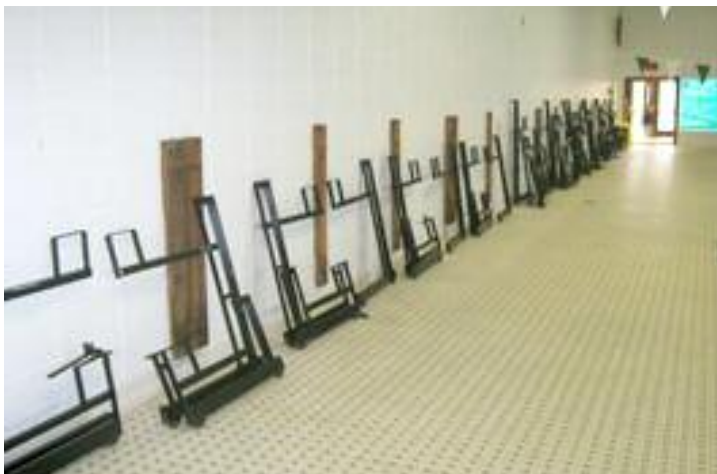
Original understructure (after remanufacturing) is “staged” in position before anchoring to the wall. Note floor has been cleaned before understructure is re-installed.

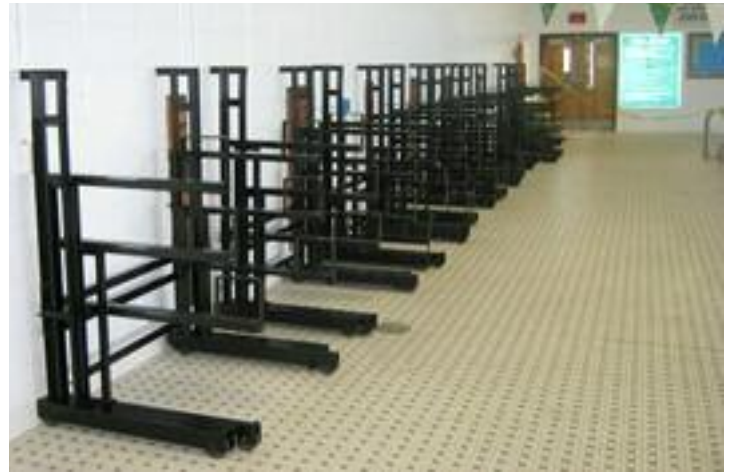
Evergreen Bleacher understructure now anchored to wall. This understructure has been sandblasted, powder coated with special baked-on rust-resistant paint, then powder coated again.

The rebuilt bleachers were upgraded for use in a high moisture area by first sandblasting the understructure. Next one coat of DuPont zinc primer (with 7000 hours salt water resistance) powder coat was applied, plus a second coat of heavy duty powder coating, rated at a minimum of 1000 hours of salt water corrosion resistance.

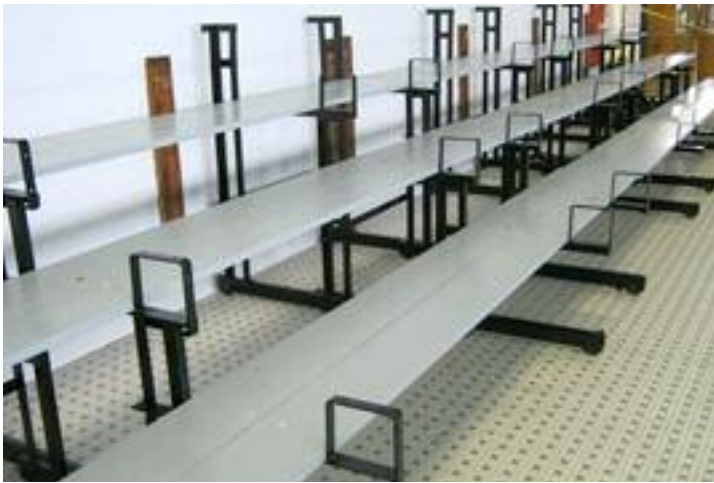
Footboards go on first, as the new bleachers are installed. Heelboards will be attached next. Bleachers are being made code-compliant, meeting closed-deck safety requirements.

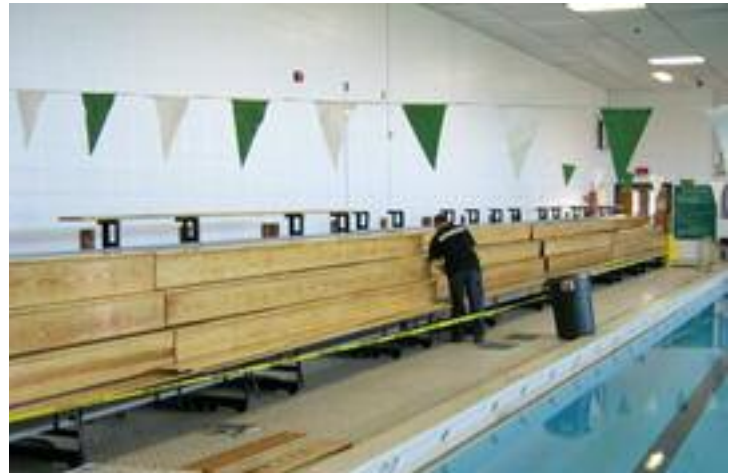
Reconditioned Fir wood seats and risers are installed. It's hard to believe this is the same wood that was removed from the original bleachers. They look new again!

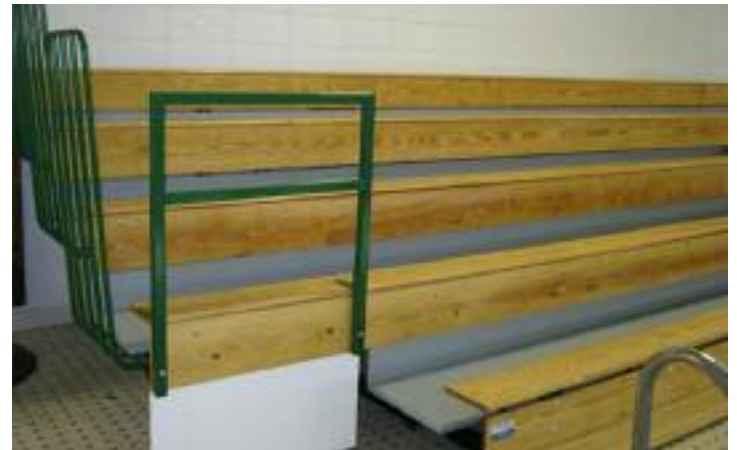
ADA cut-out for wheelchair with safety rail and self-storing end safety rails installed. Like the P-rails, they match the school's colors. All painted surfaces received multiple coats of marine-grade coatings to resist moisture.

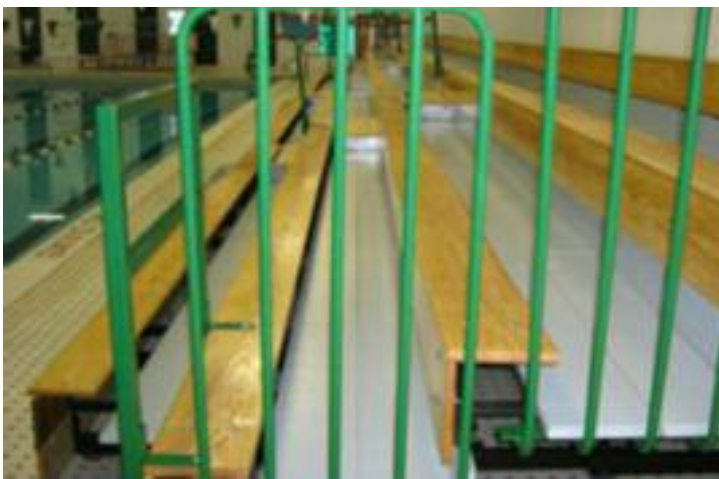
End view of bleachers with safety rails installed.

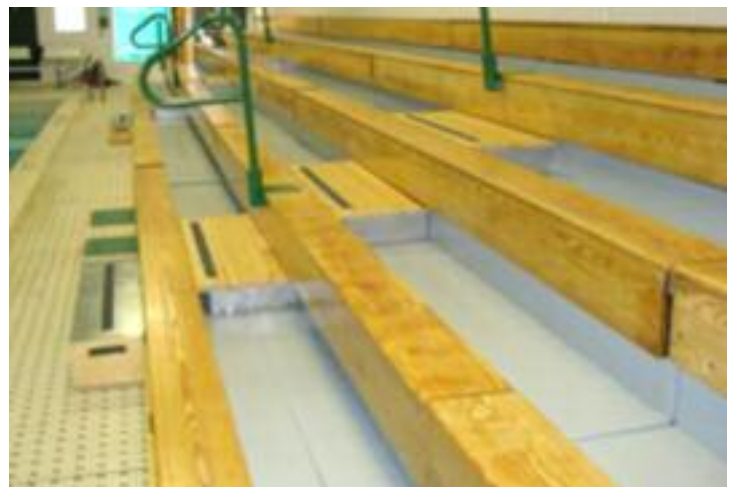
Completed bleachers with demountable first step, non-skid on intermediate steps, contrasting color footboards, etc.

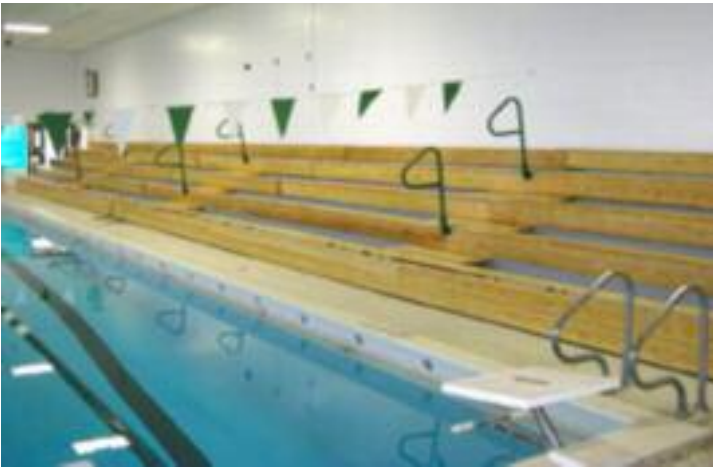
Another view of the completed bleachers. Note that the riser boards are three-piece laminated boards, which show the color variation this is normal in this material.

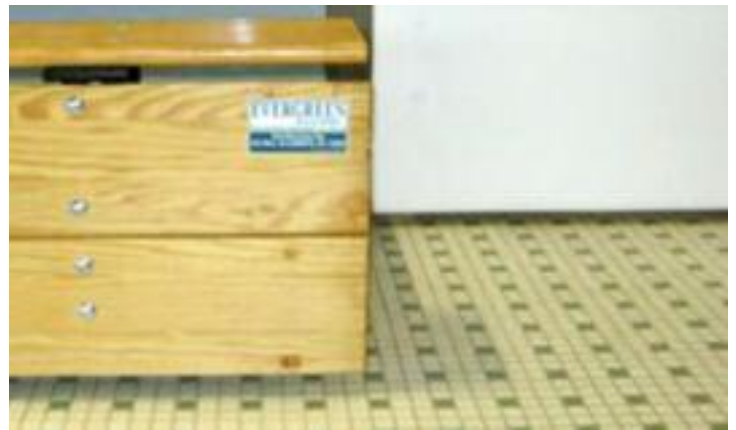
The final touch: adding the Evergreen Bleachers™ label, showing that these bleachers are in a class by themselves, stronger than any new bleacher available today.

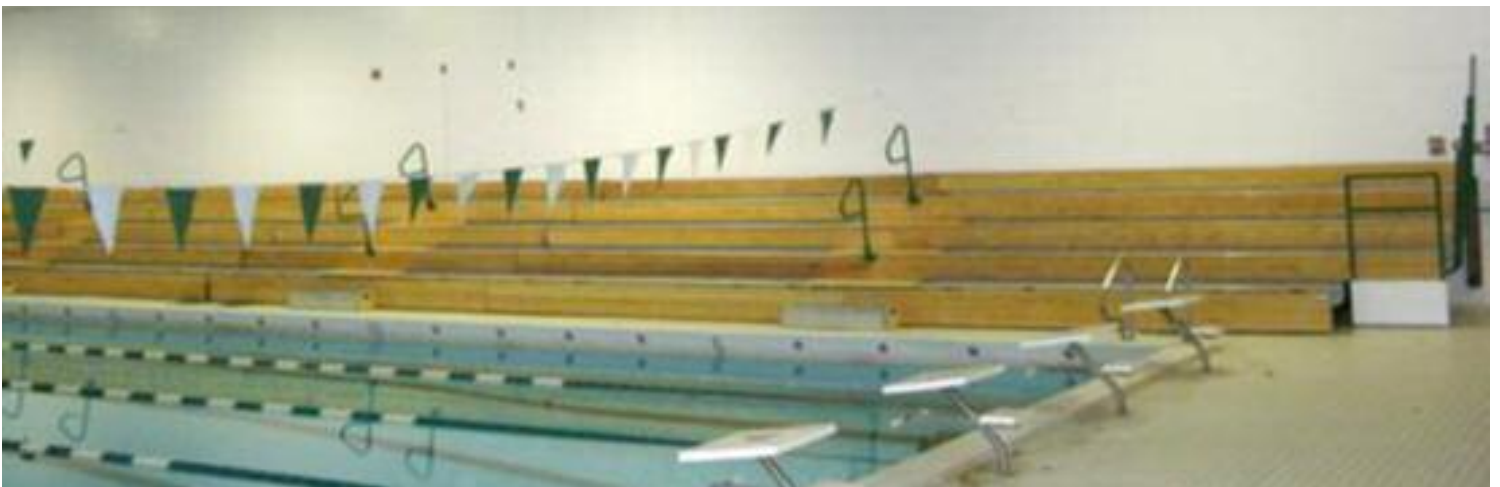
Completed bleachers are ready for spectators in the Steinert High School natatorium. The process of remanufacturing (to meet code requirements and protect the bleachers in this high moisture environment) co-mingled the original 4-horse under-structure with new parts. Nothing of value was discarded. The Bleacherman was able to save the school district money (compared to buying new) in this demanding high-moisture environment, AND provide “as new” telescopic bleachers that would last in this difficult application.
