## Case History 2 of 3: Folding Bleacher Co.

**Situation:** North Tonawanda High School (near Buffalo, NY) had 10-year-old Folding Bleacher Co. telescopic bleachers in the “new gym.” Extensive sagging made the bleachers difficult to open and close, put an extra strain on the motor system. Many of the plastic seats had sustained damage from sagging, as well as regular wear and tear.

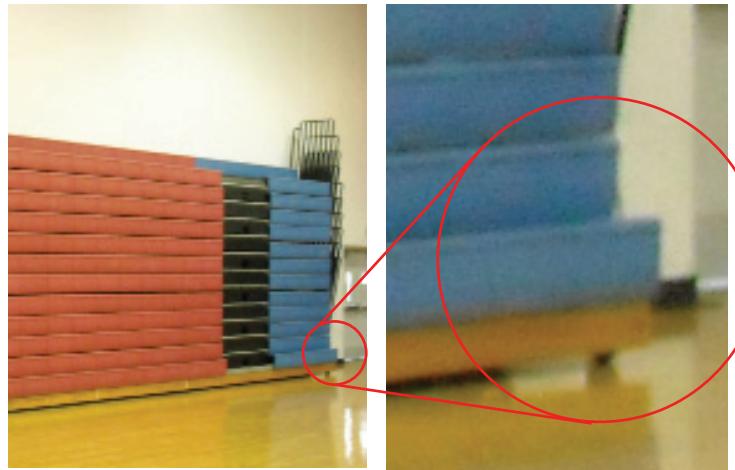
10-year-old Folding Bleacher Co. motorized bleachers are sagging so badly that the bleachers cannot be fully closed. (Note first row at right-hand side.)

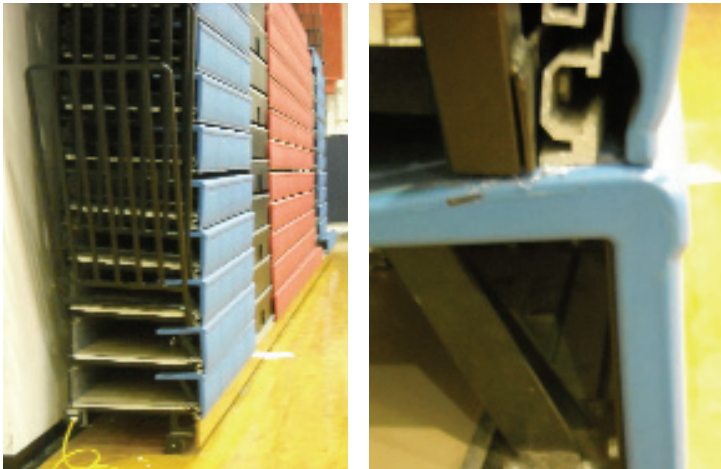
Sagging lower rows are bent so much that they are scraping on the plastic seat below.

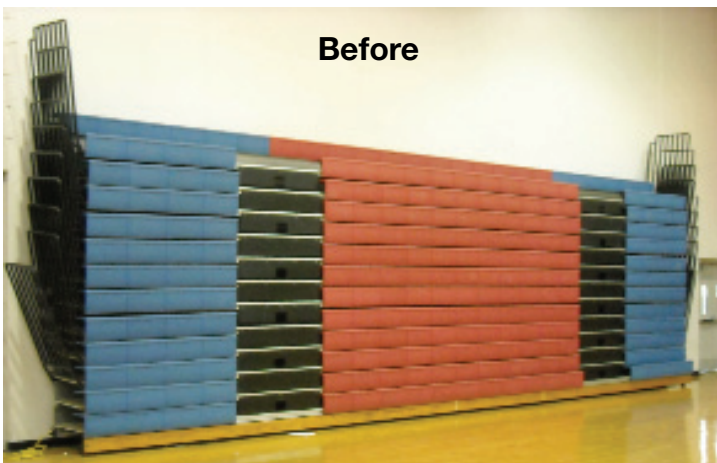
Before renovations, bleachers were sagging. This bank has a bent safety rail on the left-hand side. Aisle closure panels were bent and had sharp edges - a safety concern. Also note the uneven row spacing.
