## Case History: York Catholic High School, York, Pennsylvania

**Complete seating refurbishment: 1 bank of Interkal (Vinyl On Steel),  
4 banks of Horne Bleachers converted to Evergreen Bleacher System**

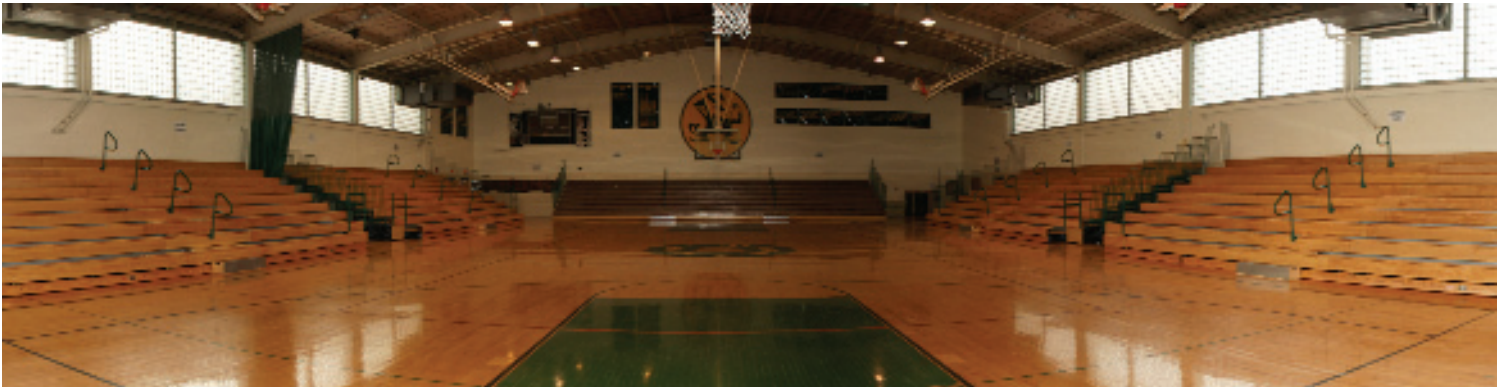
Photo above shows the high school gym after completion of job. Telescopic bleacher renovation included four banks of Horne bleachers (facing each other) replaced with the Evergreen bleacher system, and one bank of Interkal bleachers (at the far wall) was upgraded with the Century Design® no-sag system and code updates. Note that all the valuable fir boards from the Horne bleachers was recycled and reused in the new bleachers.

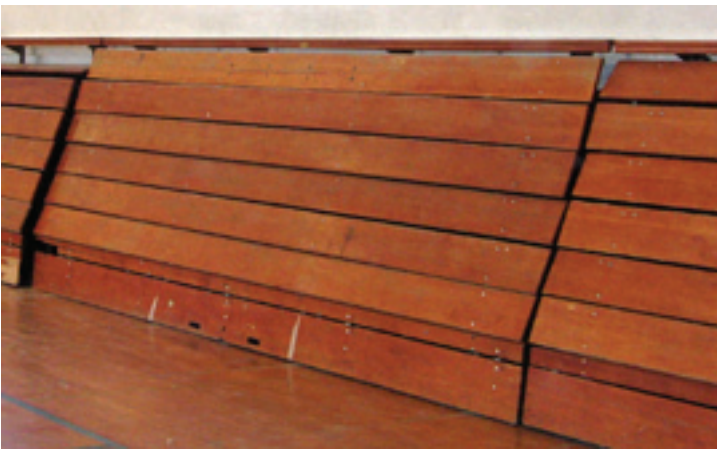
Original Horne bleachers were slant-style, 50-yrs and could not be brought up to full code compliance. The understructure was discarded and the lumber saved.

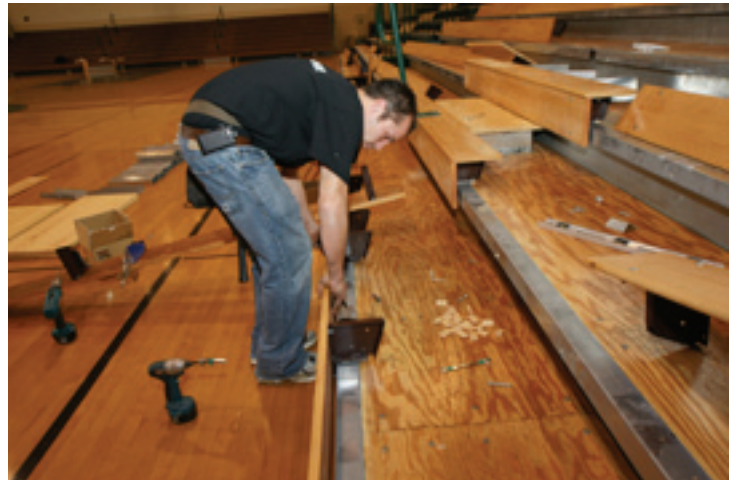
Bleacherman technician starts installing seating and required safety equipment on Evergreen bleacher system.

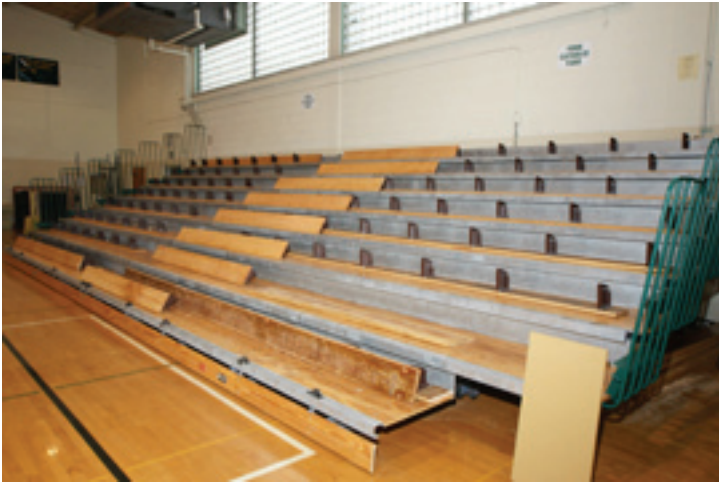
One bank of the Evergreen bleacher system is put into position, then new safety rails were installed, before the refinished lumber is refitted.

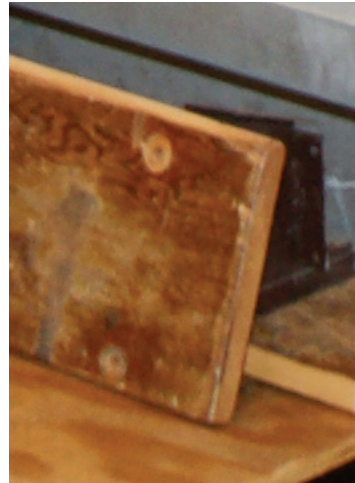
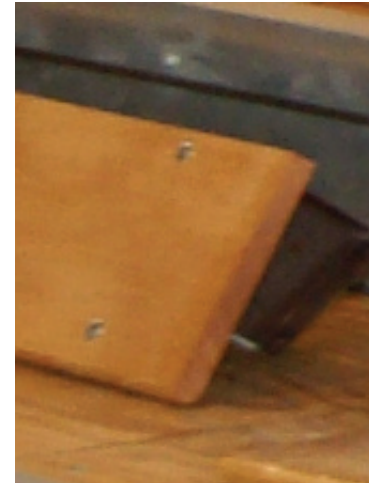
At left: 50-year-old douglas Fir boards were showing their age when removed for refinishing. At right: after being planed, sanded and edged, the refinished lumber was reinstalled with new hardware.

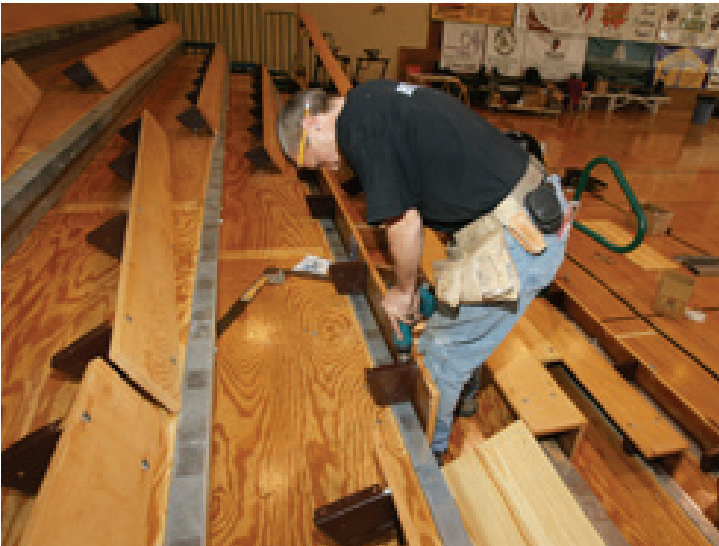
Attaching the mounting hardware for seats and risers.

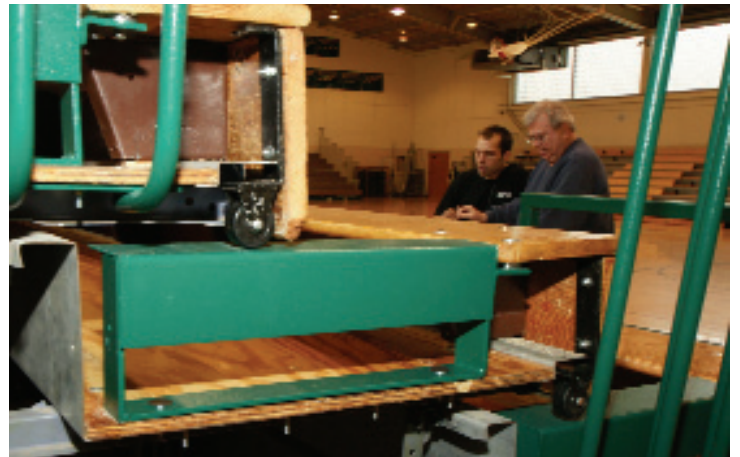
Century Design® system is installed on ends to provide continuous support in any configuration. Bleachers can't sag, because the wheel mounted on the row above rides on the rail and seat below. Safety rail temporarily removed to show Century design detail.

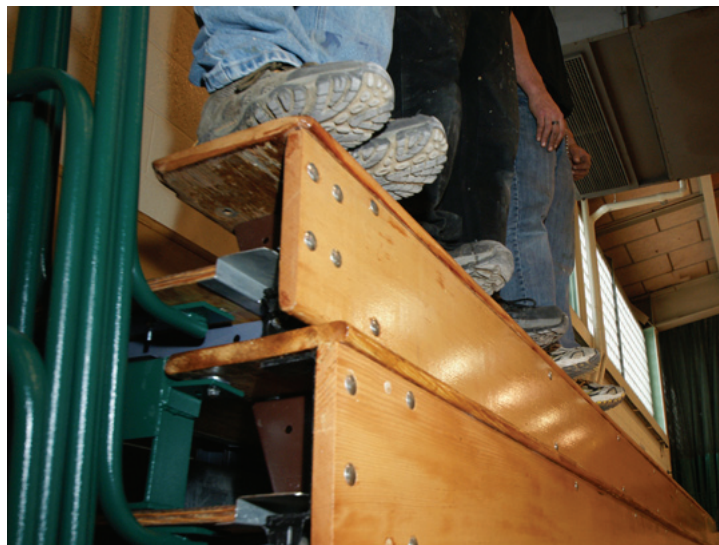
The Century Design® system allows for climbing or loads in the closed position (unintended for occupancy).

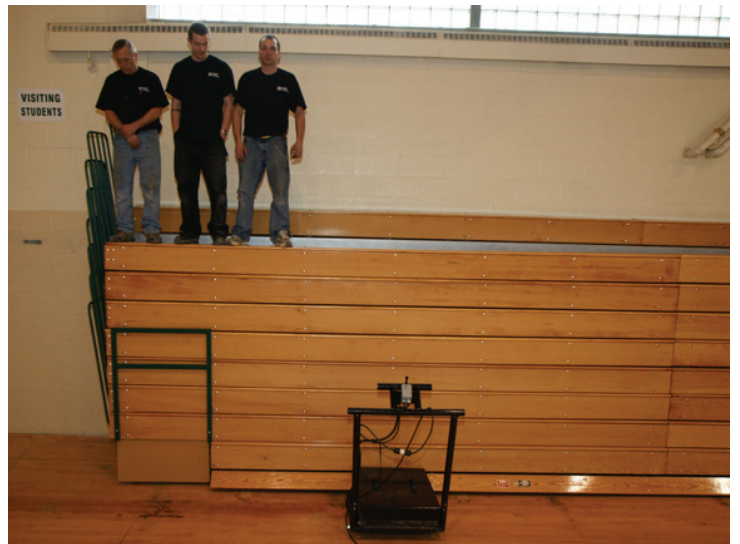
No sagging, no problem with Century Design®.

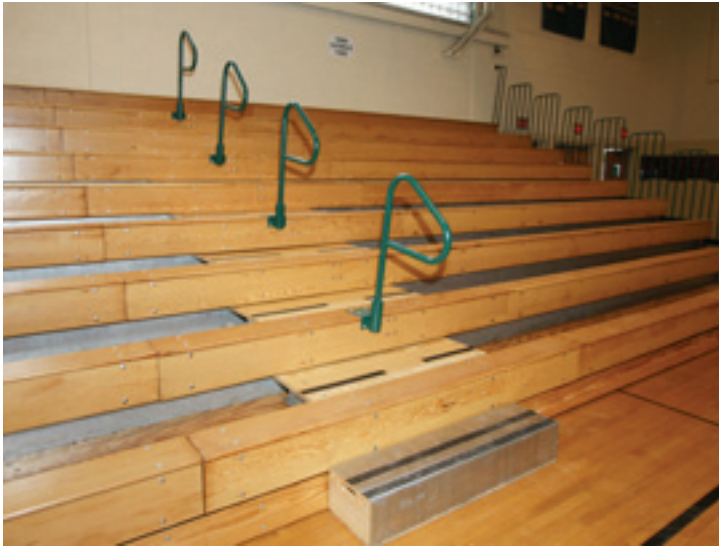
Photo shows aisles with P-rails, first row step and non-skid tape.

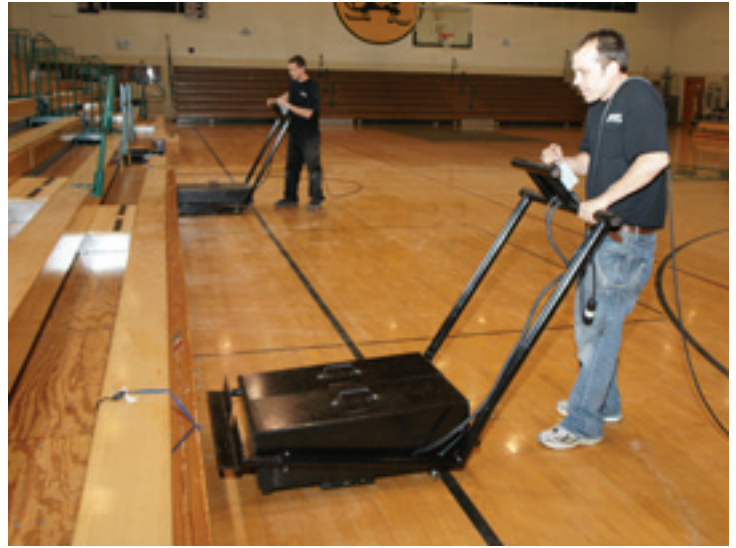
All five banks of telescopic bleachers are opened and closed with a two-man "mule team." Mule can be converted to a motorized drive mounted below the bleachers at a later date.

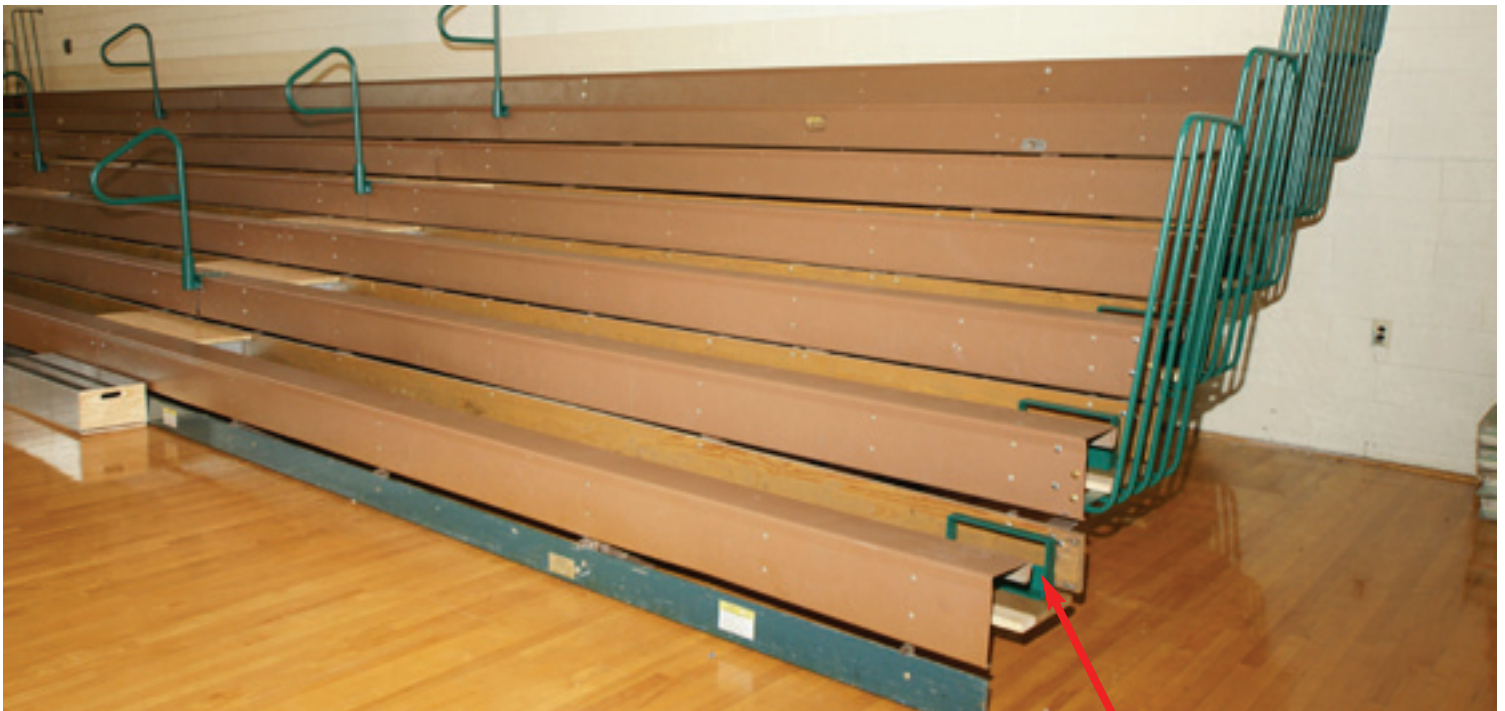
Vinyl on steel Interkal understructure was repaired to OEM condition, then outfitted with safety equipment such as P-rails, end rails and seat level aisles. All this is done prior to the Century Design® system installation.

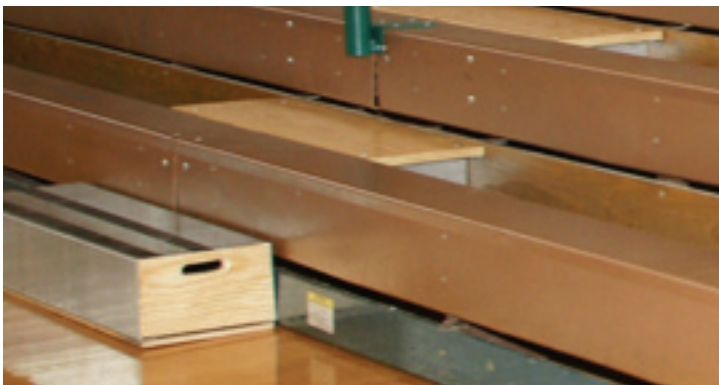
Detail shows first row step and seat level aisles.

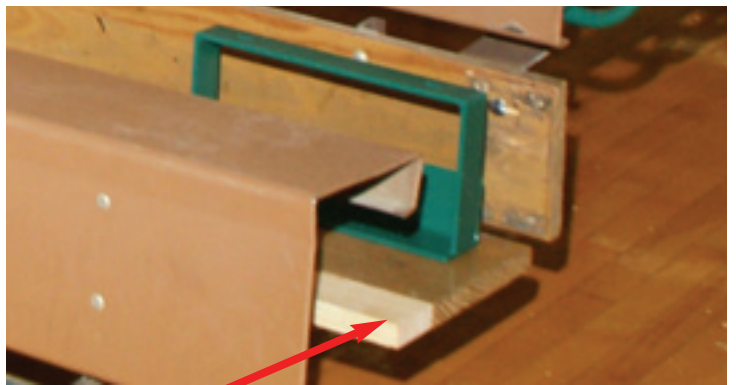
Footboard extension (prior to refinishing) can be seen in this close-up view for closed deck requirement.
