## Case History: Bleacherman fixes others mistakes

**Situation:** Croton-Harmon High School in Croton, NY had 25-year-old Hussey Bleachers that showed signs of wear and tear. The school district contracted with a local company for bleacher refurbishment. Unfortunately, this refurbishment ended up costing a lot more than the owner had anticipated. The job was not completed to the owner's satisfaction and was not accepted upon completion. (This required additional expense for legal fees.) Ultimately, the Bleacherman was called in, to finish the job correctly.

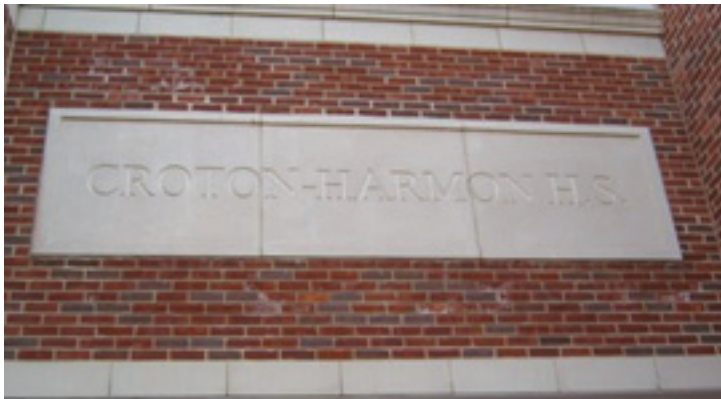
Croton-Harmon High School's bleachers were refinished and refurbished by another company (not the Bleacherman). Owner had concerns that the quality of workmanship and functioning of the bleachers was not right.

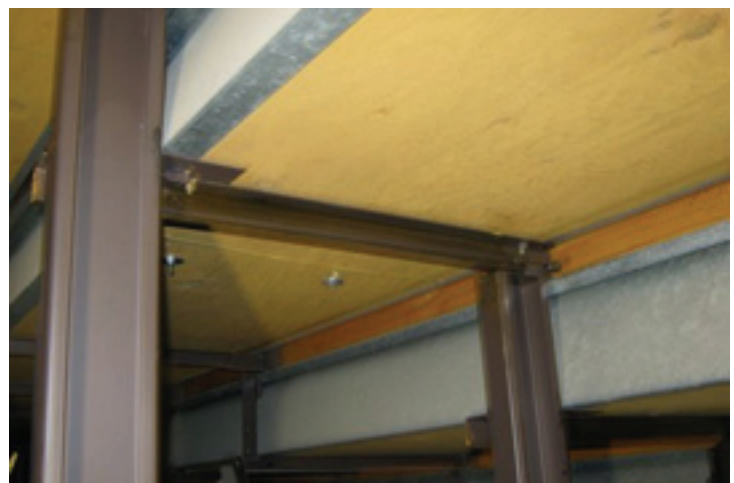
Circle shows where the row lock for this vertical support column used to be. It appears the contractor removed all of the row locks from the bleachers. This device actually locks the row in place in the open position, for added stability. These are a necessary and required part of the bleacher understructure. The Bleacherman replaced all the missing row locks from our extensive parts inventory.

In addition, after repair and service of the the understructure, it was thoroughly cleaned by the Bleacherman. No dust bunnies or debris on the floor here! We clean everything.

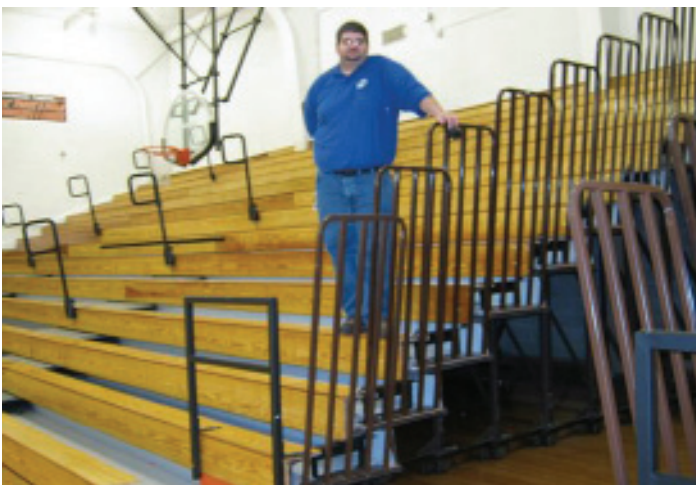
Seen here, the second, third and fourth rows are in the partial open position. The Century Design ® no-sag system provides continuous support in any configuration.

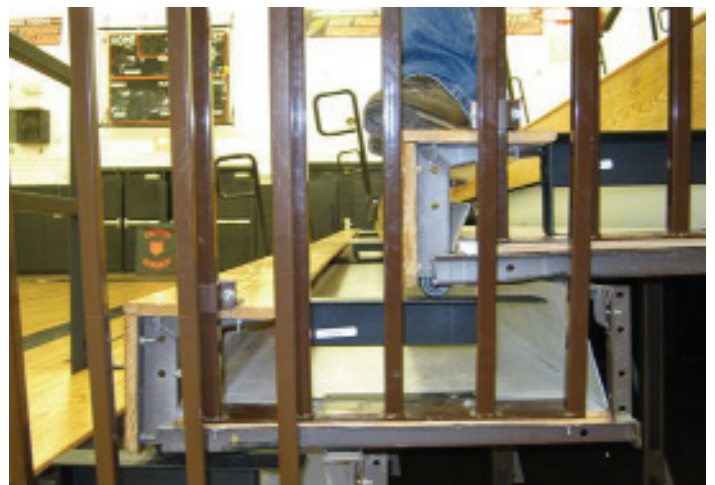
End view of third and fourth row in partial open position, showing the Century Design ® no-sag system. Note wheel on seat level "runner" supporting the live load on the row above.

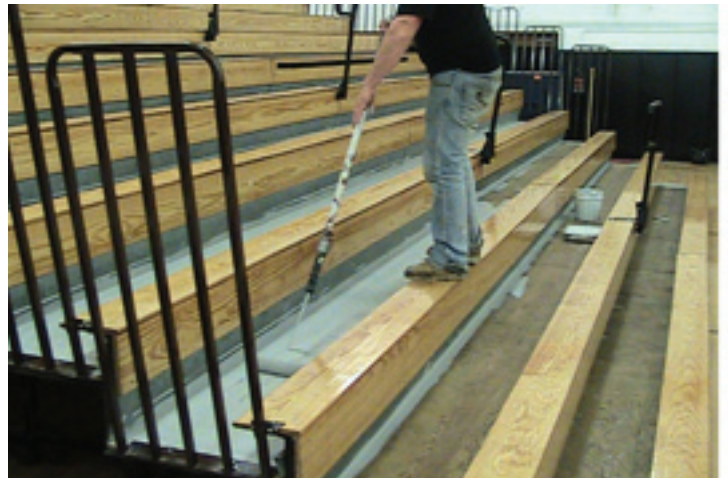
Here the worker is applying the first of two coats of approved deck sealer. The contrasting color is required by ADA, for those who are color blind or have depth perception issues.

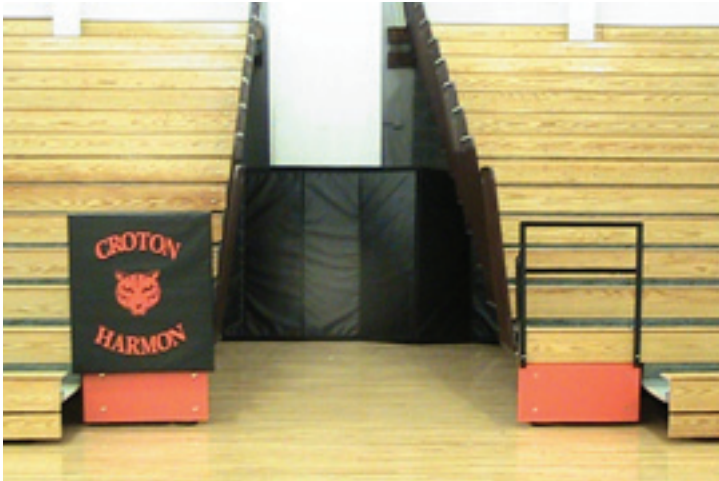
Completed bleachers now have the required ADA wheelchair spaces. Bleacherman also offers safety pads for ADA rails that can be customized with the school's colors and mascot.

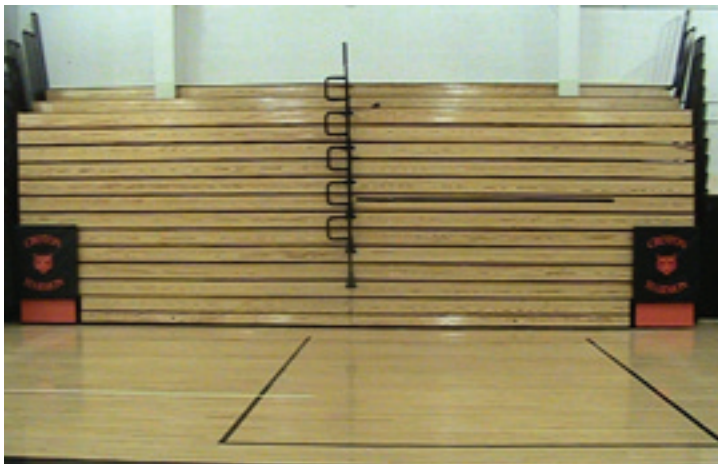
Now the bleachers have the aisles and P-rails in the correct position, second row end safety rails added, wheelchair cut-outs added. Bleachers were adjusted to provide an additional 18 inches of space from the "out-of-bounds" line to the leading edge of the first row. This space was 30 inches, now it is 48 inches.

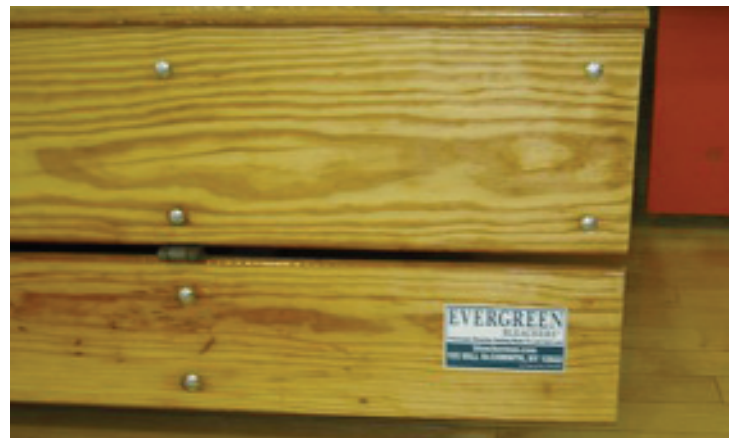
Bleacher section in closed position. Note even row spacing, now that the Century Design® no-sag system has been installed.
