Case History: Pecos High School, Pecos, New Mexico Universal Accu-Roll

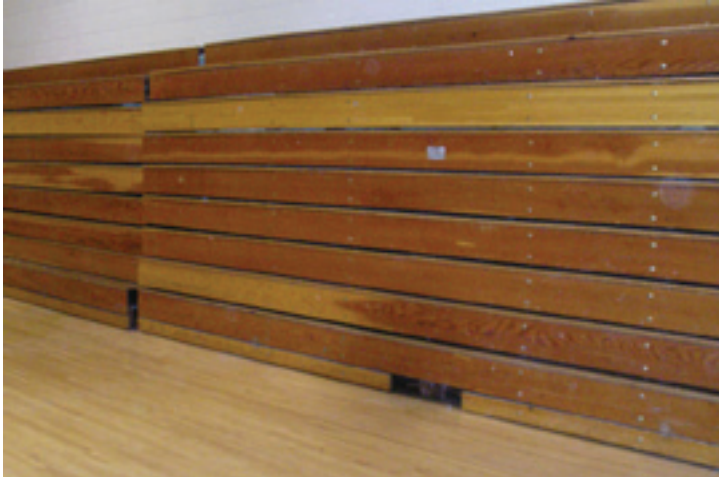
Over the years, some of the original fir boards were replaced with an assortment of laminated and solid pine boards, resulting in a “checkerboard” appearance.

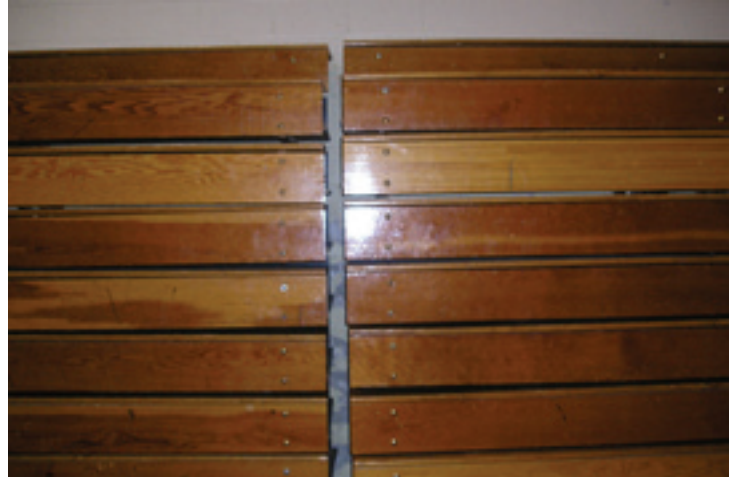
Unsafe gaps like the one seen in this photo were eliminated by relocating and re-aligning the sections together, that a child’s foot cannot pass and cause injury.

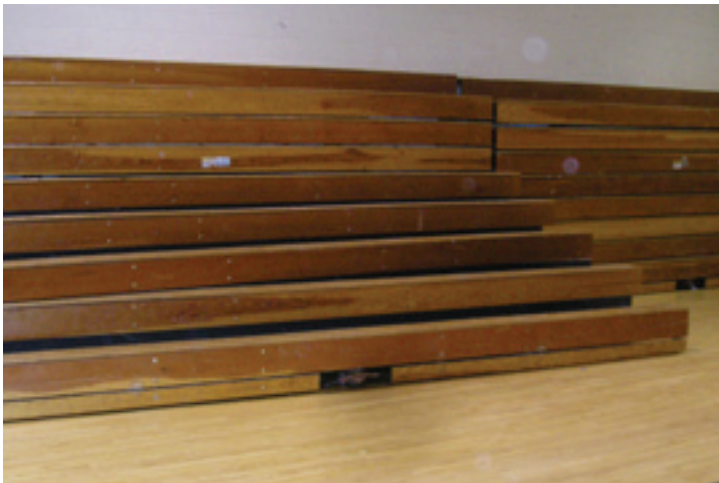
Before refurbishing, original bleachers were manually opened in sections. Opening individual sections creates a potential safety hazard because there are no safety rails at the ends.

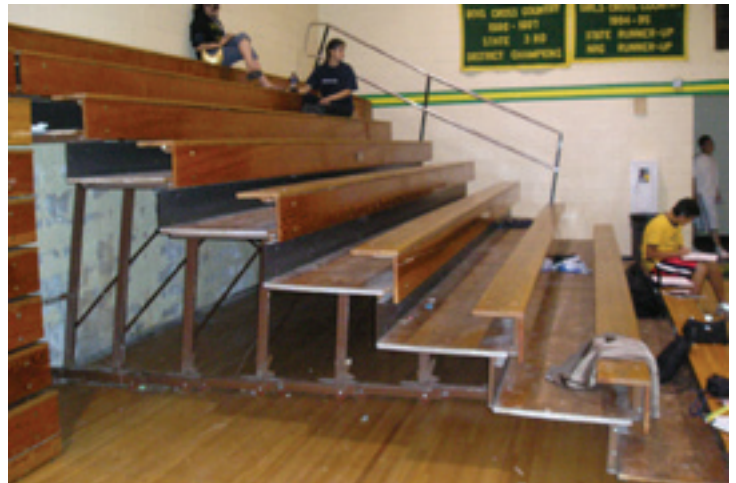
Older-style safety rail (near the wall) can be seen in this photo. Note there are no aisles or intermediate rails to facilitate ingress/egress.

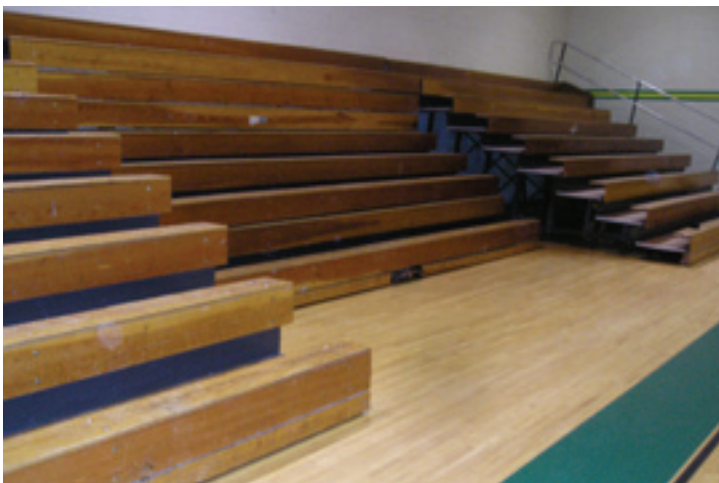
Even though these 30-year-old Universal bleachers lacked some modern safety features, they had many positive features such as excellent understructure, a closed deck and 1-inch thick fir lumber for seats. Bleacherman built upon these and preserved the owner’s equity in the original bleachers.

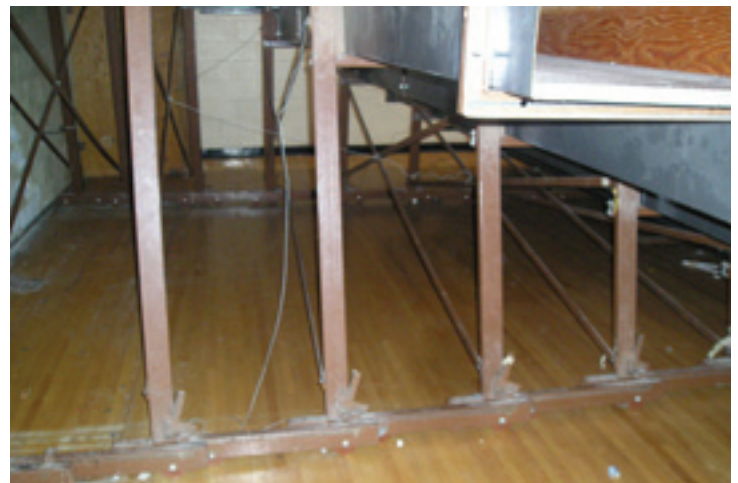
The Universal Rollaway understructure was a premium bleacher structure in its day. Even after many years of use, this understructure was basically sound. With Bleacherman’s expertise, quality understructures like this can be remanufactured to provide many more years of service – at a substantial savings.

Original lumber was removed while the understructure was unfastened from the wall and re-aligned (to remove gaps). Wood was sorted and grouped by type and species. Then all boards were planed, edged, sanded and stained to match. After two coats of sealer, boards were hand-sanded, then re-installed with new hardware prior to final coat of sealer. All wood refinishing was done on-site.

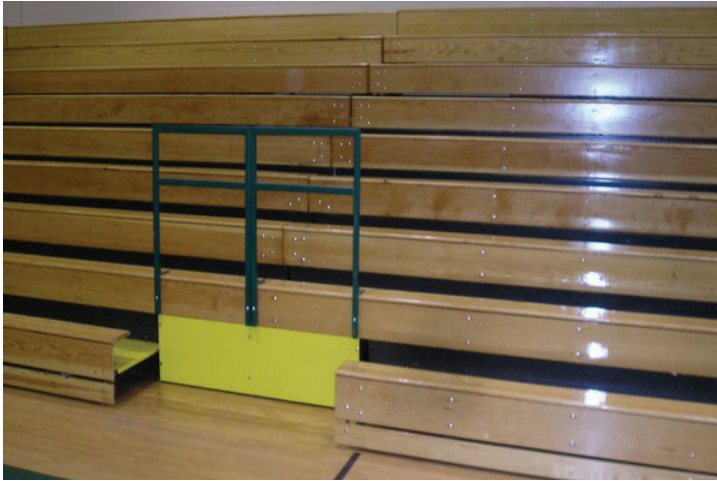
First row cut-out provides ADA compliance for wheelchair spaces with companion seats.

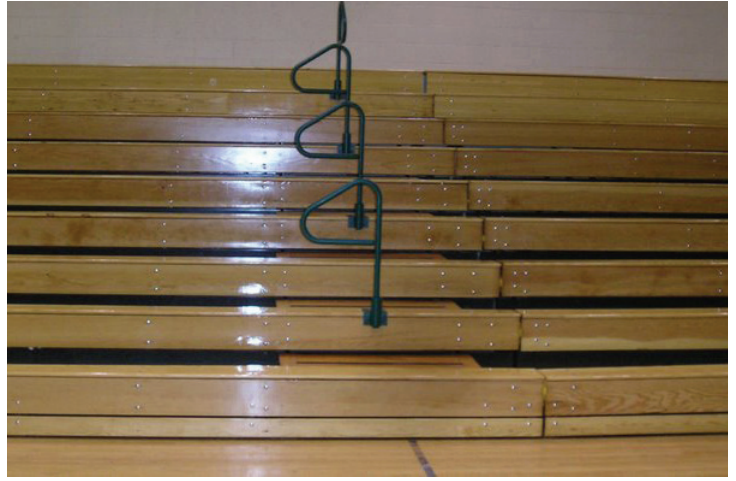
Seat level aisles and self-storing “P” rails help prevent trip and fall accidents from happening, by providing safer ingress/egress to bleachers.

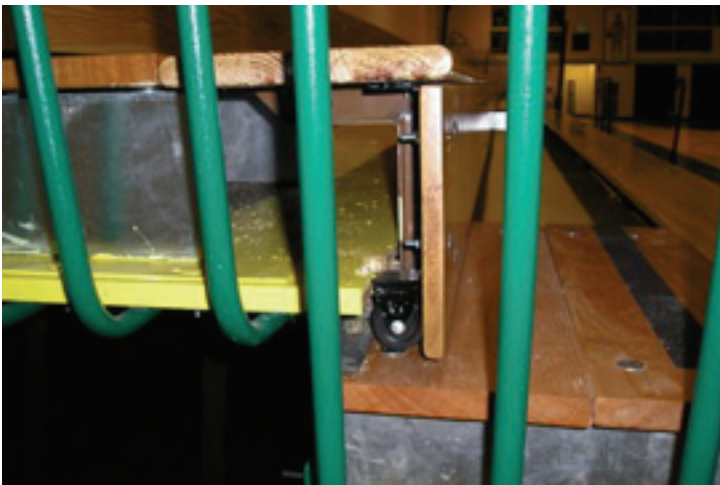
Century Design® system prevents sagging. End aisles (or intermediate aisles) provide continuous support for the Century Design® wheel.

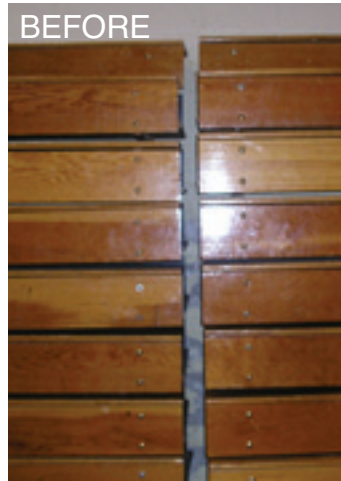
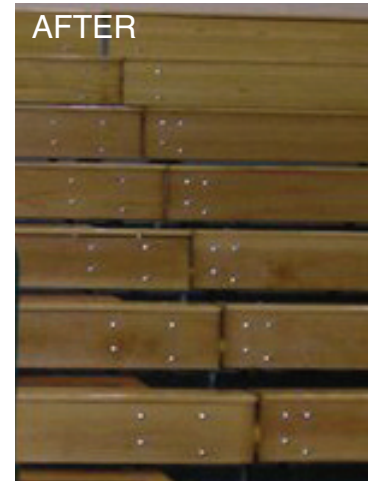
Compare the before-and-after difference of the gap between sections, as well as the improved look of the refinished wood.

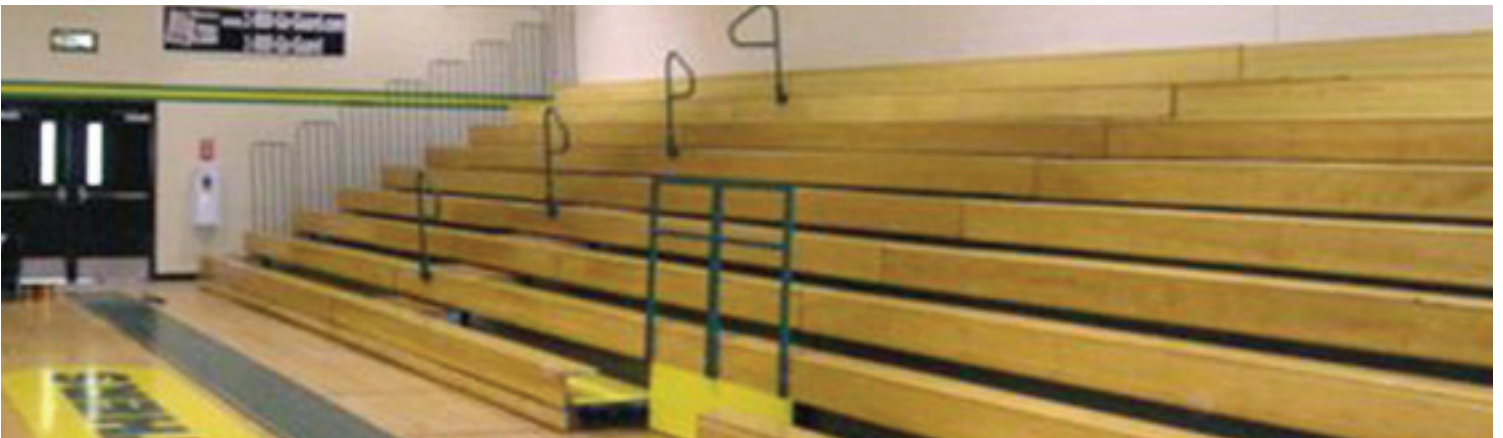
Aesthetics are important. MARS-Bleacherman pays attention to details, color-matching the footboards and railings to the school colors of yellow and green (as shown on the gym floor). When combined with functional features such as push button operation in conjunction with a no-sag Century Design® system, these bleachers are not only refurbished -- they are actually remanufactured to be better than new! Evergreen™ Seating Systems provide long-term trouble-free use at the lowest cost.
