Case History: remove old bleachers, install new Evergreen bleachers

Situation: Pickering-Sisson Middle School in Lynn, Massachusetts received a grant from the NFL as part of their “Keep Gym In School” program. The grant funded refurbishments to the gym, including refinishing the gym floor, walls and bleachers.

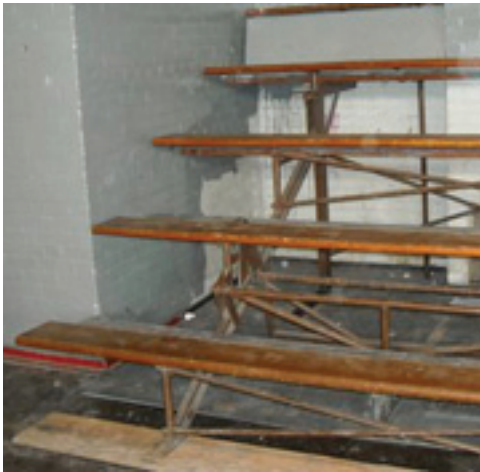
No safety rails, no aisles, Note walls and floor need refinishing.

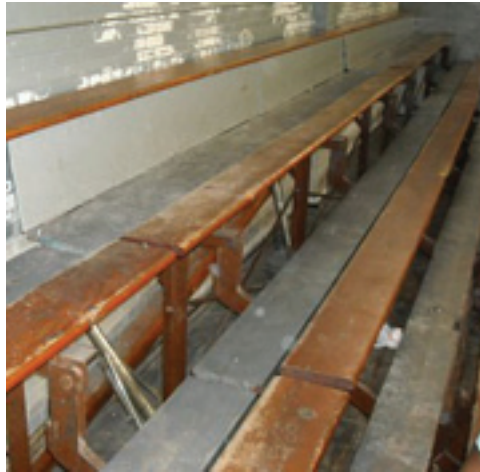
Large openings (between seatboard and footboard) present a safety hazard.

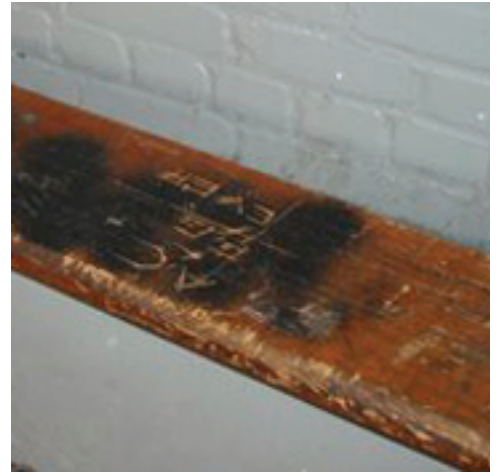
Fir lumber was solid 1.5” X 10” -- Years of wear and tear, plus vandalism, made it unsightly (but restorable).

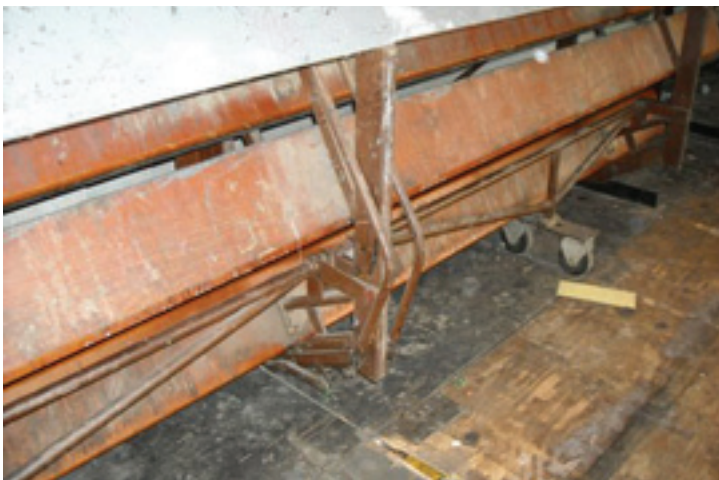
Old bleachers were manually folded up against wall. Note poor condition of gym floor.

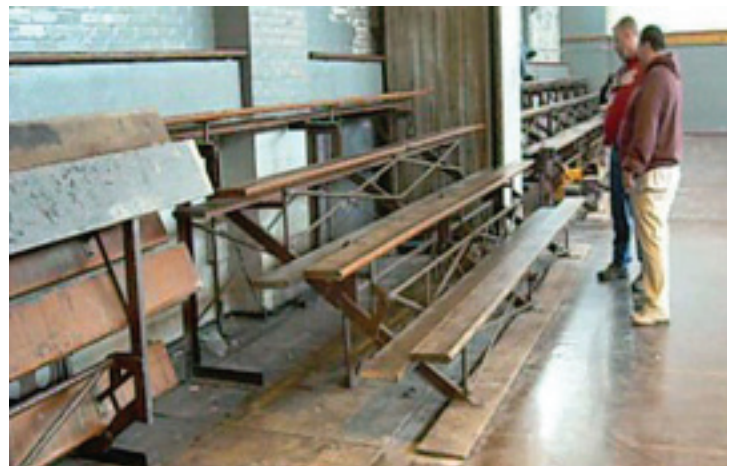
Old (60 - 70 years) slant-style bleachers cannot be made to conform with building and safety codes.

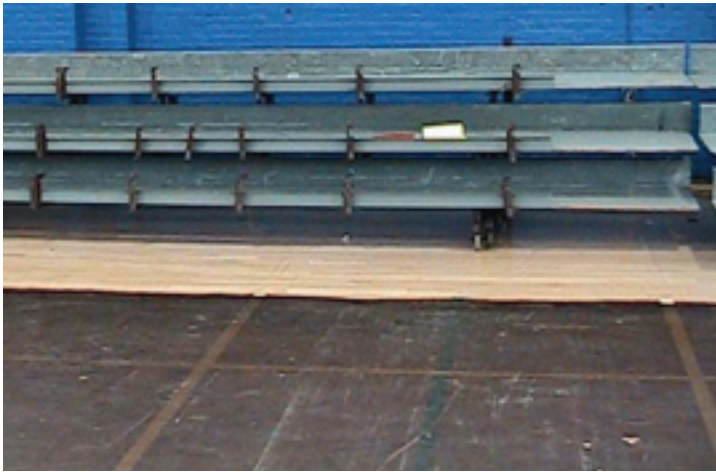
Old “slant-style bleachers were removed, then the area beneath the bleachers was sanded and sealed, prior to installing the new bleacher understructure.

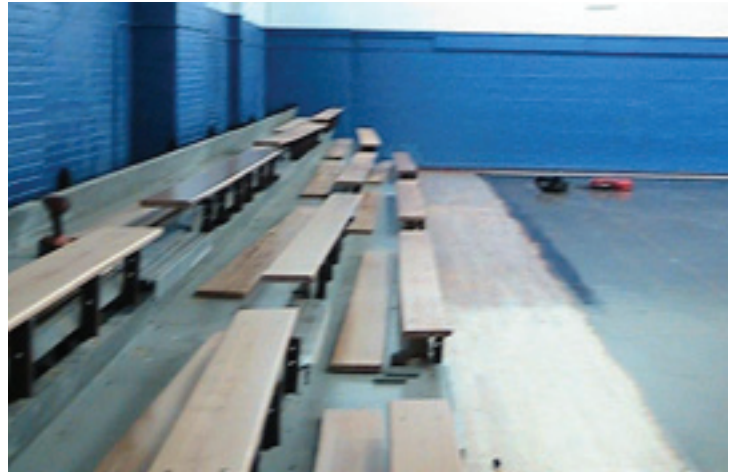
Remounting the fir seatboards after reconditioning. Note the before-and-after difference of the bleacher boards and the gym floor.

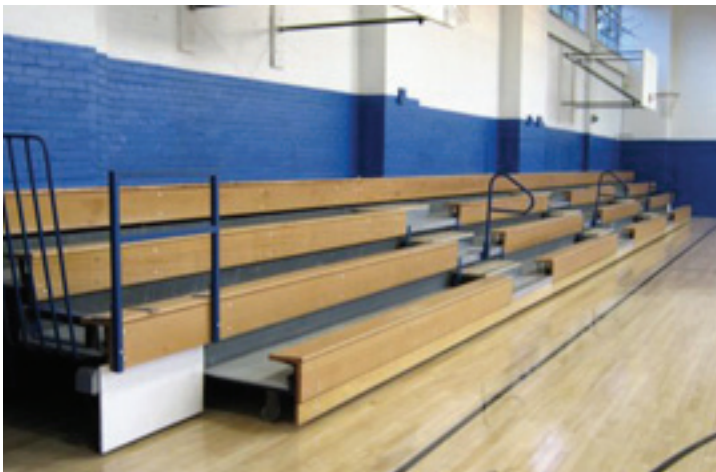
Long view shows the new safety equipment in place: end rails, ADA rail, P-rails, closed deck with 48-inch aisles

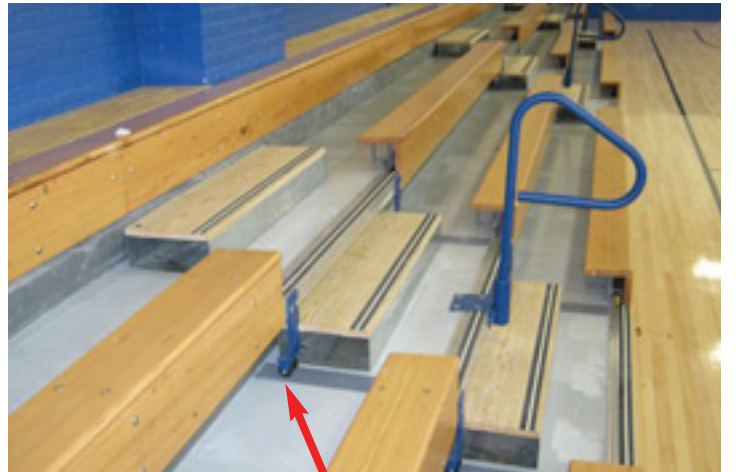
Foot-level Century Design® “no-sag” system reinforces the new bleachers, comes with a 20-year warranty. Intermediate steps with non-skid tape are code-compliant.

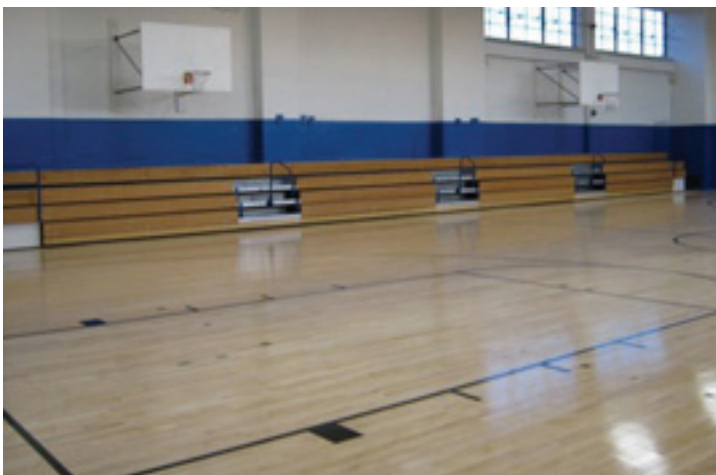
Fully refurbished gym looks brand new. Reconditioned bleacher wood maintains the traditional beauty of its original furnishings. No new wood was required, providing a very substantial savings.

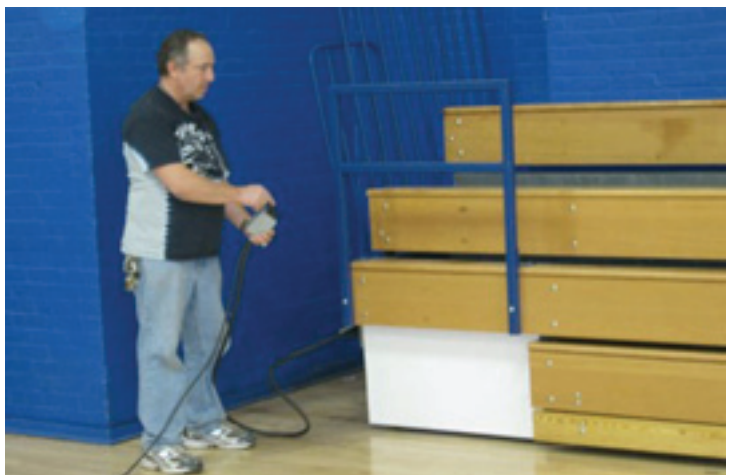
Another safety feature: bleachers have no live wiring underneath. Drive system is energized only when the operator plugs in the pendant controls to the nearest wall outlet to open or close bleachers.
