Case History: Plattsburgh Middle School, Plattsburgh, NY

Old “Slant Style” bleachers had to be discarded -- New Evergreen Bleachers™ took their place

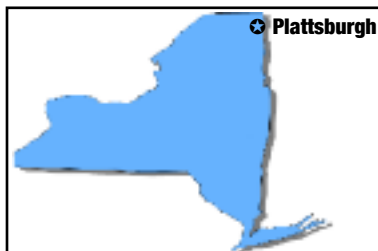
Situation: Plattsburgh Middle School had very old “slant-style” bleachers. This type of bleacher is no longer manufactured and cannot be made code-compliant, because its open deck design has openings that a child could fall through.

However, this old fashioned type of bleacher did have a sturdy “four-horse” understructure (i.e., four vertical support columns for each section of bleachers).

The bleachers were removed and replaced with new Evergreen Bleachers™, with a four-horse system and closed deck. The existing Fir boards from the original bleachers were reused, after they were planed, edged, sanded and sealed for an “as-new” look.

Self-storing end safety rails, aisles with P-rails, ADA rails and the patented Century Design® “no-sag” system were installed to make the bleachers safe and meet applicable safety codes.

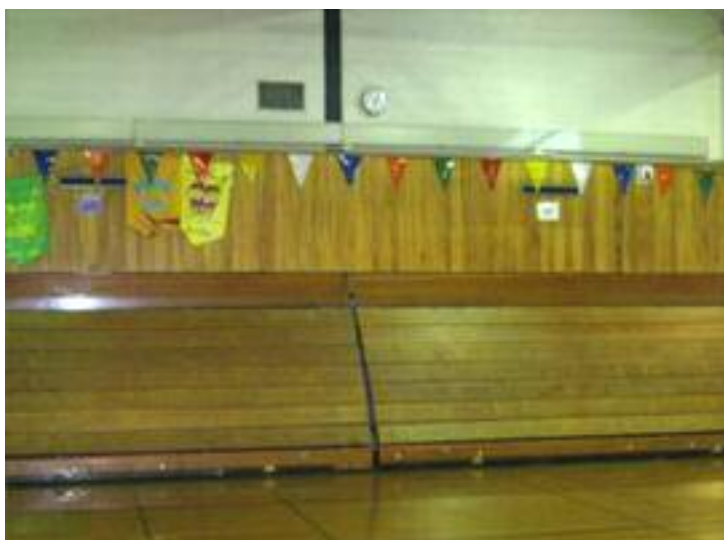
The original “slant-style” bleachers in the Plattsburgh Middle School gym. This old-fashioned design is sturdy, but its open-deck design has large gaps when opened.

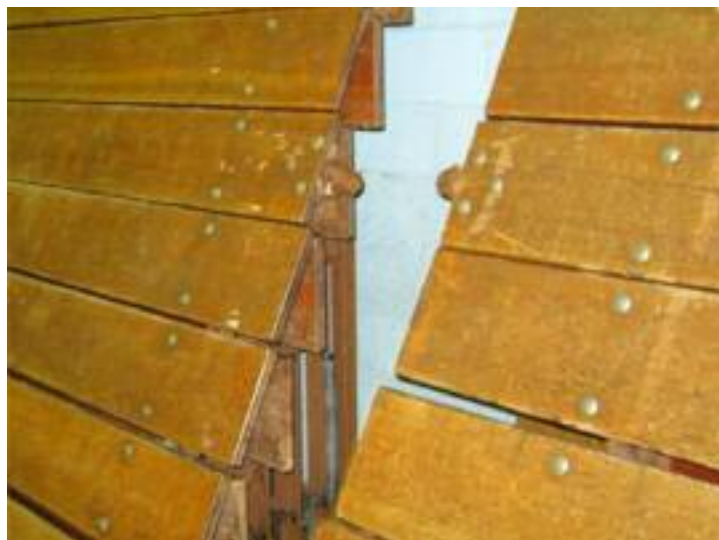
Original Fir boards showed decades of wear-and-tear, yet were of good quality and thick enough to be refinished to like-new condition.

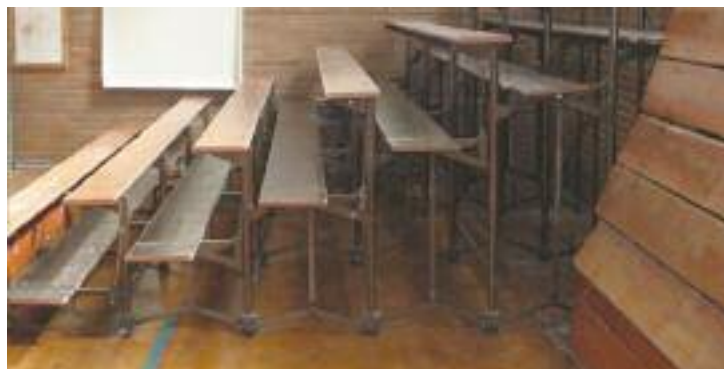
Same bleachers at a different school

Photo of the same kind of “slant-style” bleachers shows the open deck system. Large gaps on each side of footboard have been described as “an accident waiting to happen.” This outmoded type of bleachers does not meet safety codes and must be replaced with a closed deck system.

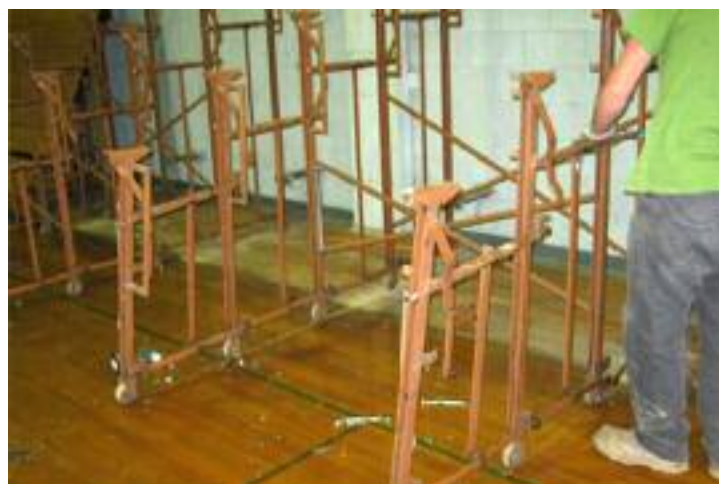
After the Fir lumber was removed for refinishing, the original understructure was dismantled.

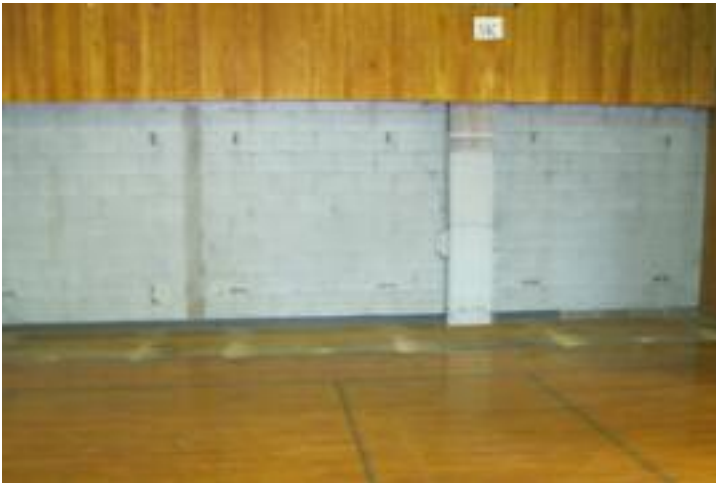
Removal down to bare walls is complete.

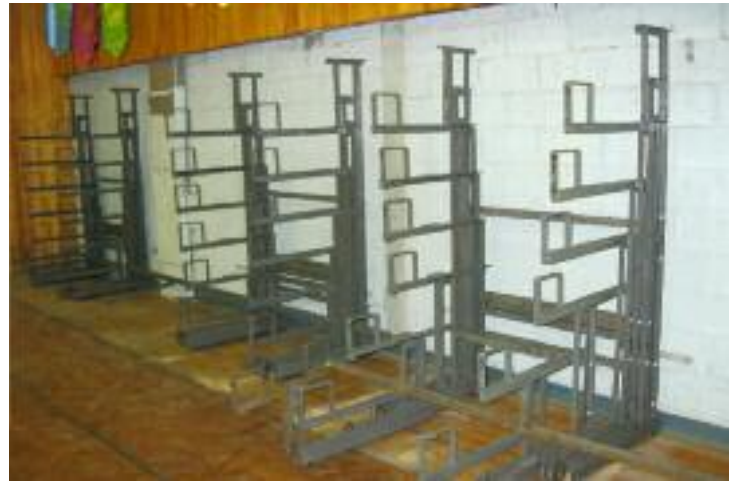
Evergreen Bleachers™ understructure being installed. Owner wanted to continue with a “four-horse” system for durability and longevity.

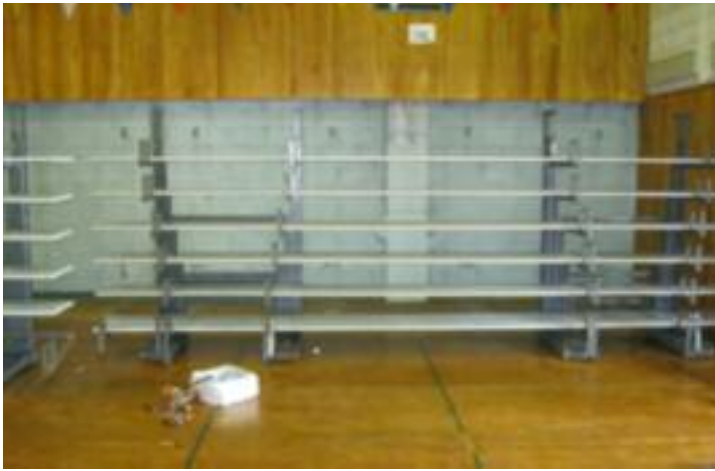
After the understructure was anchored to the wall, new footboards (painted gray) are installed.

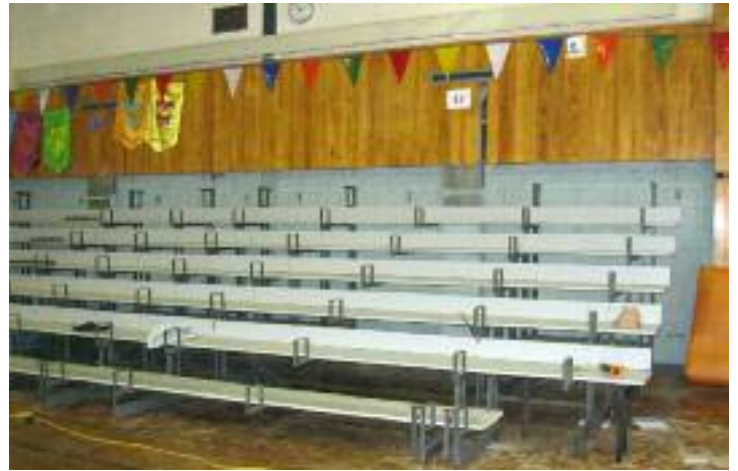
After footboards are attached, heelboards are installed. The new bleachers will have a “closed deck” design, with no gaps that can present a safety hazard.

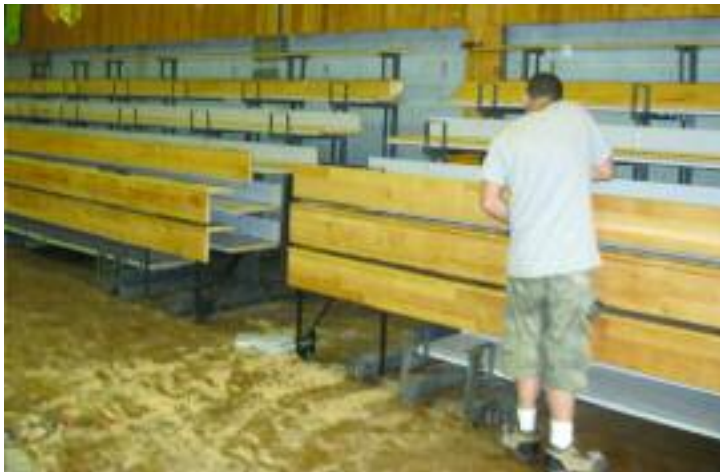
Bleacherman crew member installing newly refinished risers and seats. All the original Fir lumber was reused, for a fraction of the cost of new lumber.

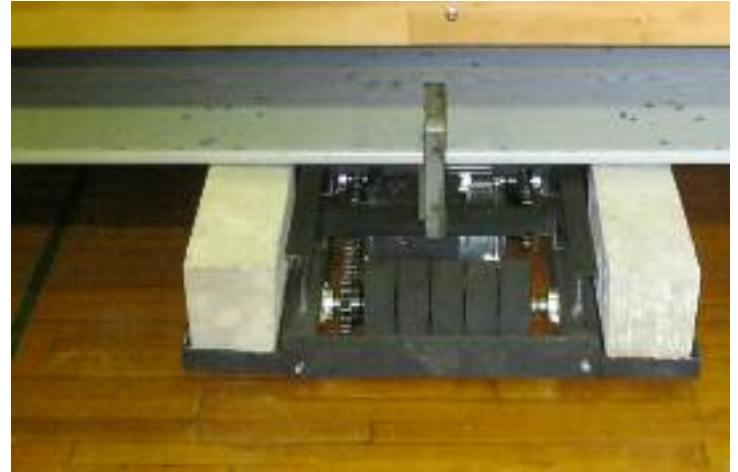
New motorized drive with ballast blocks on each side is attached at row one. New bleachers will open at the touch of a button, instead of being manually operated.

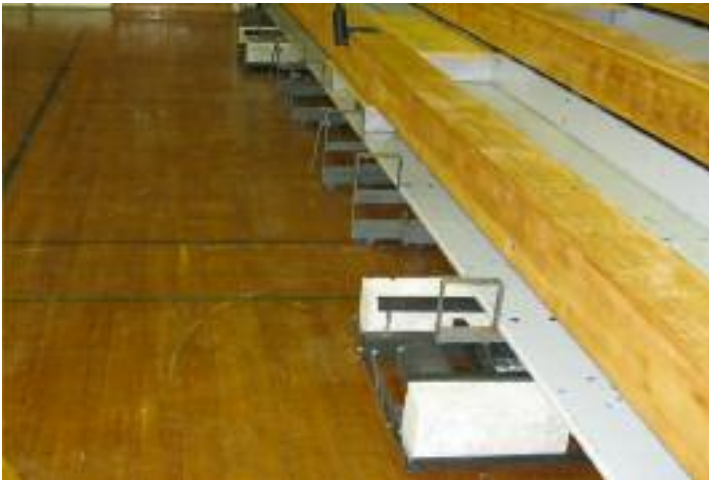
Two motorized drives can be seen on this bank of bleachers. The nosebeam and first row seats will be attached later.

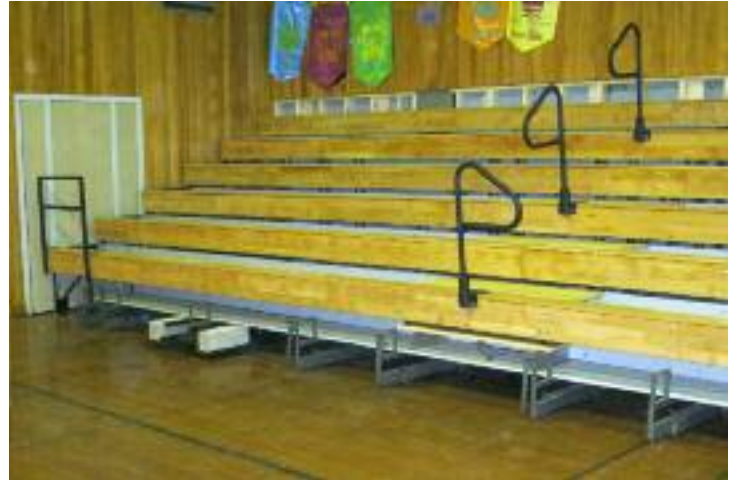
P-rails and ADA rails are installed. First row seat boards and noseboards are yet to be installed in this photo.

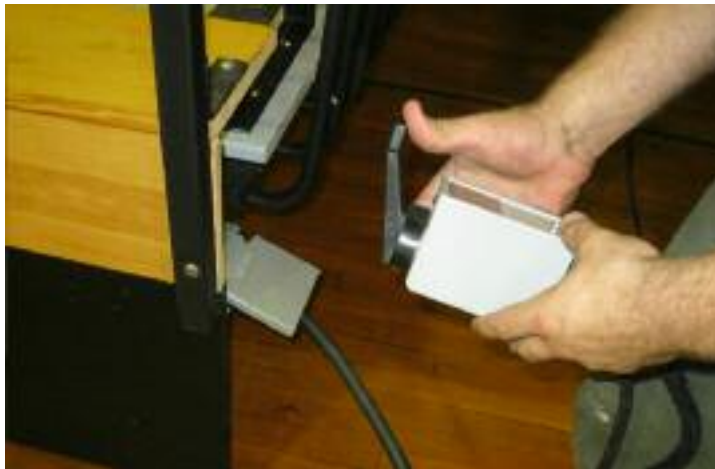
Removable pendant controls for motorized drive are a safety feature -- only authorized maintenance personnel can open and close the bleachers.

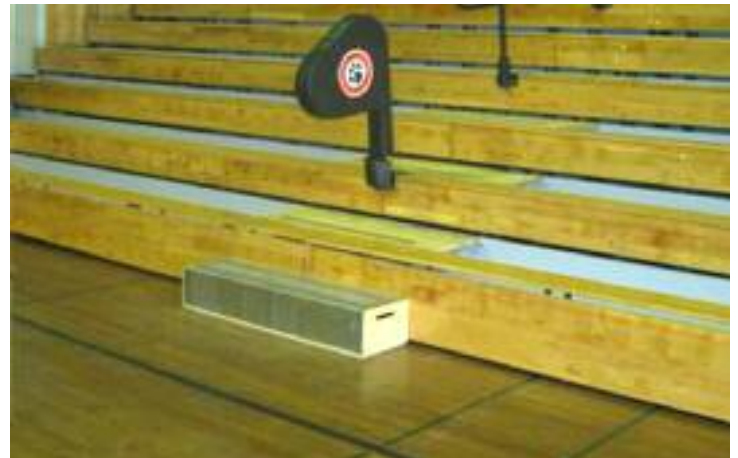
Photo shows seat-level aisles with demountable first row step. In addition to providing better ingress/egress, these aisles provide support for the Century Design® system that is installed at the aisles.

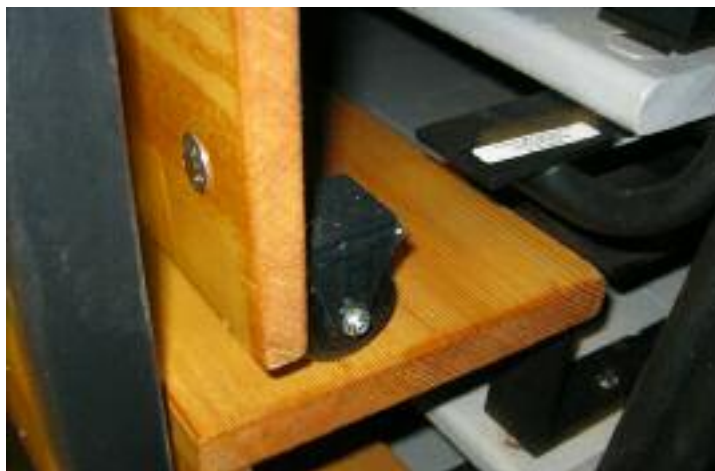
Patented Century Design® "no-sag" system uses seat-level runners at the ends of the bleachers, and intermediate steps at the aisleways.

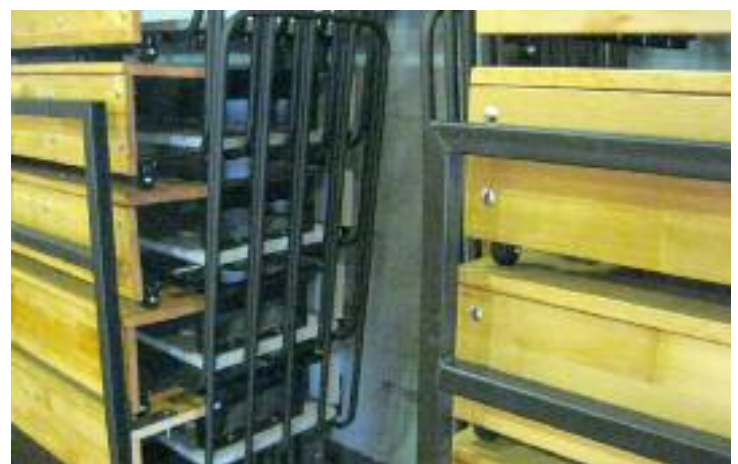
Showing end safety rails and Century Design® system at end of bleachers.

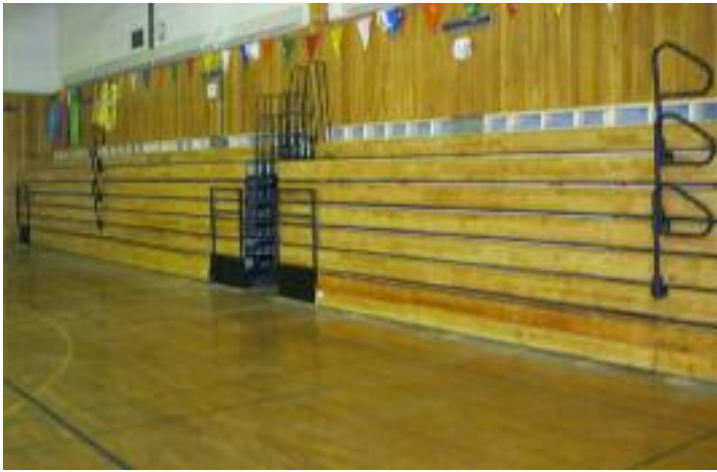
End safety rails and P-rails are self-storing -- they remain mounted in place when the bleachers are in the closed position.

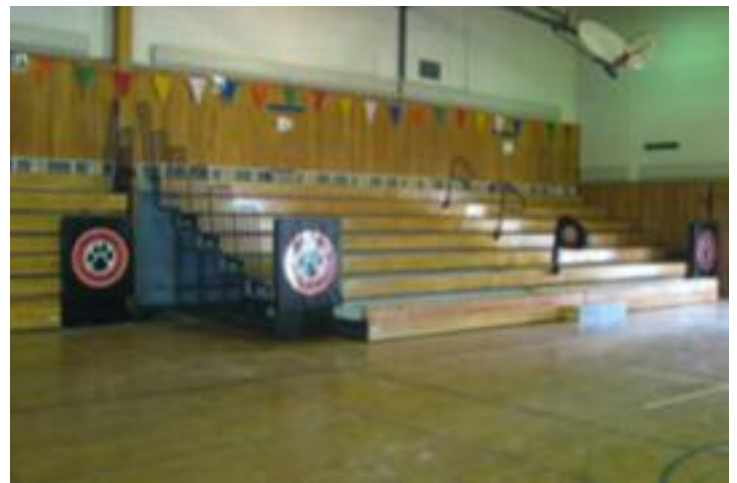
Photo shows one bank in open position. Note demountable first row step at aisleway. All intermediate steps have non-skid tape.

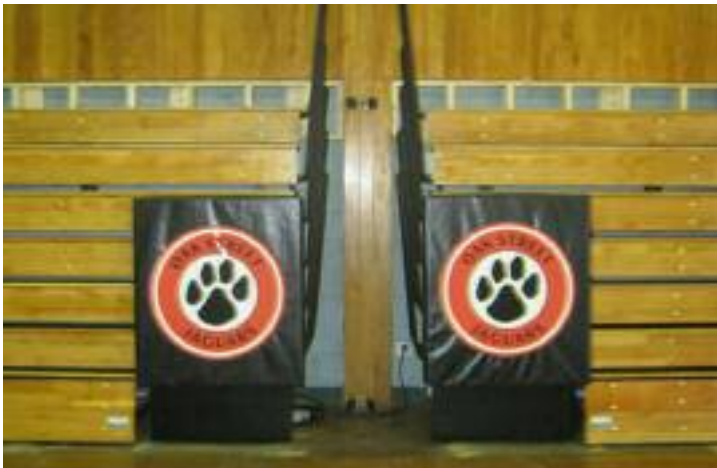
Pads for ADA safety rails. Logo artwork imprint of school mascot insignia is provided courtesy of the Bleacherman.

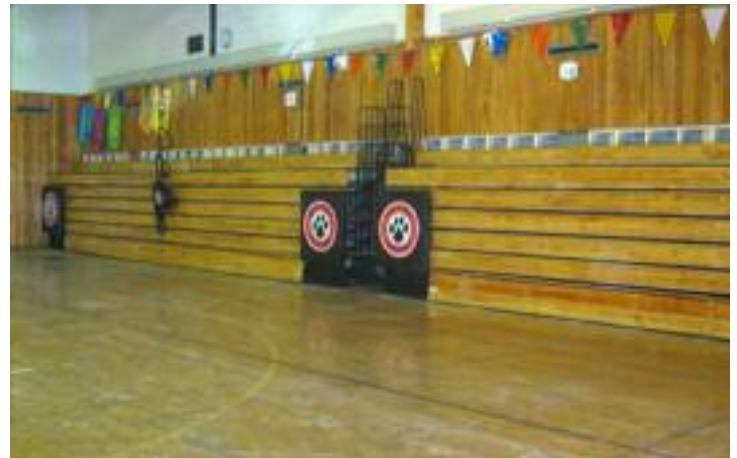
Removable padding for both ADA rails and P-rails is seen in this photo.
