Case History: Quechan Tribe Community Center, Yuma, Arizona
Complete seating remanufacturing including code updates and motorizing:
2 banks of Medart Bleachers converted to Evergreen™ Bleacher System
Plane, edge, sand and seal wood seats and risers on-site

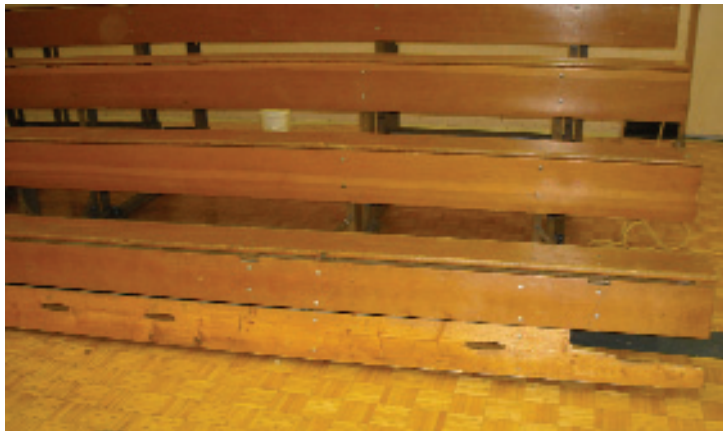
Original Medart bleachers were unanchored from the wall and moved forward, allowing room to repair the floor and wall behind bleachers. These bleachers had a lot of damaged wood, so top row seats and risers were replaced with new lumber.

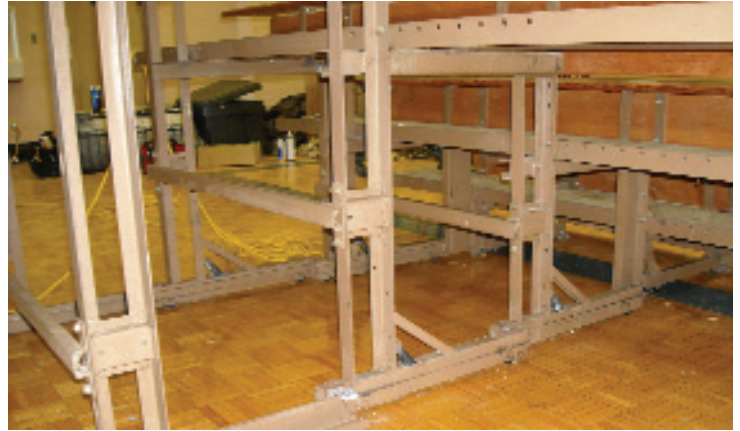
“Open deck” feature of original bleachers can be seen here. Because of the potential safety hazard, open deck seating will not meet most current code requirements.

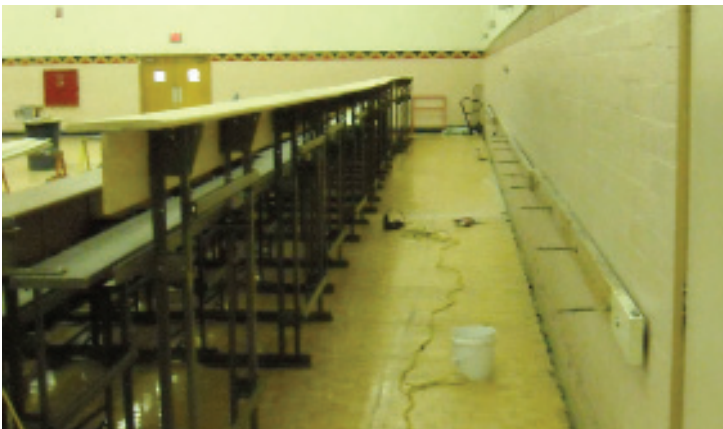
The understructure was thoroughly cleaned and repaired.

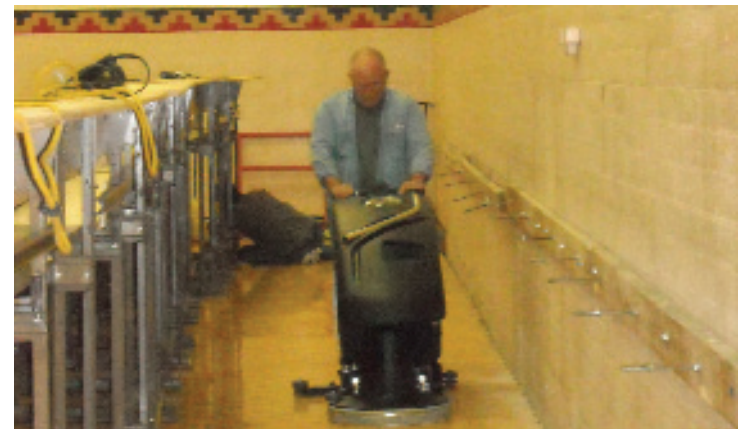
Owner refinished walls above and below colored stripe on wall. The stripe represents an Indian basket design.

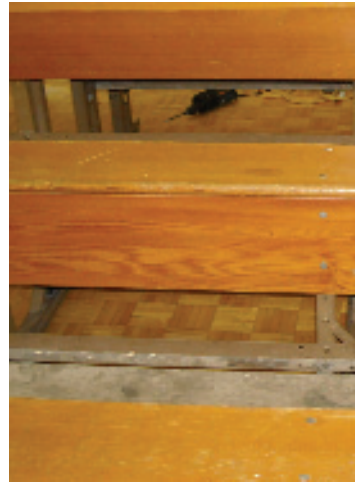
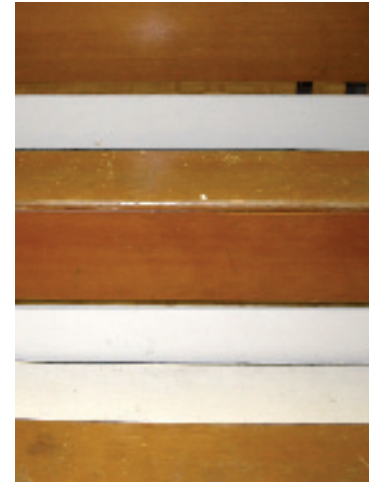
Bleachers on both sides of the Community Center were unanchored from the wall and moved to make room for cleaning and refinishing.

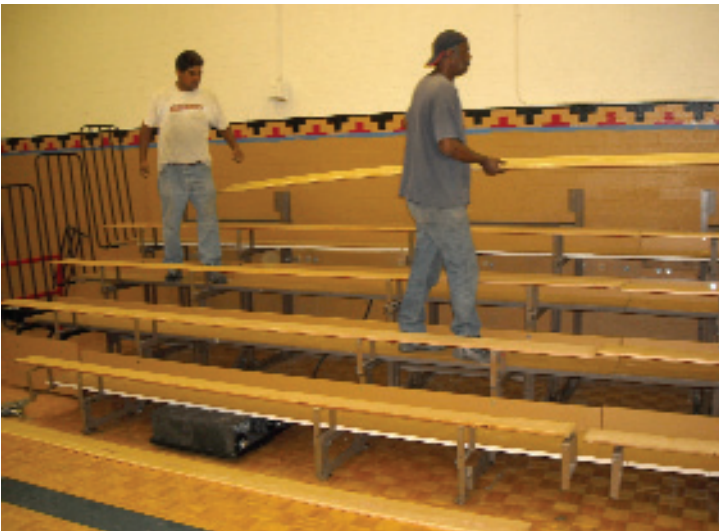
At left: Open deck of original bleachers. At right: new heel-board and partial footboard (seen here with a primer coat of white) now make this a closed deck. Bleachers are safer, because a child's foot cannot pass through the opening.

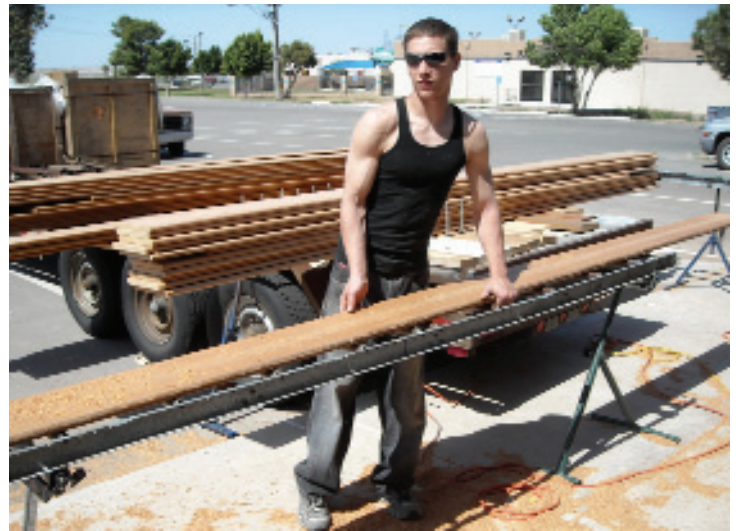
Seats and risers being removed for refinishing.

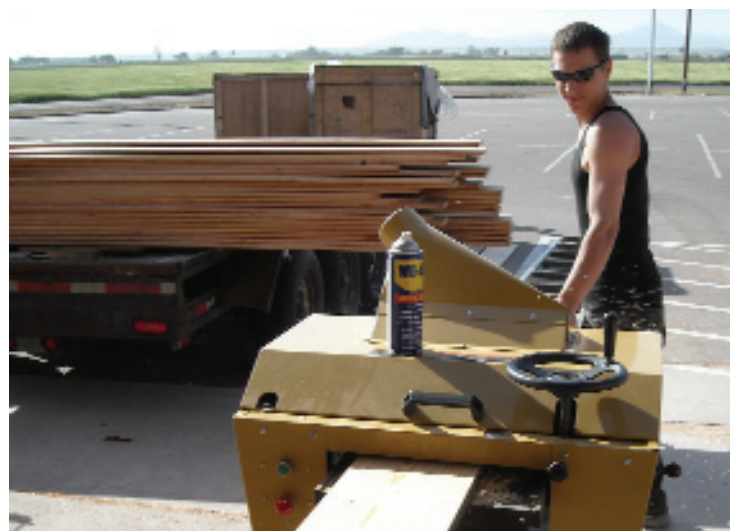
Boards were planed, edged and sanded outside, to minimize the mess.

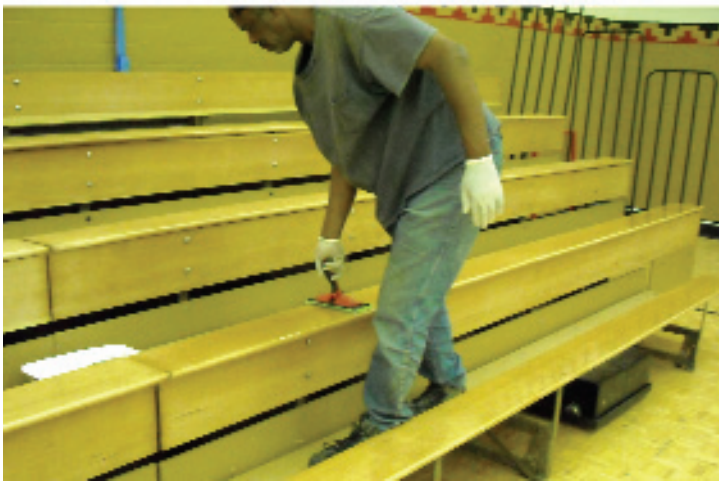
Photo shows employee refinishing seats with three coats of approved sealer.

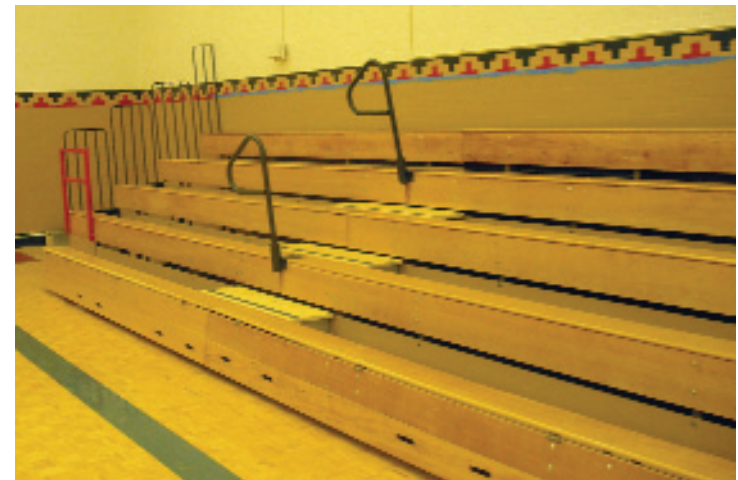
ADA wheelchair cut-out and safety railing is incorporated into the end of the telescopic bleachers.
